**FINAL REPORT ON THE
AUGUST 18, 2004 DCS EVENT**

ERCOT COMPLIANCE

January 2005

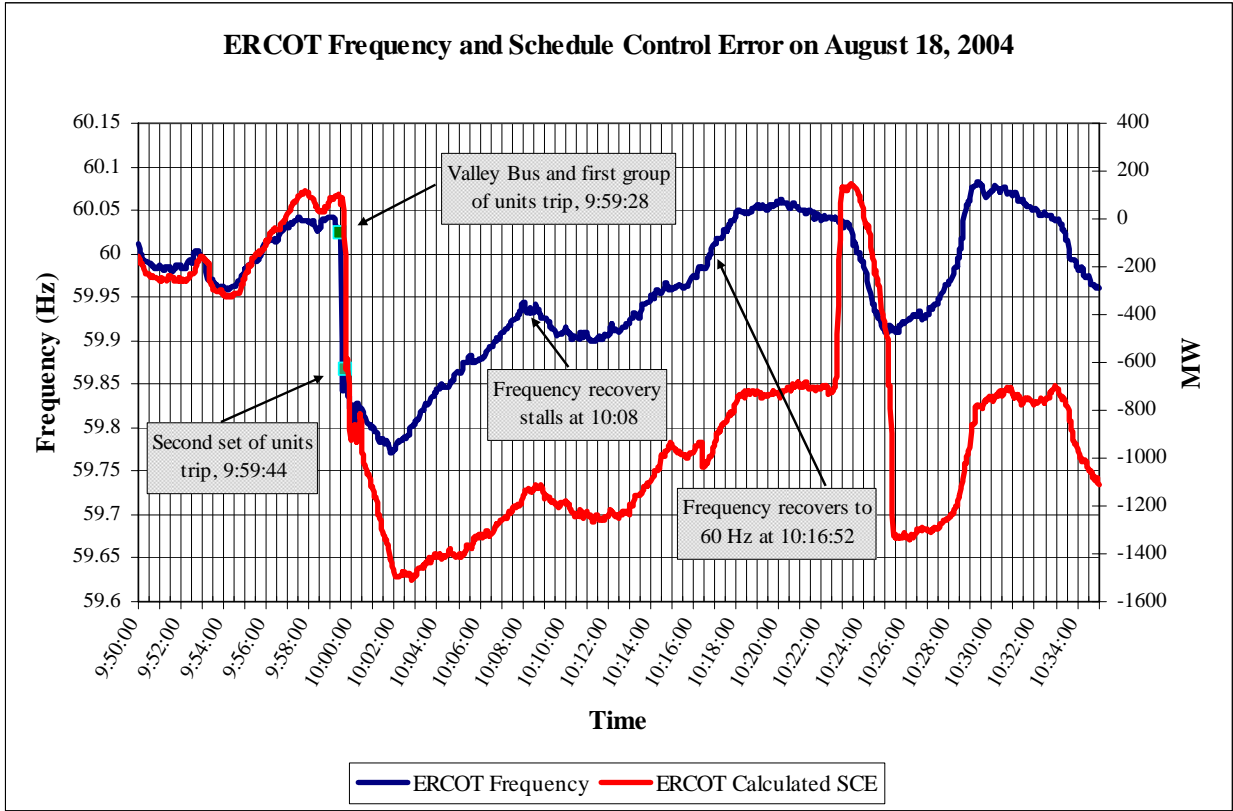
Figure 1: ERCOT Frequency and SCE on August 18, 2004

Frequency recovery began as expected with deployment of ancillary services. Approximately 10 minutes into the event, frequency recovery stalled for 6 minutes. The stall was apparently due to a combination of factors including, a large load increase of 900 MW, and a large amount of down balancing in progress at the beginning of the event.

If there had been no large load increase as ERCOT was recovering system frequency—all other factors being the same—the overall recovery time back to 60 Hz would have been several minutes shorter and within the required DCS standard. See Figure 1, note points where frequency stalled and recovered to 60 Hz.

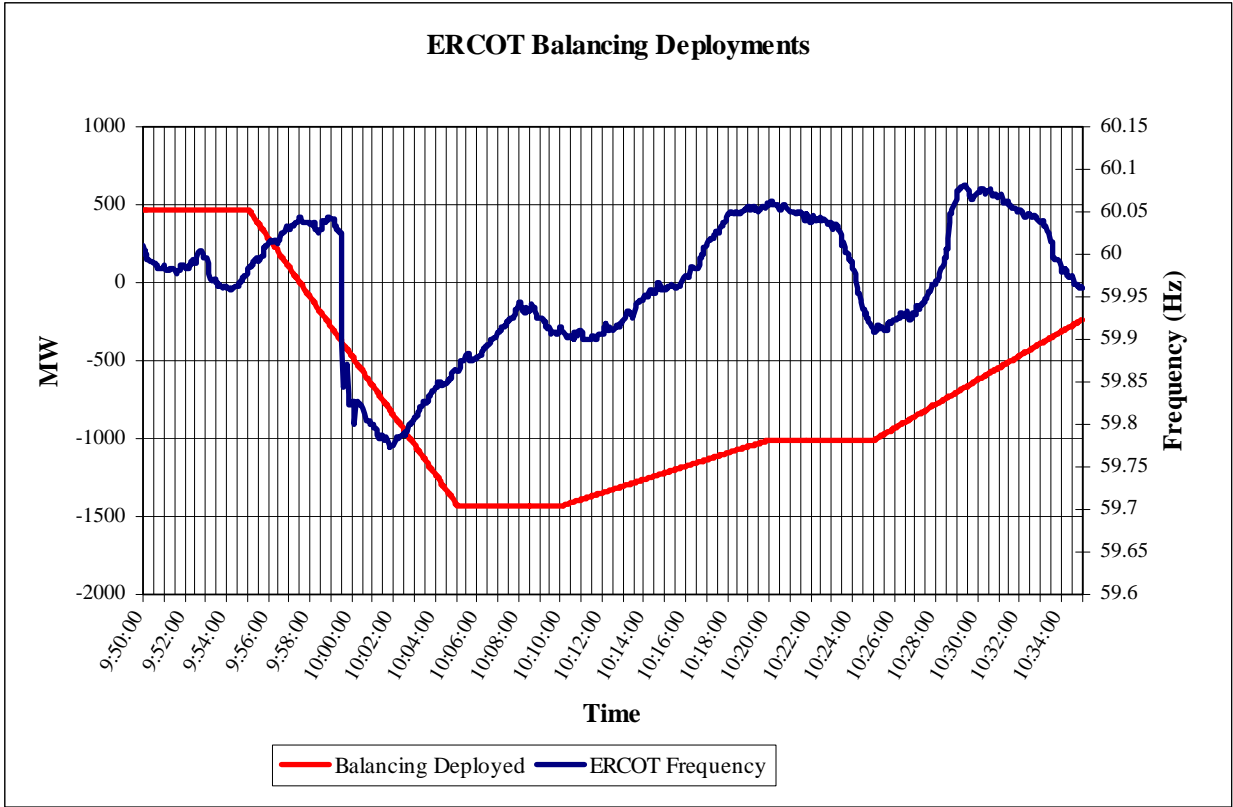
Figure 2: Balancing deployments on August 18, 2004

As the disturbance occurred at 9:59:20, down balanced QSEs were already 4 minutes into their ramp and were instructed to keep down balancing for the next 5 to 6 minutes, see Figure 2. If ERCOT was not in a down balancing situation when the event occurred, it is likely recovery would have been achieved much sooner, since the units would not have had to overcome their downward inertia. See Table 3.

Thus at 9:55, ERCOT had issued instructions to many QSEs to balance down, even though load was increasing. When the event occurred—almost halfway through the ten minute ramp window—several QSEs were decreasing generation vigorously to support these down balancing deployments. This large amount of down balancing was in response to the QSEs raising their fleet generation to meet their expected obligations for the hour.

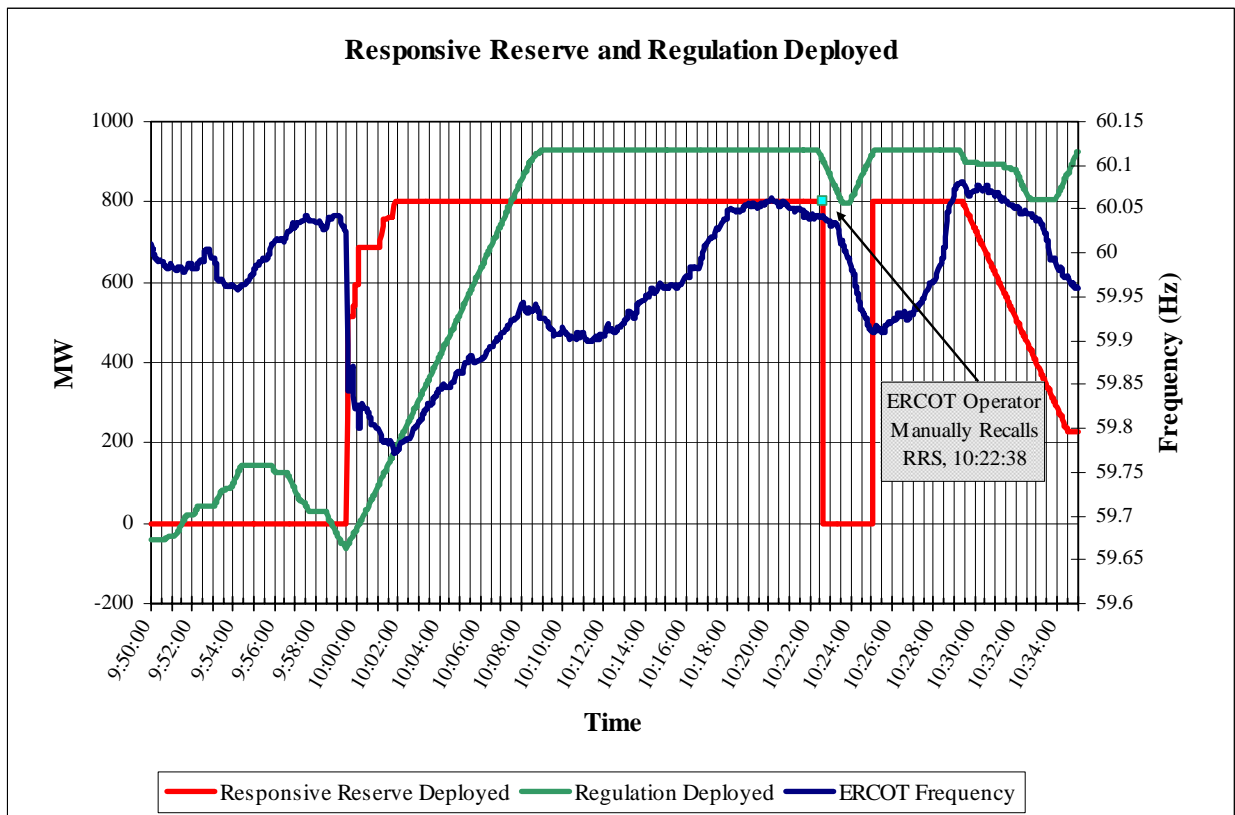
Figure 3: Responsive reserve and regulation deployed on August 18, 2004

With the QSEs ramping up to meet schedules, ERCOT frequency was above 60 Hz near 9:56. Down regulation is deployed at 60.036 Hz, thus ERCOT was sending down regulation instructions just as the DCS event began, see Figure 3. When the first of the units tripped at 9:59:30, ERCOT recalled 55 MW of down regulation and started deploying up regulation at a rate of 108 MW/minute. Up Regulation reached its available limit at 10:09:02 with 930 MW. Up Regulation reached its available limit at 10:09:02 with 930 MW.
