# ERCOT HURRICANE IKE Summary

On Behalf of the ERCOT Reliability and Operations Subcommittee

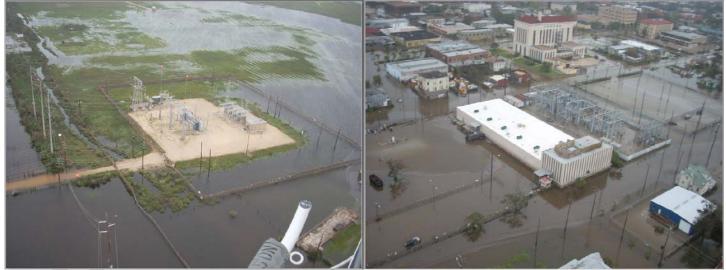
Older lower elevation substation designs were more susceptible to storm surge.

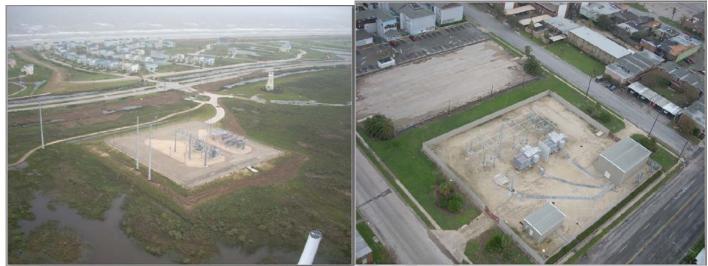
Newer higher elevation substation designs were helpful in protecting against storm surge.

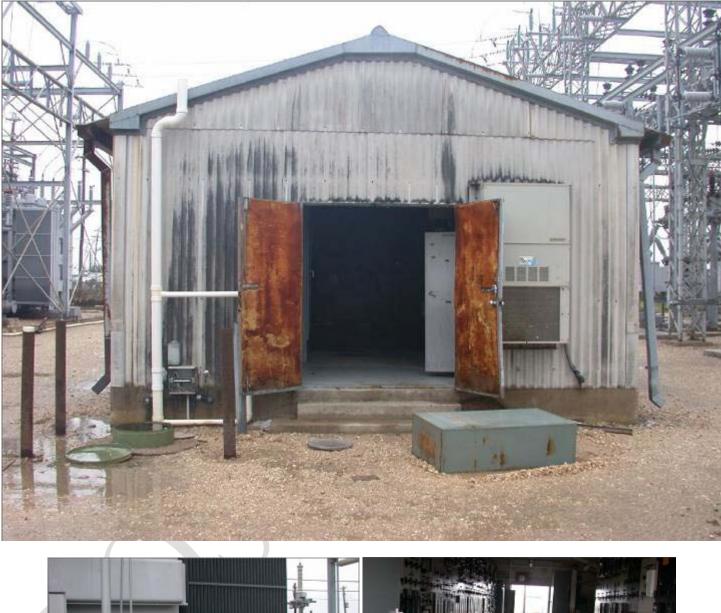
STORM SURGE IN GALVESTON WAS SIGNIFICANT AND DAMAGE TO THE WEST GALVESTON SUBSTATION WAS PRIMARILY DUE TO ITS PROXIMITY TO THE COAST.

- After reviewing damage assessments and analyzing power flow study results, CenterPoint Energy decided not to restore the 69 KV portion of damaged West Galveston substation and 69 KV Ckt. 13, Lamarque – West Galveston
- Removal of damaged 69 KV connections to Galveston Island could cause some increased loading on remaining three 138 KV connections to Galveston Island (Timing depends on rate of load restoration and growth on Galveston Island)

- CenterPoint Energy believes upgrades of remaining 138 KV facilities would be more practical, cost-effective, and timely than restoration of damaged 69 KV facilities
- o CenterPoint Energy will evaluate upgrades to remaining 138 KV connections to Galveston

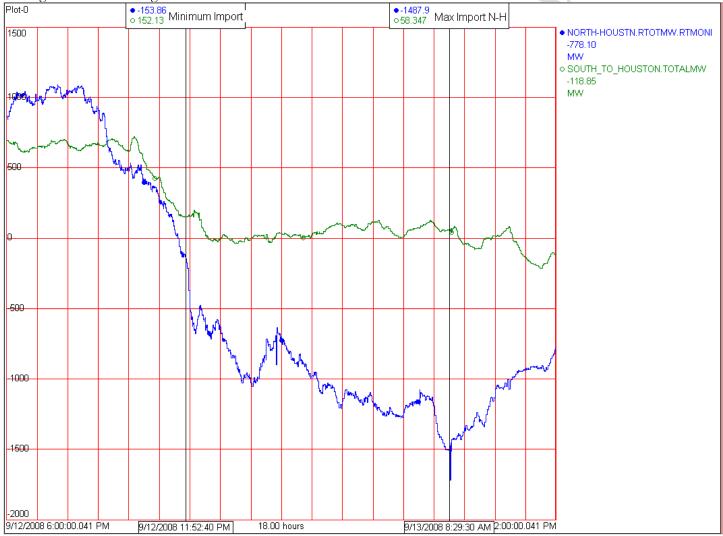
## Chart-ERCOT Transfers Houston Area 9/12/2008 6:00:00PM to 9/15/2008 6:00:00PM

The following Chart shows the flow as approximately 100 MW net export from Houston at midnight. During the storm Houston became a net exporter as load dropped due to distribution outages. At 8 am ERCOT observed a maximum export of approximately 1500 MW. By this time the storm had passed over the Houston area and was located between Cleveland and Conroe Texas. The storm was moving slowly at about 15 mph North and East. The Entergy and ONCOR systems were starting to encounter outages due to Hurricane force winds in their service area.

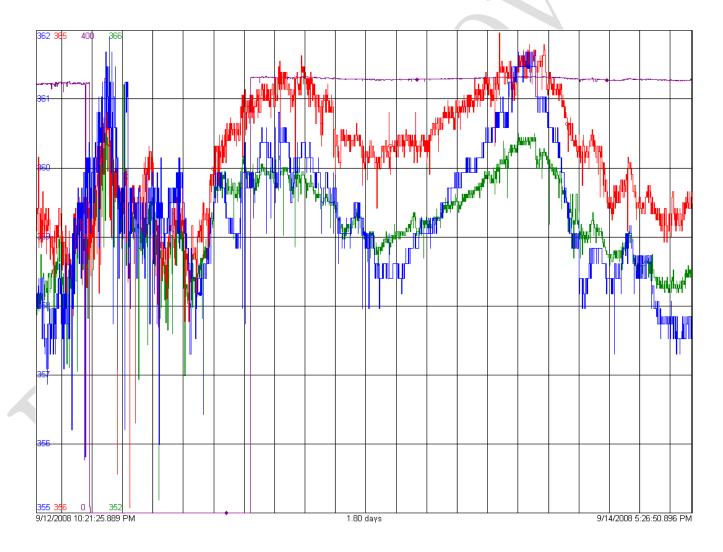
This chart shows Voltages on the 345 KV system were as high as 363 KV at THW and 361 KV at WAP 345 KV busses, within 5% of nominal voltage. As indicated on the following chart, NRG's generators on the 345 KV system (WAP units 6, 7, and 8) operated in the lead to reduce voltages, while the 138 KV unit (WAP-5) operated slightly in the lag, close to unity when generator transformer losses are considered. This indicates good performance by the generating units in controlling high 345 KV voltages. Less generator support was required on the 138 KV system because the 138 KV system voltage is largely managed by automatic tap changing 345/138 KV autotransformers.

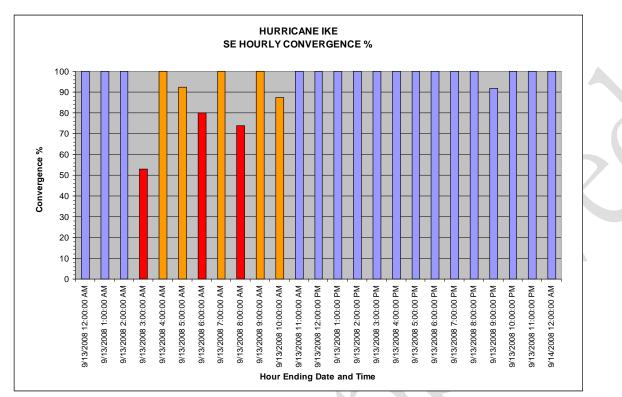
Figure 1 State Estimator Convergence Performance

It can be seen for hour ending 3am, the convergence performance reduced to approx 52%. This is due to the time when Hurricane Ike made land fall at approximately 2:10am on the Texas coast resulting in the loss of transmission elements and large numbers of topology changes in the State Estimator. During multiple changes on network, the State Estimator was receiving momentarily incorrect status of switches on the network due to loss of telemetry caused by the Hurricane. Discrepancies between out of service elements, telemetered MW generation, transmission flows and switching device status caused a number of the State Estimator 'Invalid Solution'. This lowered the convergence performance for hour ending 3am. The same effect can be seen for hour ending 6am, when Hurricane Ike reached the Houston area at approximately 5:20am. State Estimator again produced a number of 'Invalid Solutions' due to discrepancies between telemetered values and out of service elements. The reduced convergence performance for hour ending 8am was the result of the ERCOT EMS Tap Estimation application estimating incorrect tap position for a Phase Shifter transformer. This was identified by ERCOT support personnel and required manual replacement. The issue's surrounding Tap Estimation is further discussed later.

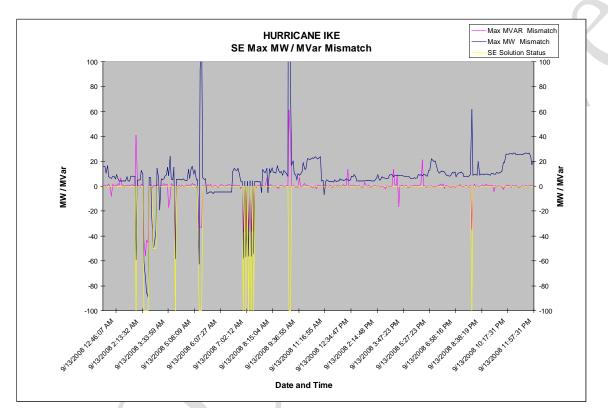
Figure 2 State Estimator MW/MV ar Mismatch and Solution Status

As mentioned earlier, to be included in the convergence performance, the State Estimator solution must be a 'Valid Solution', and meet the 30MW/MVar mismatch criteria. Figure 2 below shows the maximum MW and MVar mismatch for each State Estimator run. Also provided (in yellow) is the State Estimator solution results which are represented as Valid Solution = 0, Solved with MW/MVar mismatch = -50, and Invalid Solution = -100. This shows the number of Invalid Solutions and Solved with Mismatch around the 2:10amd and 5:20am times, corresponding to Hurricane Ike reaching the Texas coast line and also reaching Houston.

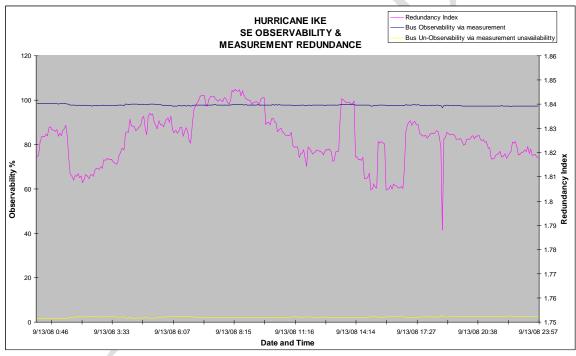
Figure 3 State Estimator observability and Redundancy Index

The State Estimator Observability was not impacted during the Hurricane event. This can be seen in the Measurement Observability statistics in Figure 3 below. Those sites that were no longer observable because of telemetry failure were already out of service and therefore did not adversely affect observability or the state estimation. On occasions when ERCOT lost telemetry before the site was physically out of service, the situations were identified quickly and resolved by manually replacing the SCADA on the ERCOT State Estimator after the situation was verified by the QSE or TSP.

The Redundancy Index during Hurricane Ike was very erratic compared to normal operating conditions. The large variations can be attributed to the loss and recovery of large amounts of telemetry from remote RTU's. The Redundancy Index is also affected by the manual replacements performed by QSE's, TSP's and ERCOT. However the number of manual replacements performed compared to the total number of telemetered points available is very small, therefore the effect on the Redundancy Index is also very small. As can be seen the Redundancy Index never went below 1.0, and on average held at approximately 1.82 for the day. During normal operating conditions the Redundancy Index ranges between 1.8 and 2.2.

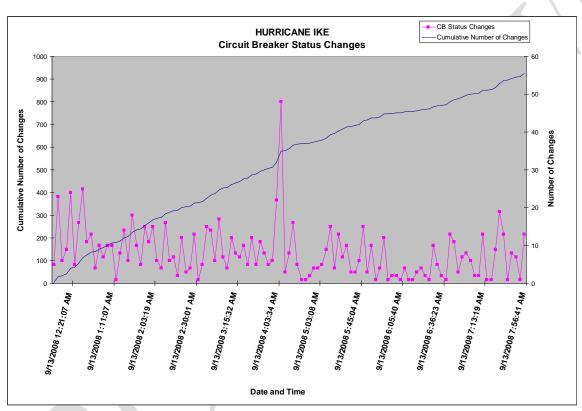
Figure 4 State Estimator Circuit Breaker Changes

The amount of system topology changes handled by the State Estimator increased during the Hurricane Ike event. Figure 4 below shows the total number of Circuit Breaker changes and the Cumulative Number of Changes with each State Estimator run. The time scale has been reduced to show the amount of changes during Ike's land fall at 2:10am and as it moved through to Houston at approximately 5:20am.

It is hard to determine from Figure 4 how much the topology changes affected the performance of the State Estimator, as it not only depends on how many changes, but also depends on the what circuit breaker and its location on the ERCOT grid. What can be seen is between the hours of 12am and 6am there was a lot of activity on the grid, some of it reflected in the telemetry and circuit breaker status changes.
