ERCOT and Texas RE 2015-2016 Generator Winter Weatherization Workshop  
September 1, 2015

## ERCOT's Authority for Spot Checks

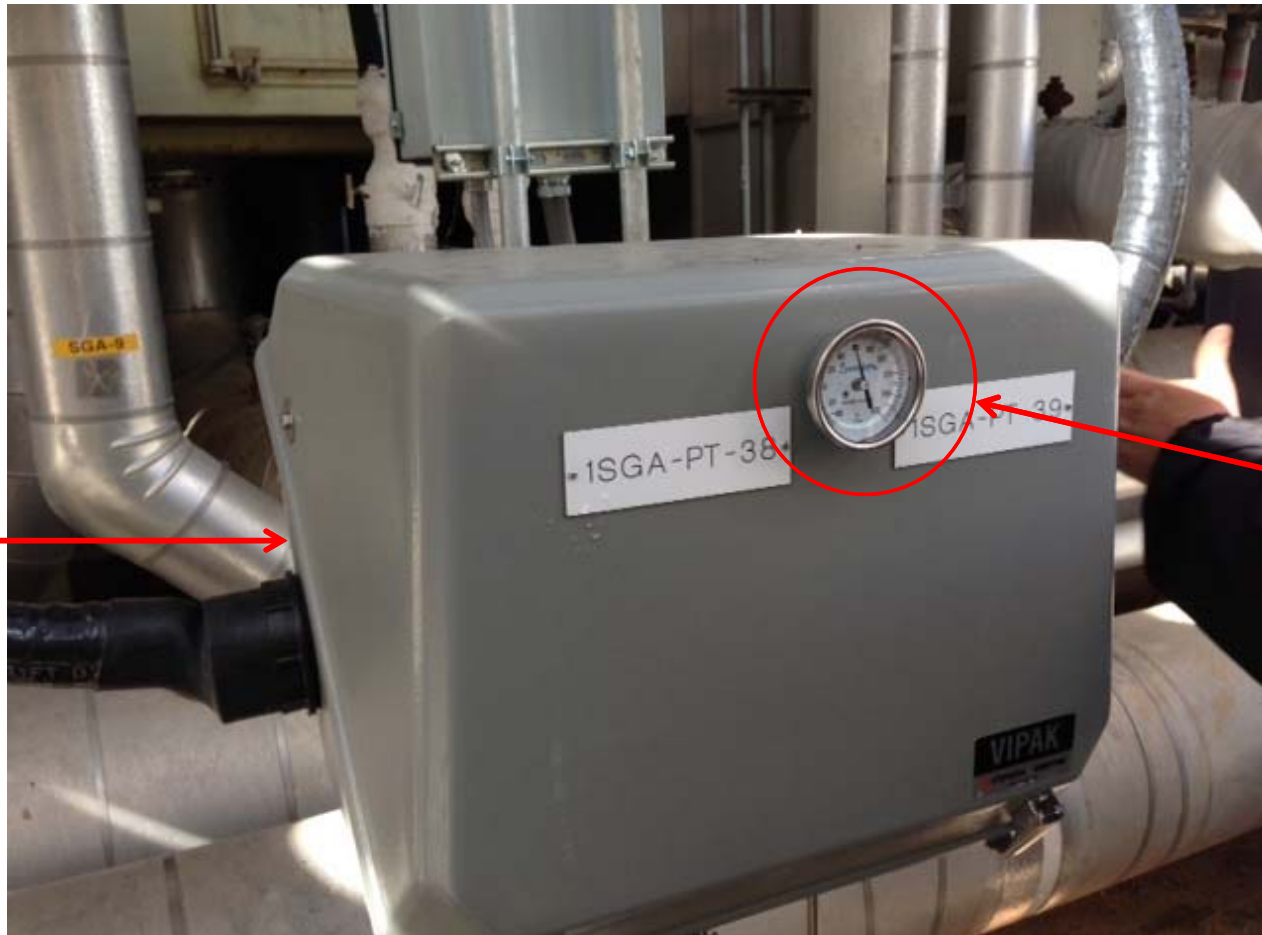
Insulated  
heated  
enclosure  
for  
transmitters

Outside  
temperature  
gauge to  
monitor  
inside  
temperature

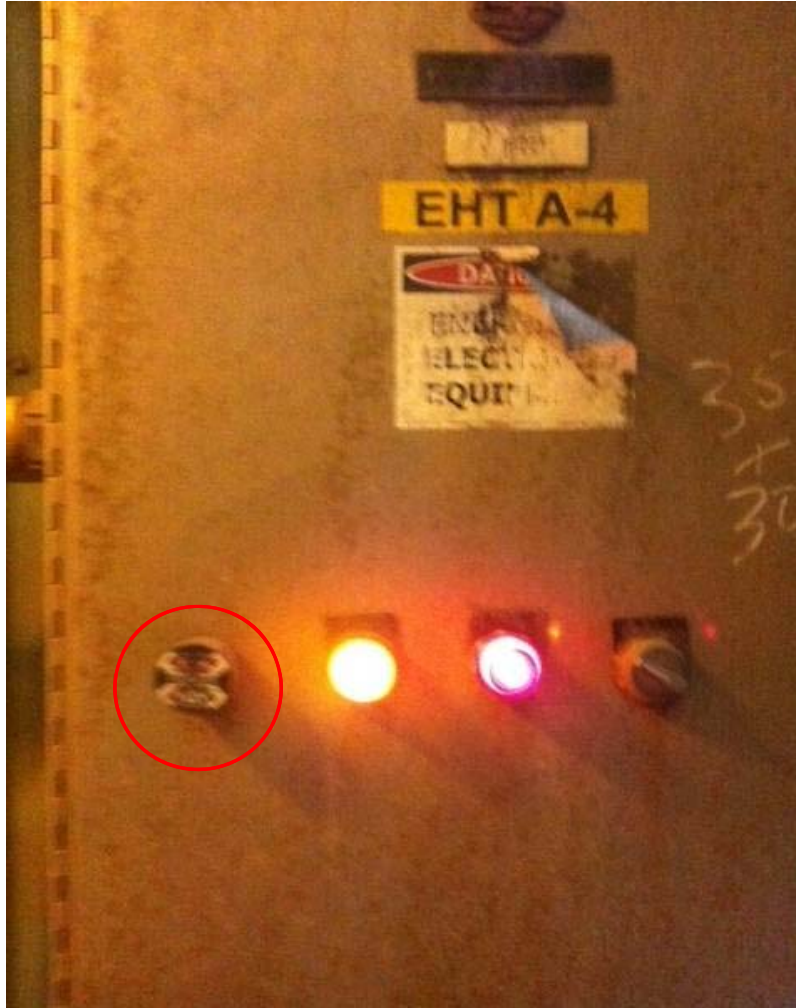
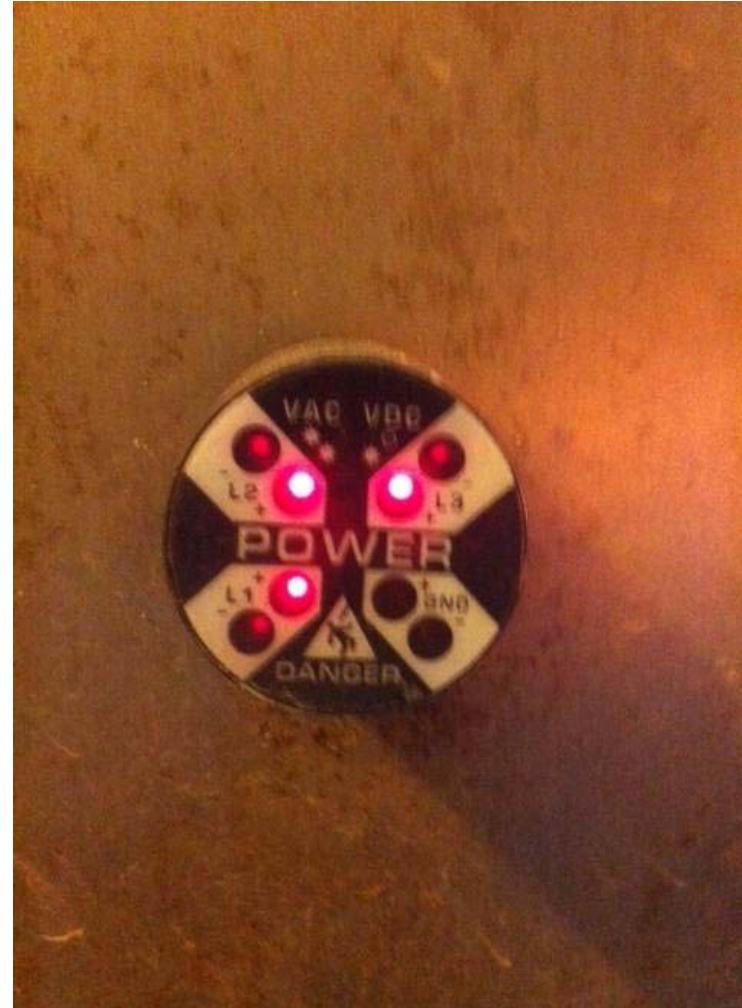
## Three phase monitor on heat trace panel – best practice

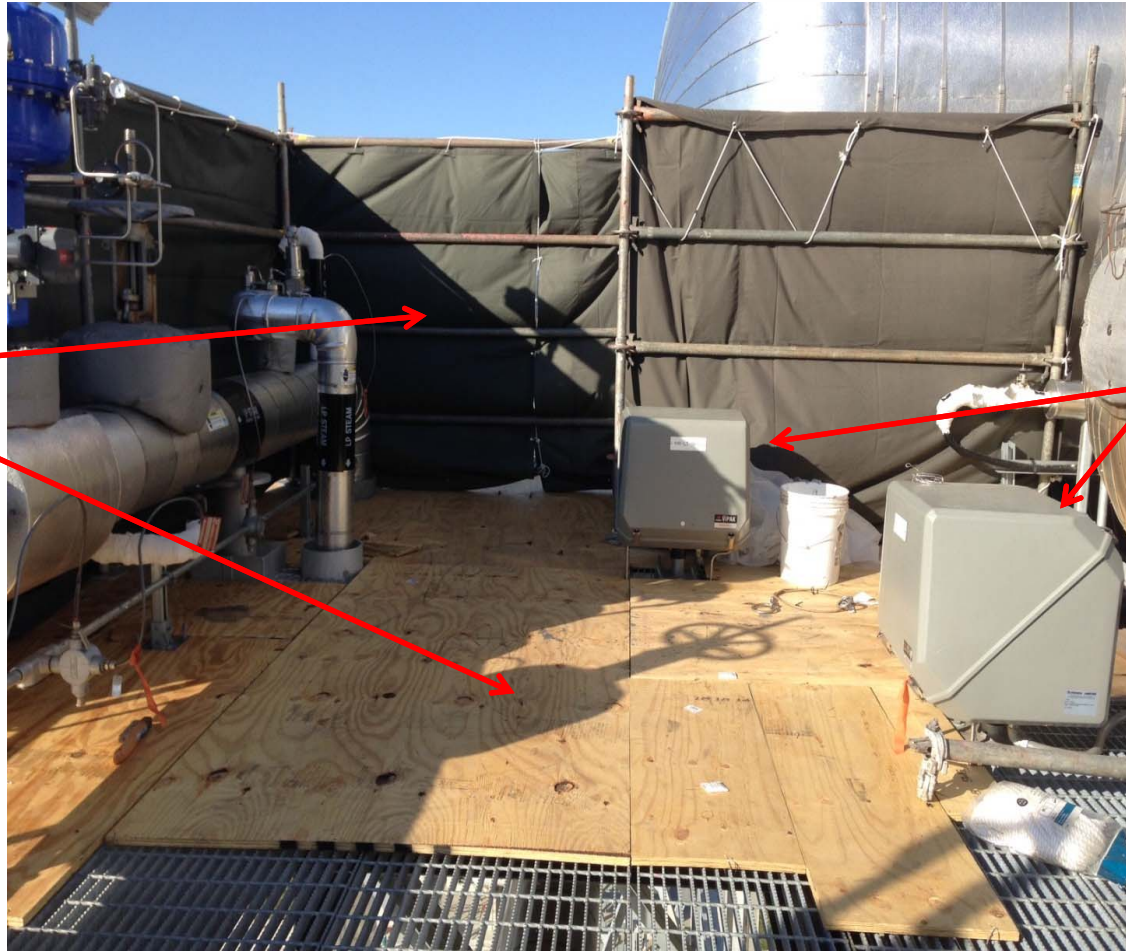
Best practice wind break and flooring to prevent tunneling effect.

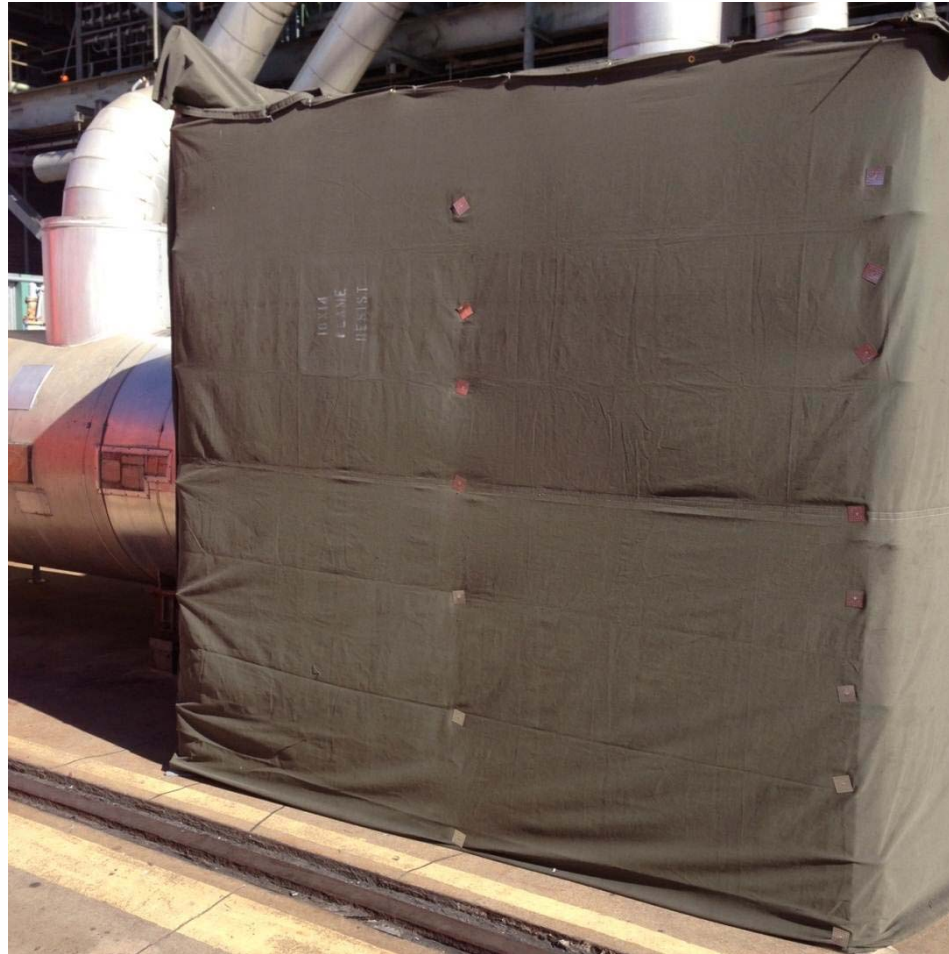
Insulated transmitter boxes

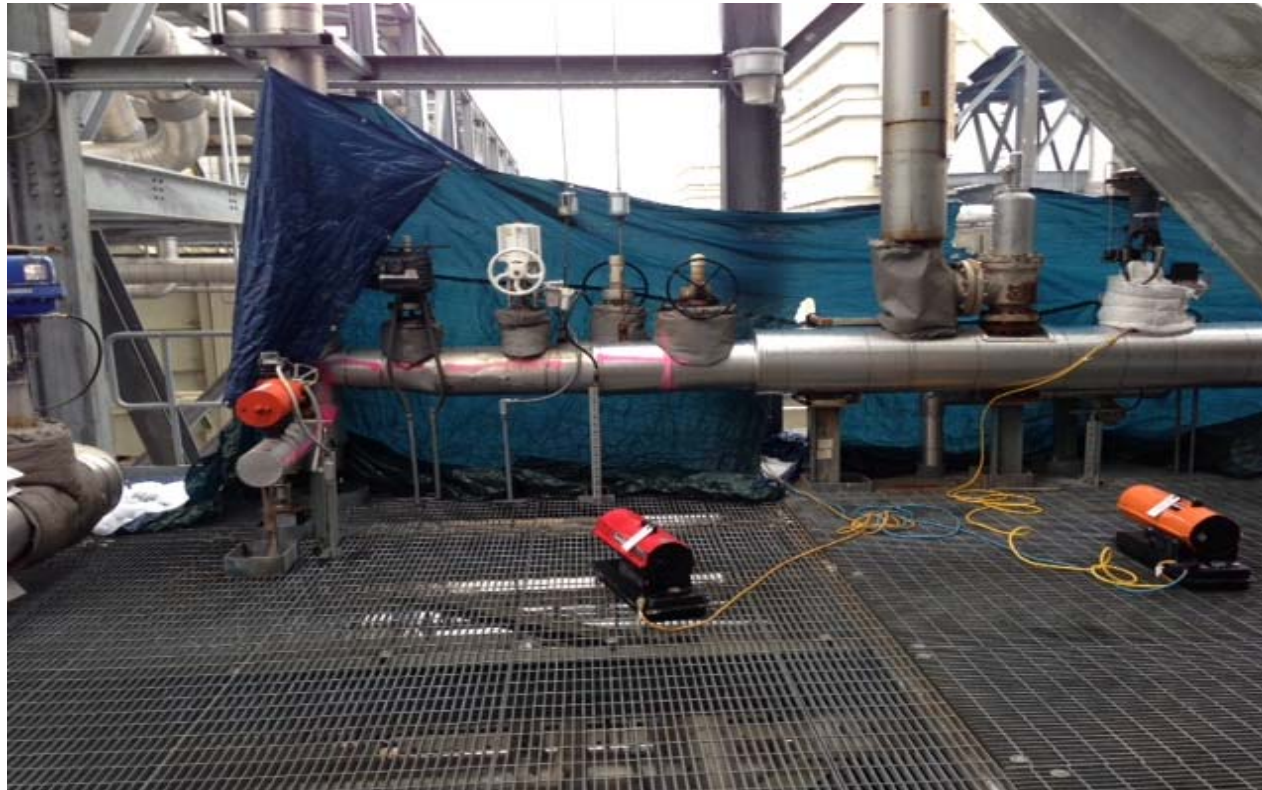
## Plant 1 - wind break measure after 1/6/14 event

Steam seal line froze delaying startup – **first** occurrence, lessons learned

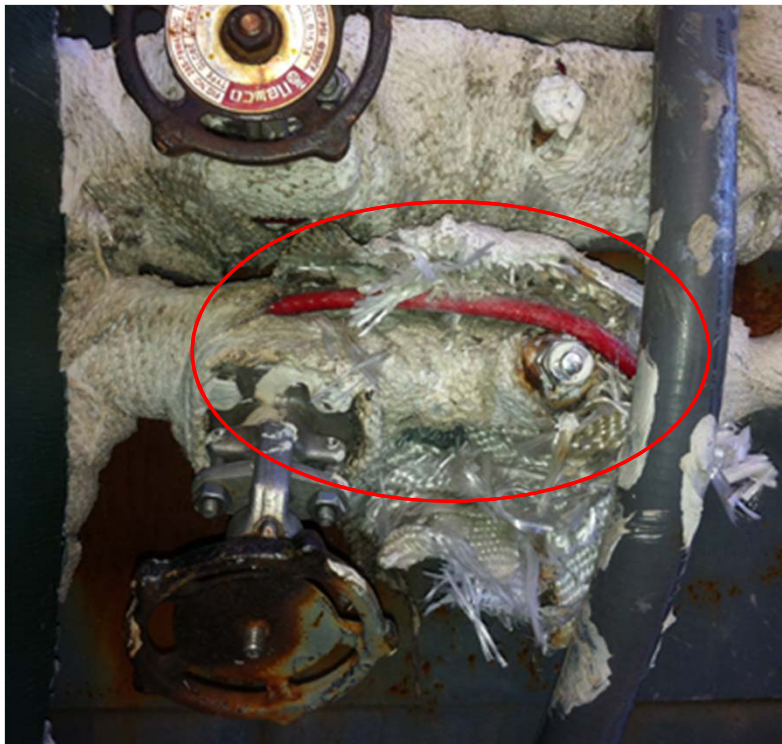
## Plant 2 – contractor error – lessons learned

January 6, 2014 derate.  
Heat trace left exposed by  
insulating contractor on steam seal  
pressure regulator transmitter.

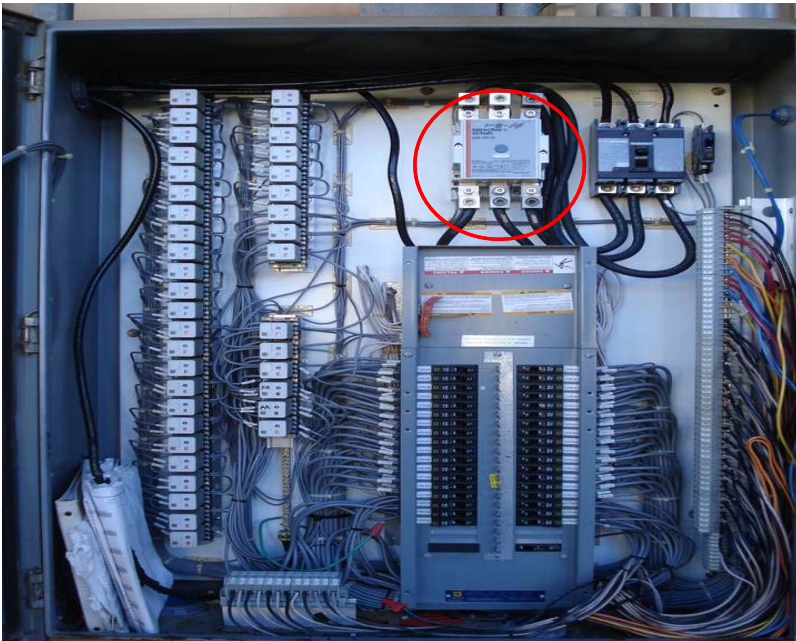
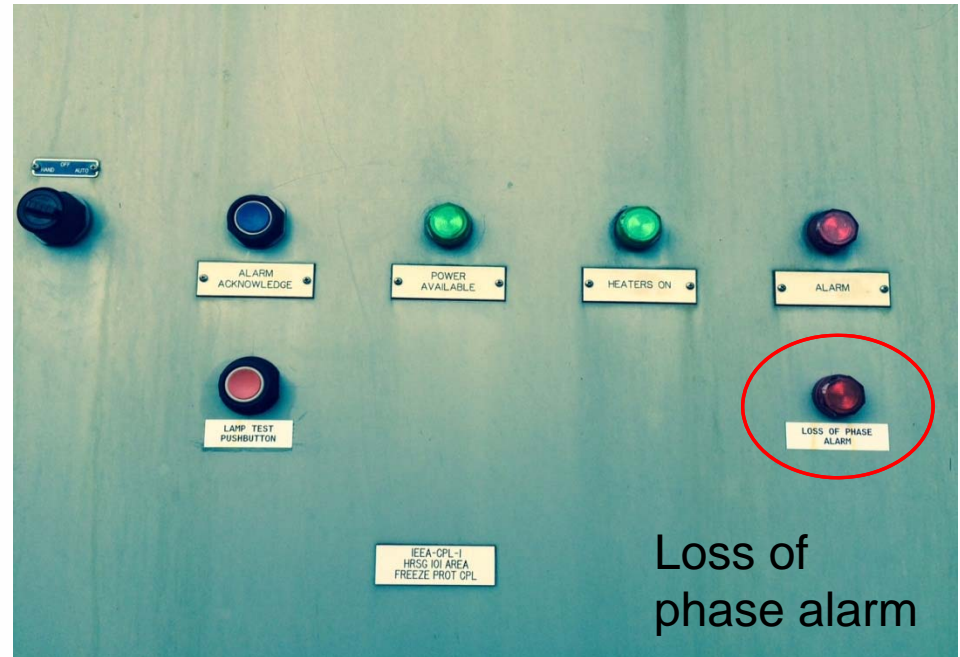
## Plant 3 – heat trace panel, three phase contactor – lessons learned and best practice

Spot check after 1/6/14 event. One phase failed to close resulting in auxiliary cooling water transmitter freezing, which tripped plant. Contactor scheduled for annual replacement.

Monitoring system installed by plant as a visual for the operators making rounds to verify three phases are energized on load side of three phase contactor. **Plant experienced no freezing equipment for winter 2014/2015.**

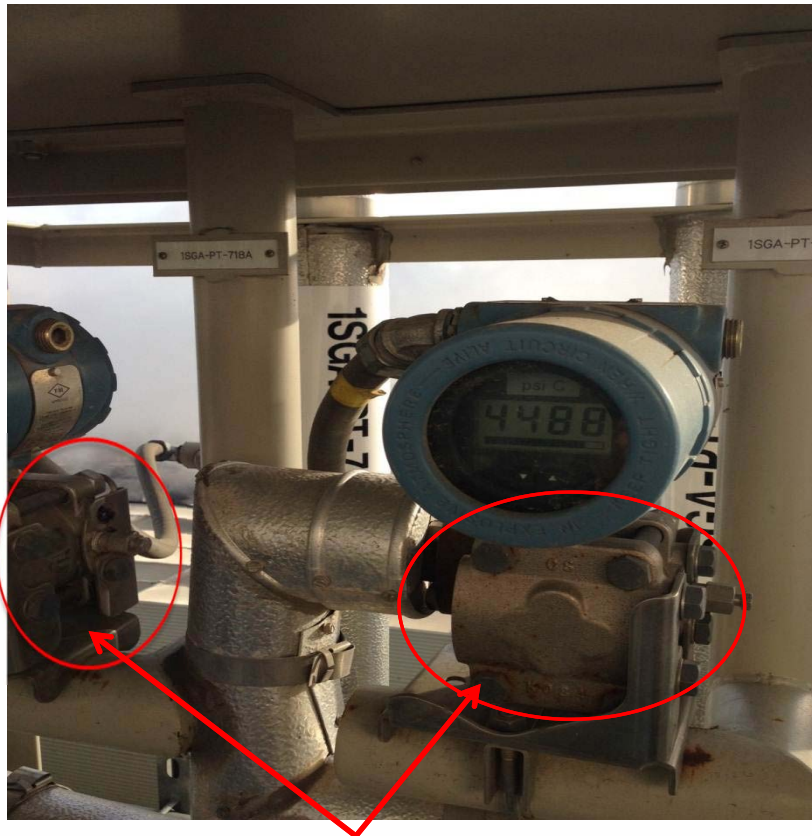
**Plant 4 – superheat steam transmitters that caused trip on 1/6/14 with boiler logic set to OR. Uninsulated transmitter manifolds.**

January 6, 2014 – lessons learned

Uninsulated transmitter manifolds

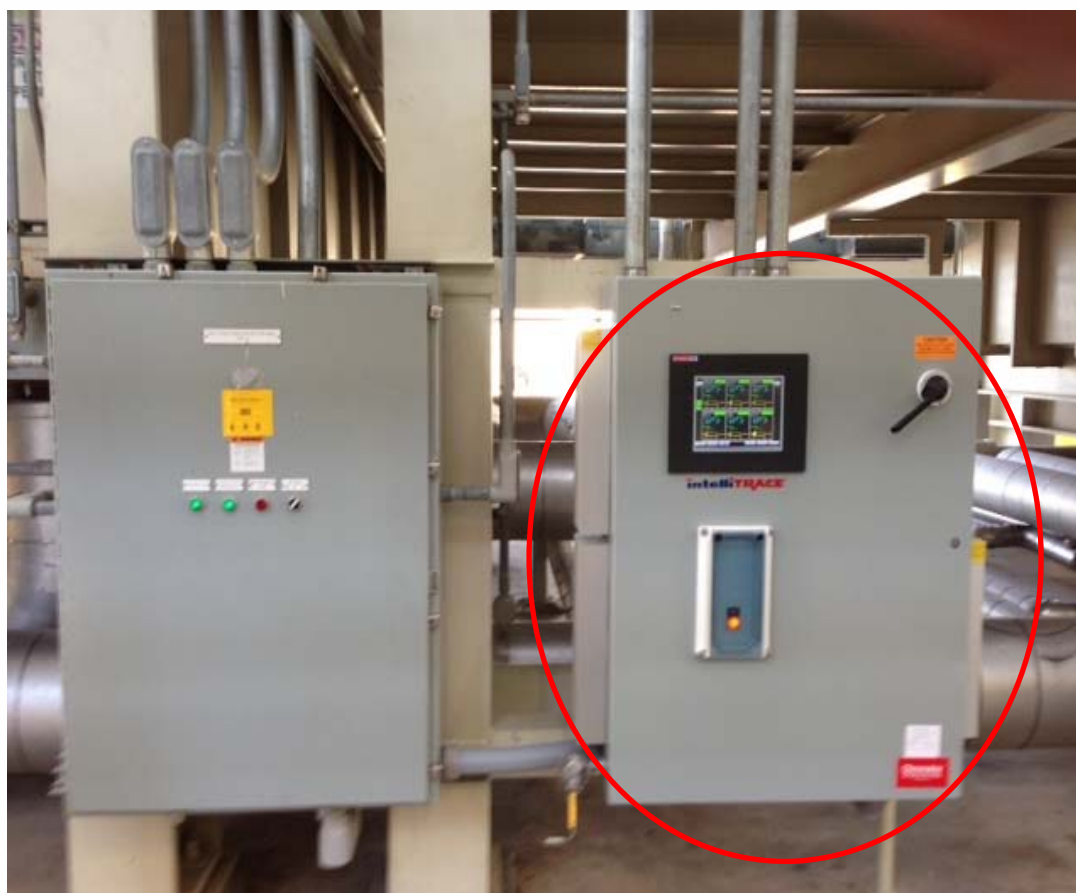
Frozen equipment (**many of the same that occurred in 2/2011**)

2 – HP steam flow transmitters

1 – 1st stage pressure transmitter in steam turbine enclosure

1 – NOX steam transmitter sensing line

1 – LP drum pressure transmitter sensing line

1 – IP drum level control valve - water penetrating resulting in valve failing to regulate due to ice

LP Economizer vents lines

**Plant 5 - improvements winter 2014/2015: new heat trace smart panel, new heat trace, new critical sensing lines for transmitters.**

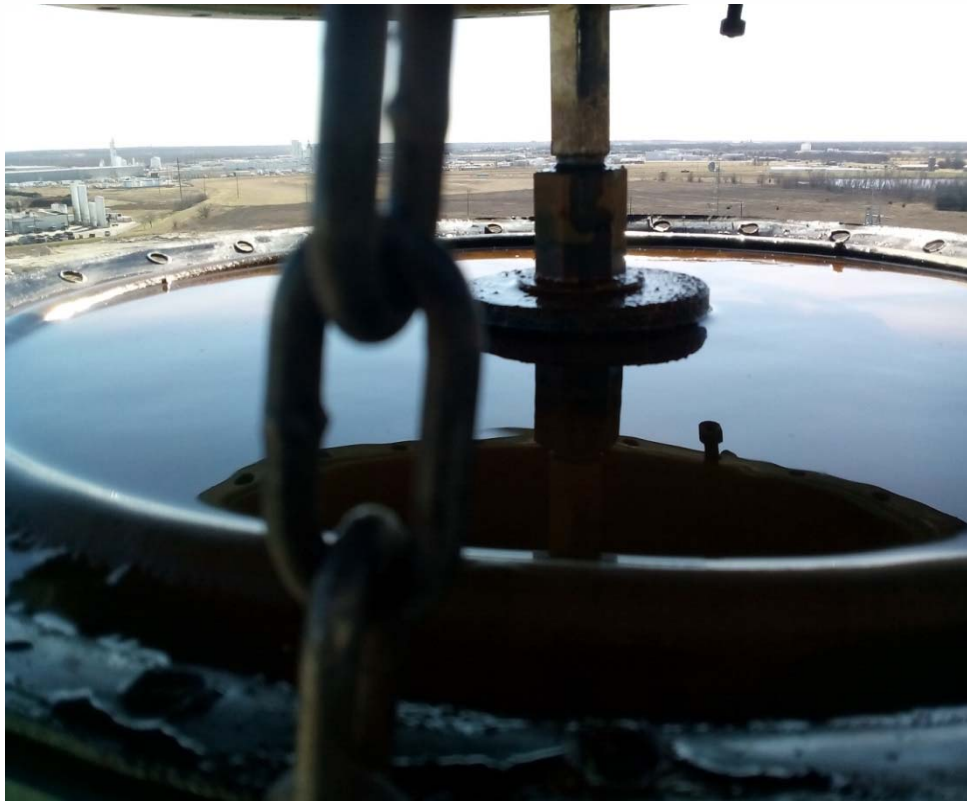
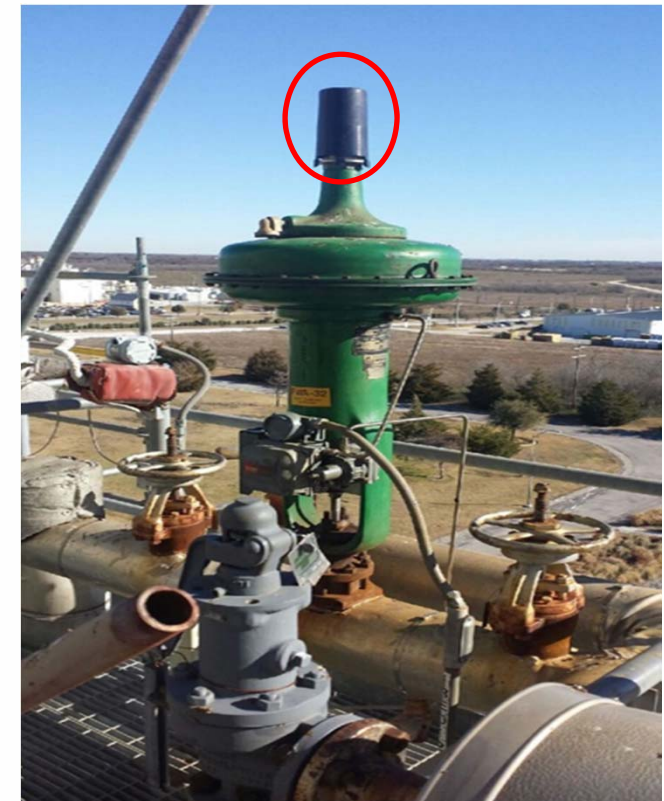
Inspection discovered valves with water that freeze up during extreme temperatures

## Plant 5 - regulating valve improvements. Nineteen valves rebuilt with rain caps installed.

Plant experienced no freezing equipment for winter 2014/2015

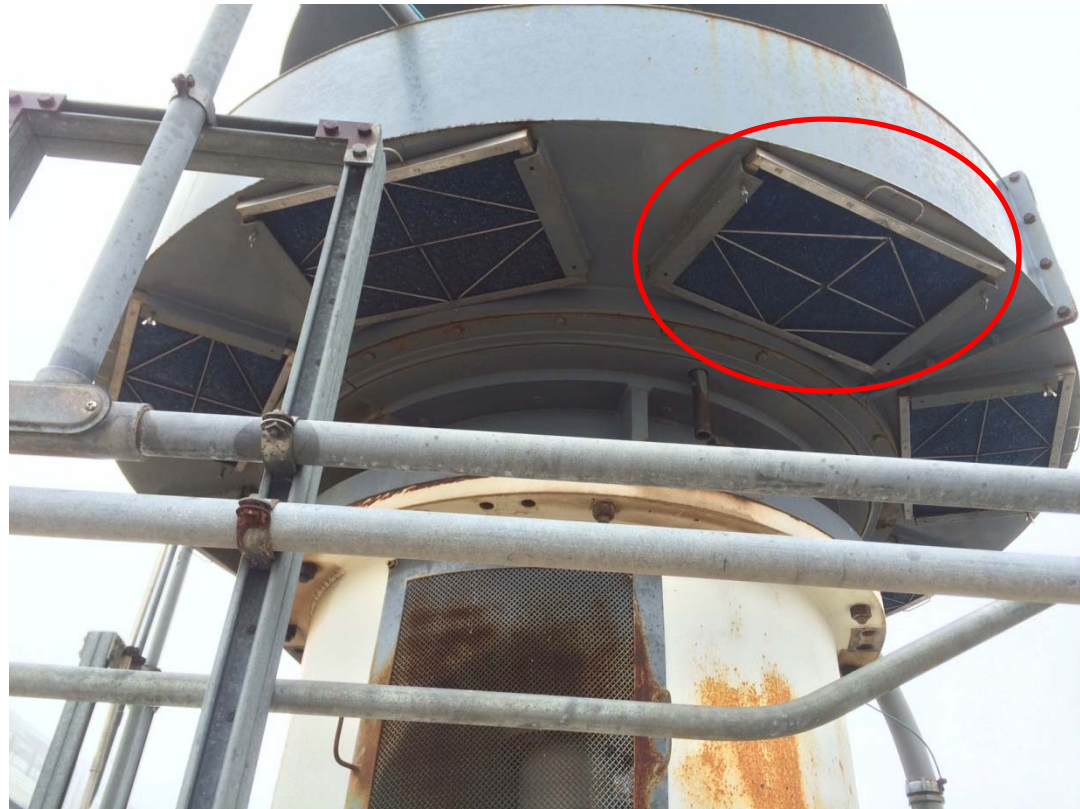
Snow and ice blocking the cooling air filters on the circulating pump motor #1 resulting in inadequate cooling of the stator windings. This resulted in a high temperature on the motor and a trip of the pump. When pump #1 tripped the resulting turbulence tripped pump #2 on high vibrations. This resulted in plant trip due to inadequate cooling of stator windings.

### Plant Trip 2/25/15 – lesson learned

- ✓ **Added** physical inspection of the motor filters to plants cold weather rounds sheet.
- ✓ **Added** the motor temperature readings to the operator cold weather rounds.
- ✓ **Added** Spare filters to stores stock for the motors allowing for filter replacement if they start to show ice, or snow build-up.
