**Generator Winter  
Weatherization Workshop**  
September 3, 2020

Alan H. Allgower  
Operations Analyst, Senior  
[alan.allgower@ercot.com](mailto:alan.allgower@ercot.com)  
512-248-4613 (o)

# Resistance temperature detector (RTD) failure – lesson learned

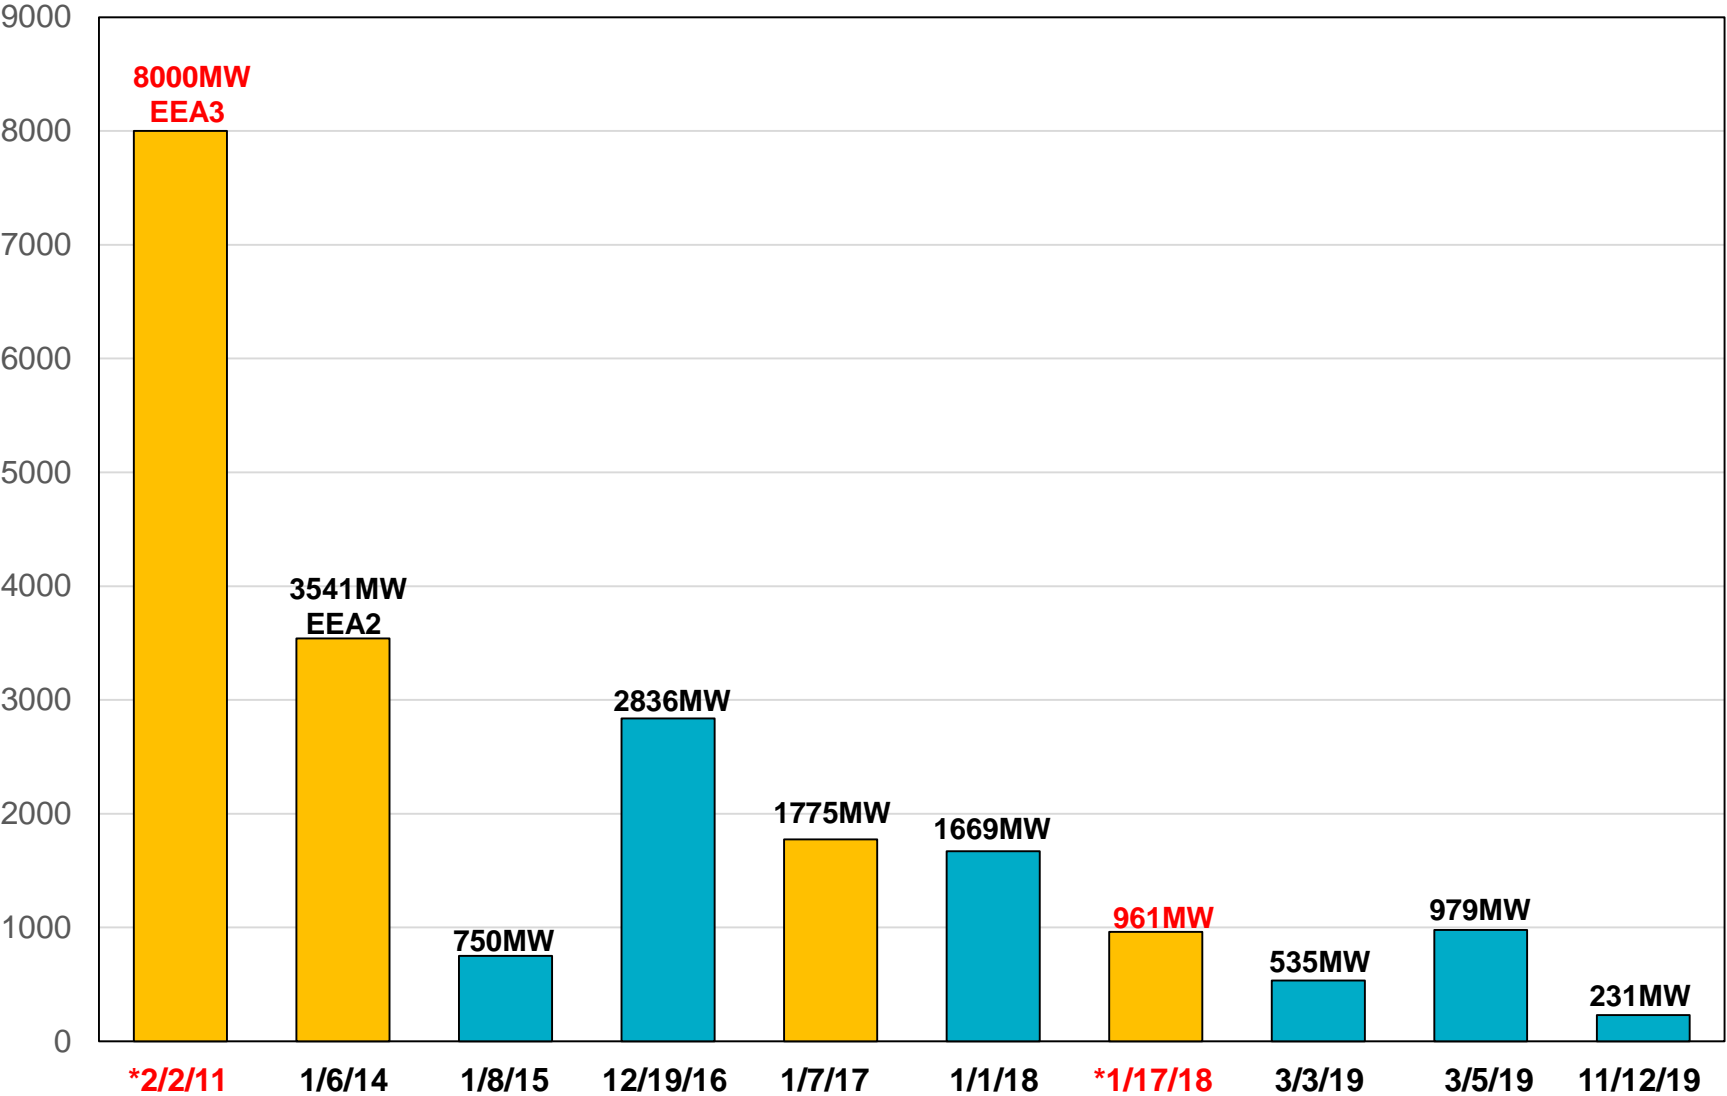
Generation (MW) tripped or de-rated due to frozen instrumentation

\*2/2/11 and \*1/17/18 were the two coldest days this decade.  
Salmon colored are the four coldest days in last nine years.

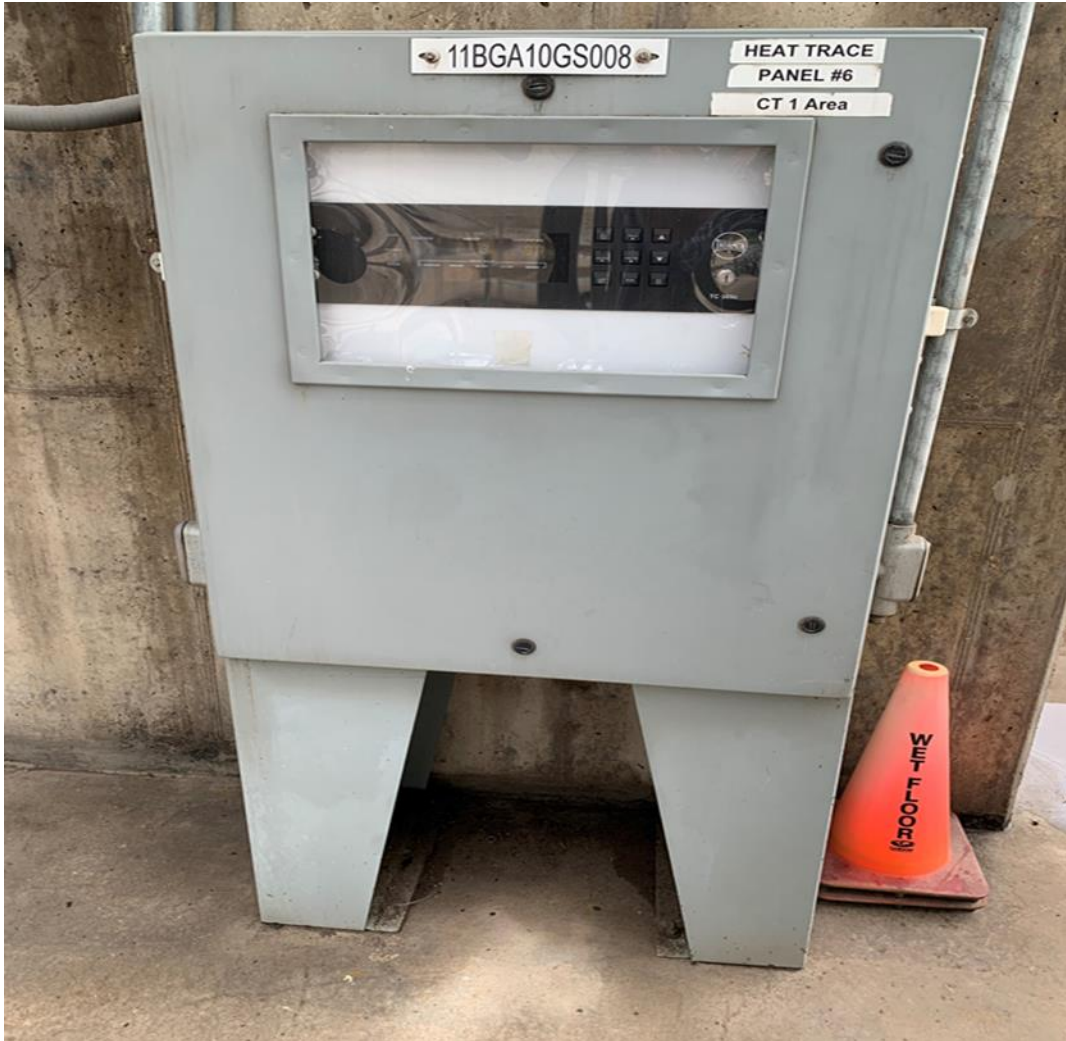
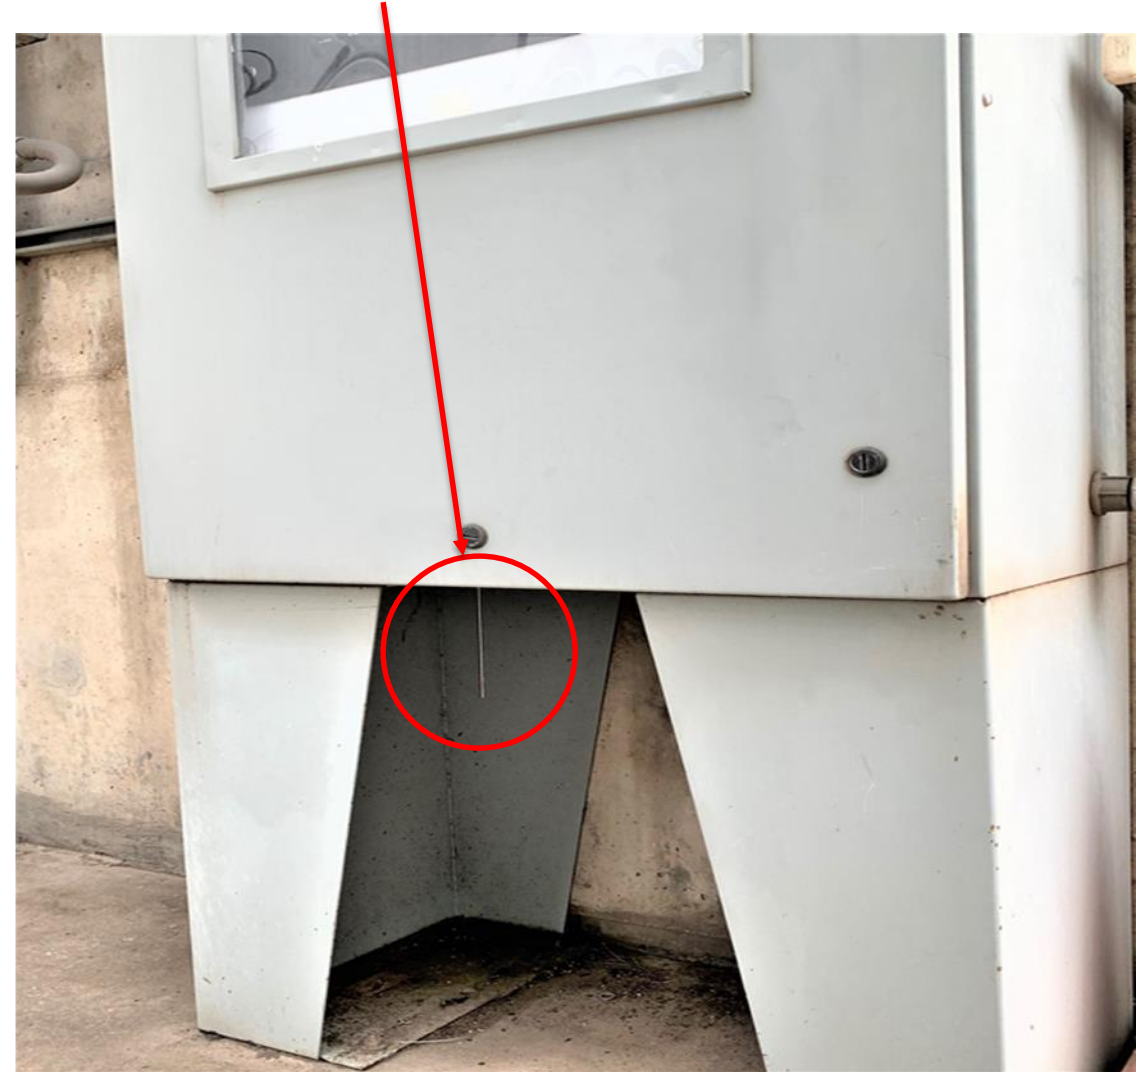
# Heat trace panel – resistance temperature detector (RTD) failure

- During the cold front on November 12, 2019 a CT experienced a trip due to transition steam flow showing a high reading.
- Inspection of the transmitter box showed that the heater and heat trace was not energized.

- I&C technician found that the RTD that senses the ambient temperature for the heat trace panel had failed.
  - RTD measures ambient temperature to energize heat trace circuits.

- Manufacturer default for a RTD failure is to de-energize heat trace circuits.
- It was also discovered that the thermometer that measures inside transmitter box temperature was reading 15DegF higher than enclosure temperature. This temperature is recorded by operators on rounds and gave the operator a false reading.

- Corrective action:
  - RTD replaced on all heat trace panels of this type.
  - All heat trace panels of this type were re-programmed to energize heat trace circuits for an RTD failure.

- All transmitter box thermometers that measure the inside temperature have been replaced.
  - During the spring 2020 outage, GMS was upgraded to telemeter internal box temperatures for all critical transmitters into the control system for monitoring by the control room operators.
