2022 Odessa Disturbance Update

Patrick Gravois
Operations Engineer – Operations Analysis

IBRTF Meeting
September 13, 2022

2022 Odessa Disturbance Event Overview

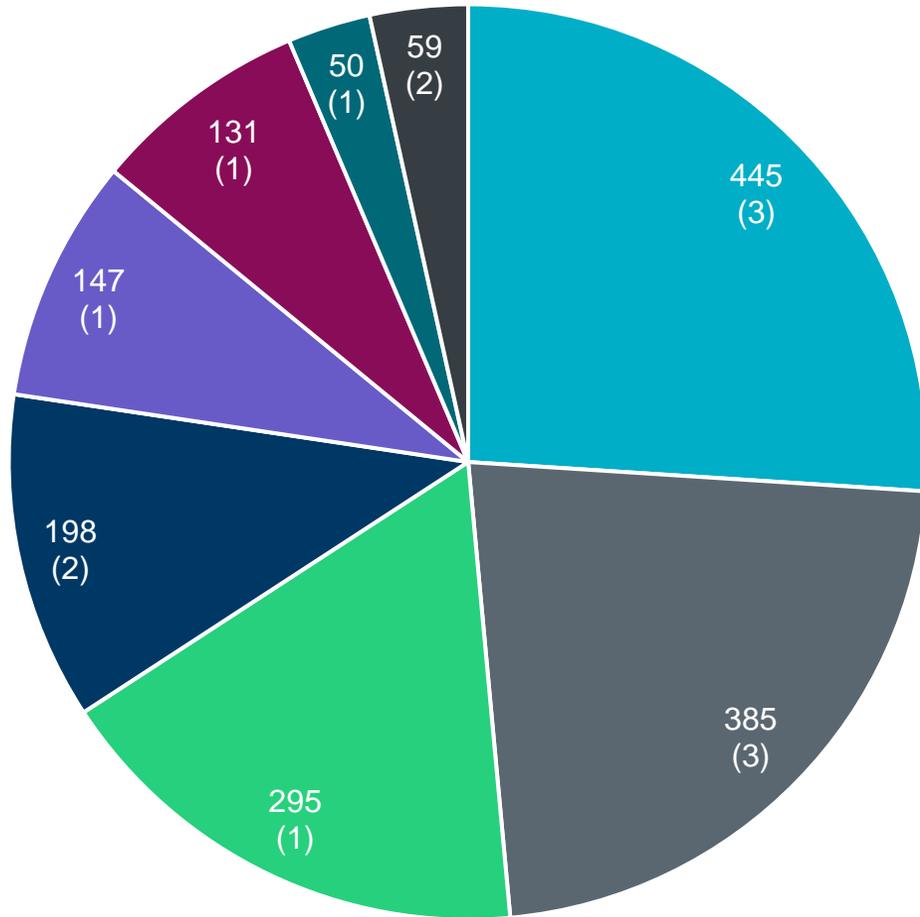
MW Loss by Root Cause

Root Cause	# Affected Facilities	MW Loss
AC Overcurrent	3	445
Volt Phase Jump	3	385
AC Overvoltage	1	295
Vdc Bus Unbalance	2	198
Slow Ramp After LVRT	1	147
Momentary Cessation	1	131
Grid Overfrequency	1	50
Unknown/Misc	2	59

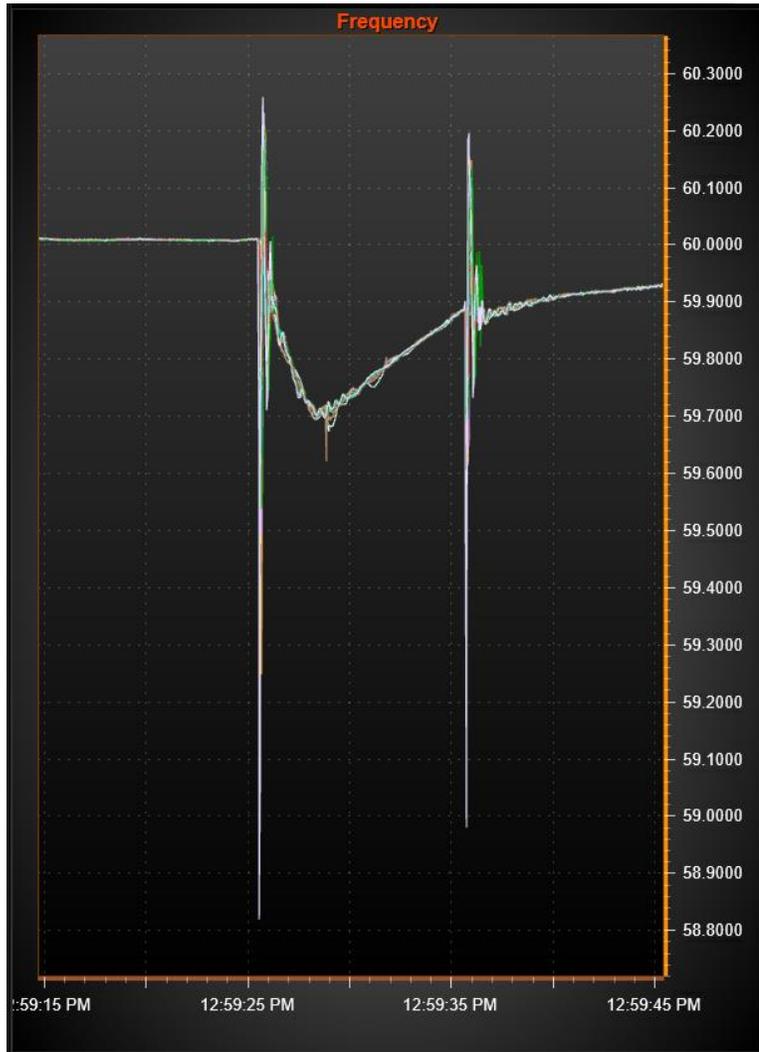
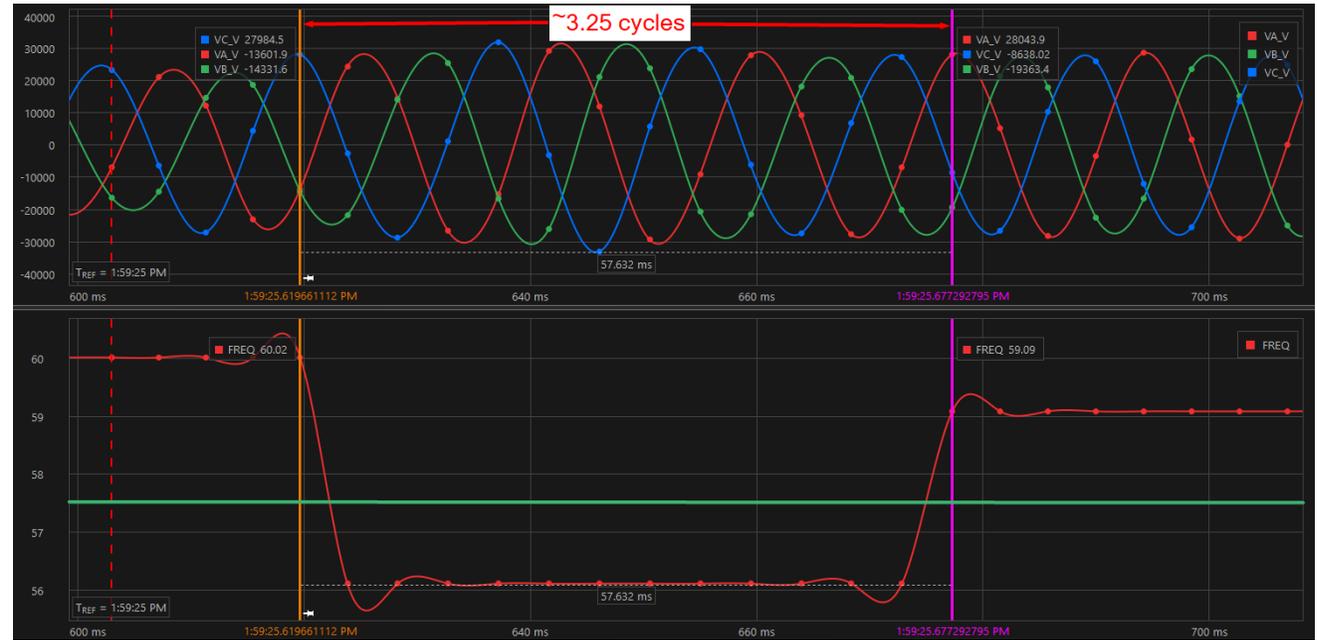
Feeder Breaker Underfrequency Tripping

- 3 feeder breakers tripped during event for frequency below 57.5 Hz
- Inverters tripped for other reasons so breaker tripping not primary root cause
- Issue highlighted in Odessa 2021 NERC event report
- Relay manufacturer recommends minimum time delay for frequency tripping to be 5 cycles
- Plants with feeder breaker tripping on underfrequency have increased measurement window to 10 cycles

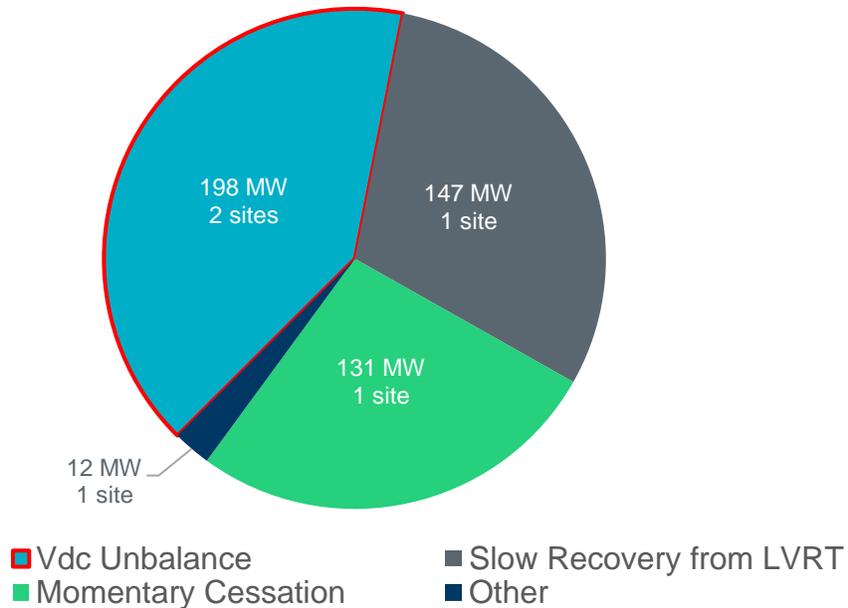
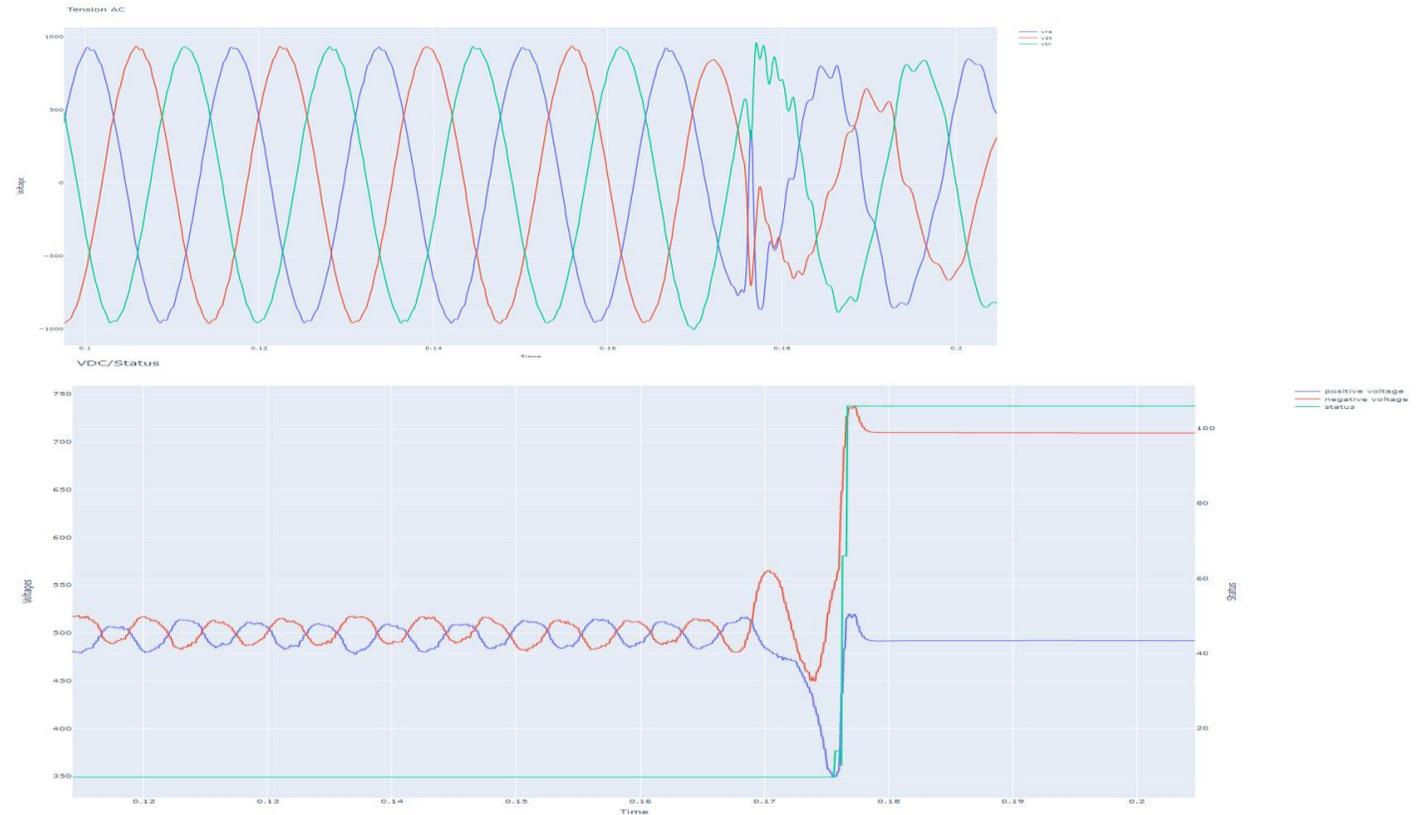
OEM2 – Vdc Unbalance

- Protection occurs when DC-side positive and negative bus voltage becomes unbalanced very rapidly – potential short
- AC-side voltage phase became unbalanced faster than controls could regulate DC-side due to disturbance
- OEM2 had seen issue in previous events and were already testing software update to mitigate
- Software update improves DC bus regulation response time during voltage disturbances
- OEM completed update to one plant on Aug. 29, second plant to be scheduled soon
- Update to be applied to all OEM2 inverters in ERCOT (with one exception)

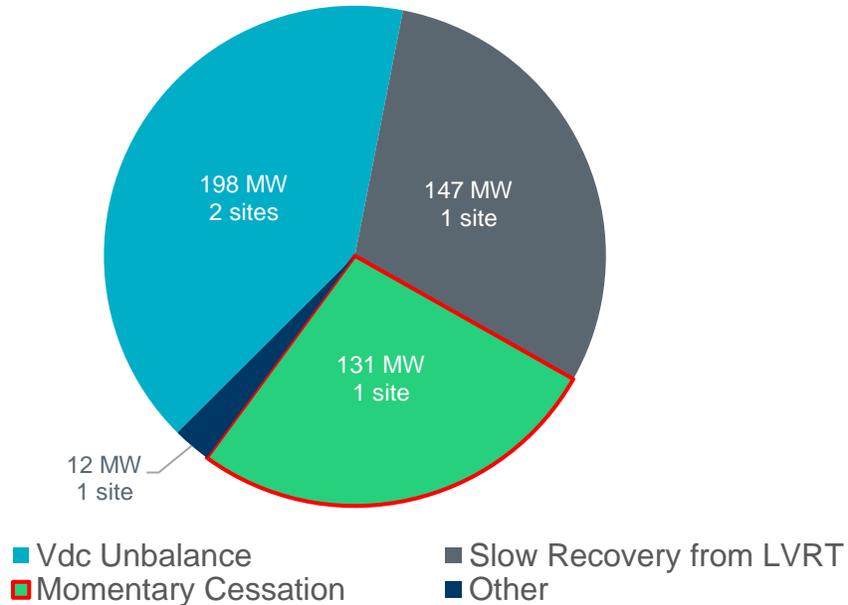
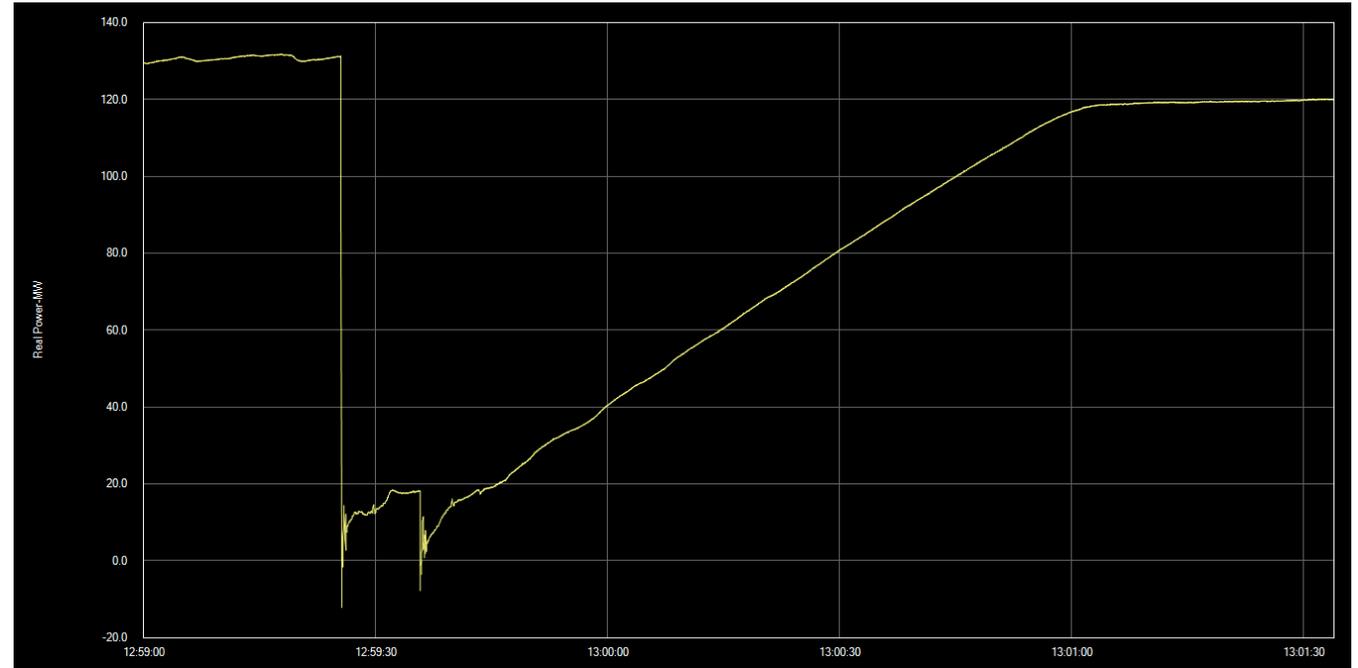
OEM2 – Momentary Cessation

- Unclear whether inverters went into momentary cessation or reduced active power and were unable to recover quickly due to loss of auxiliary power
- Older inverters with limiting logging capabilities – difficult to identify corrective actions to improve response
- Unclear whether voltage drop or phase jump caused initial active power loss
- RE to work to OEM to develop mitigation plan and timeline – installed new PPC since 2021 Odessa event
- Potentially may not be able to meet current VRT requirements with current inverters

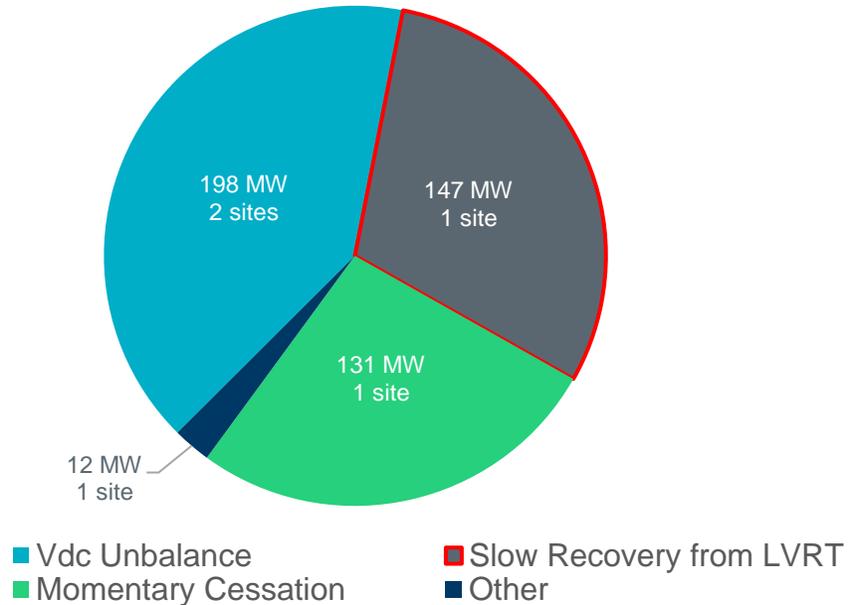
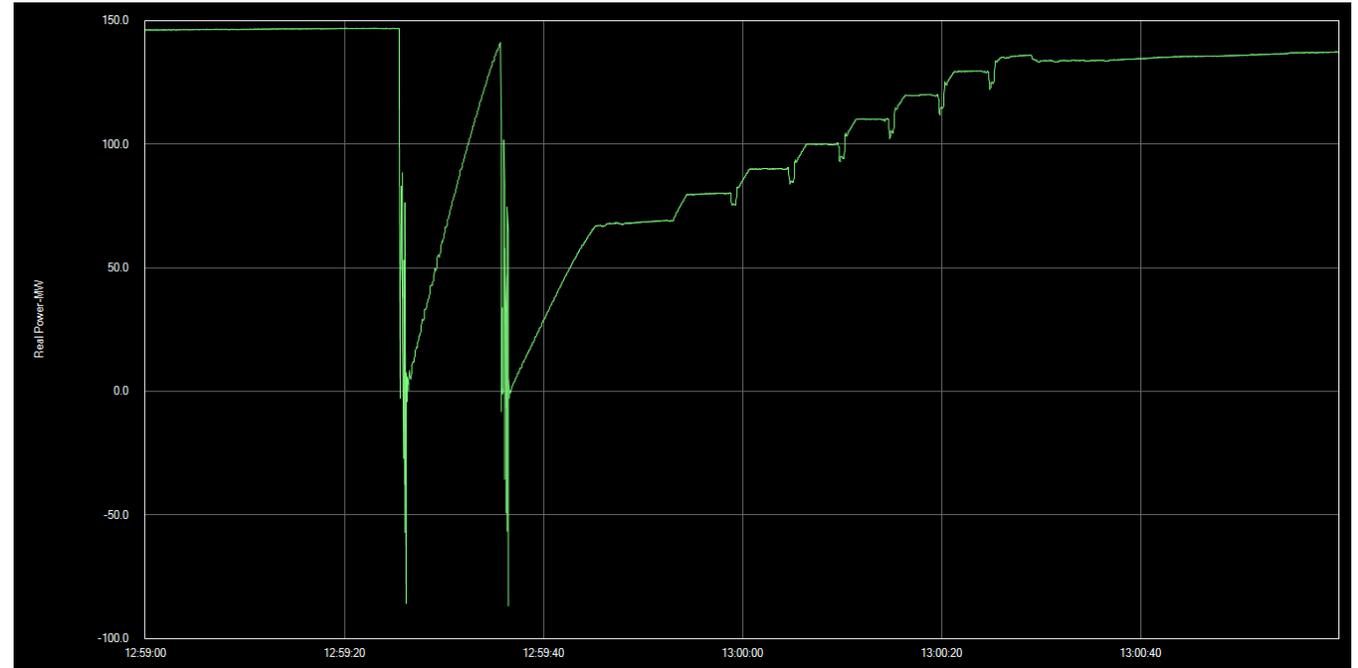
OEM2 – Slow Recovery from LVRT

- Follow up call scheduled Sept. 13
- May have already implemented corrective actions to limit MW reduction during LVRT and increase thresholds for low/high voltage inverter trip settings
- Need to determine why recovery after LVRT is slow and cause of oscillations
- Potentially some PPC interactions that need to be addressed
