Odessa Disturbance 2: June 4th, 2022

IBRTF Meeting

July 8th, 2022

Odessa Disturbance 2: Event Summary

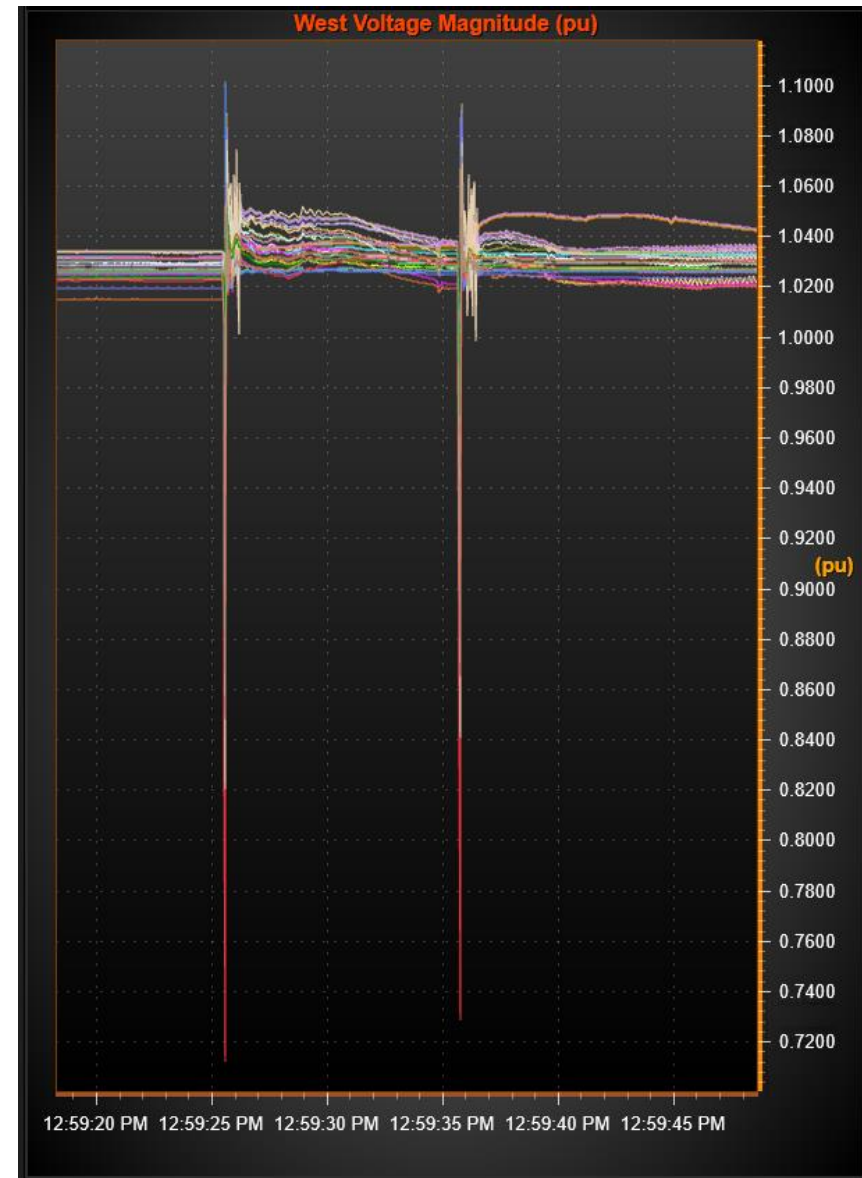
Real Time PMU Voltage

- Lowest recorded voltage of 0.714pu from PMU in Odessa area on 345 kV line
- Highest recorded voltage of 1.102pu from PMU in Del Rio area on 138 kV line
- Attempted reclose ~10 seconds later
- Faults cleared in ~3 cycles
- Within VRT “No Tripping” zone in NOG 2.9.1

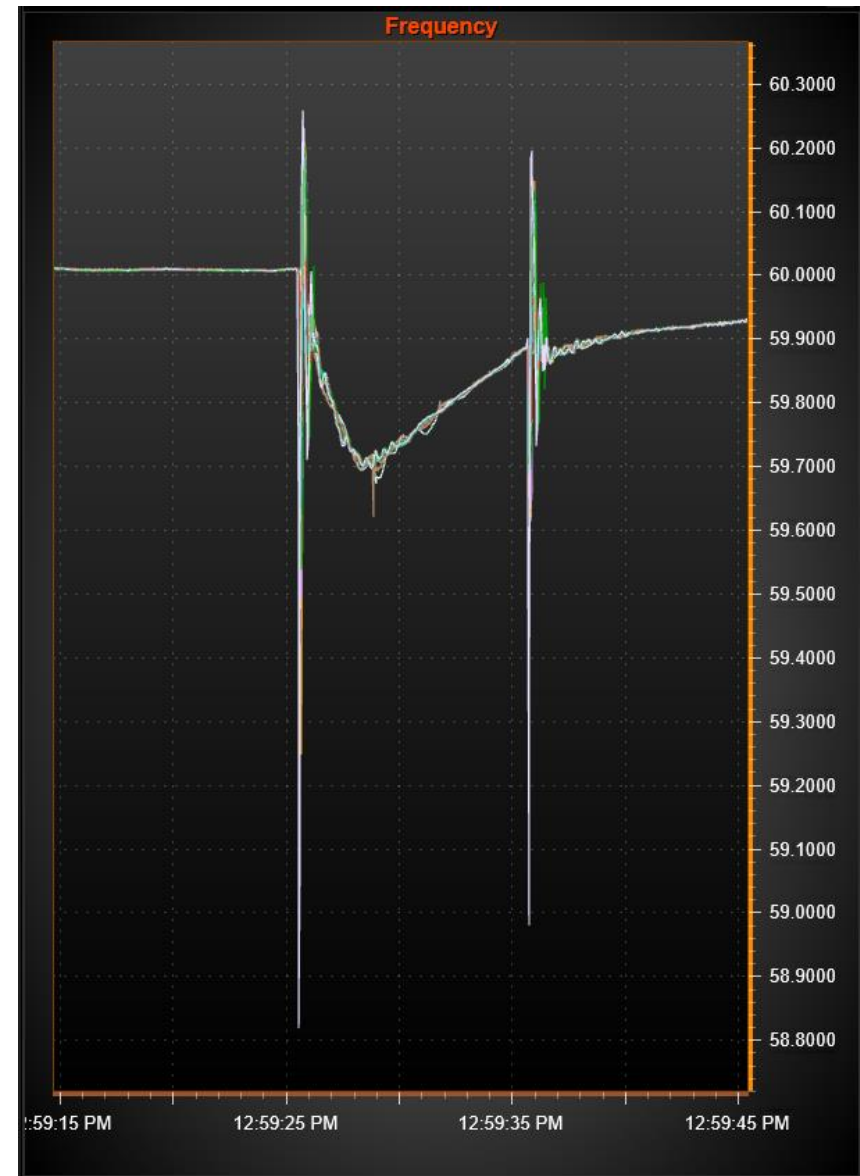
Real Time PMU Frequency

- Most PMUs lowest freq. of 59.7 Hz after LOG
- Single PMU near Laredo had lowest freq. of 59.62 Hz
- Couple other PMUs in South dipped below 59.7 Hz
- Local transient freq. seen as low 58.83 Hz and high as 60.26 Hz in Far West
- Protection settings should not be set on transient freq.

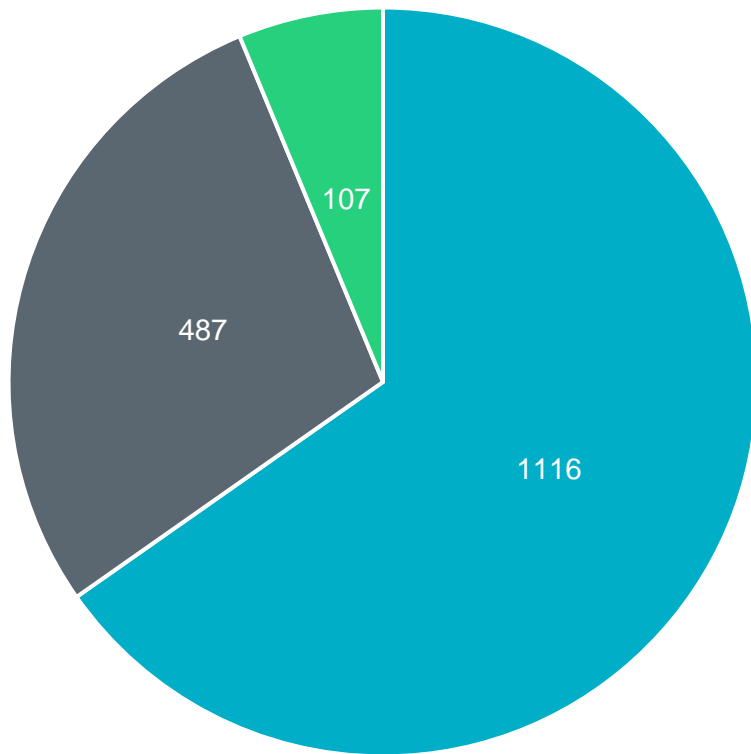
2022

MW Loss per Inverter Type

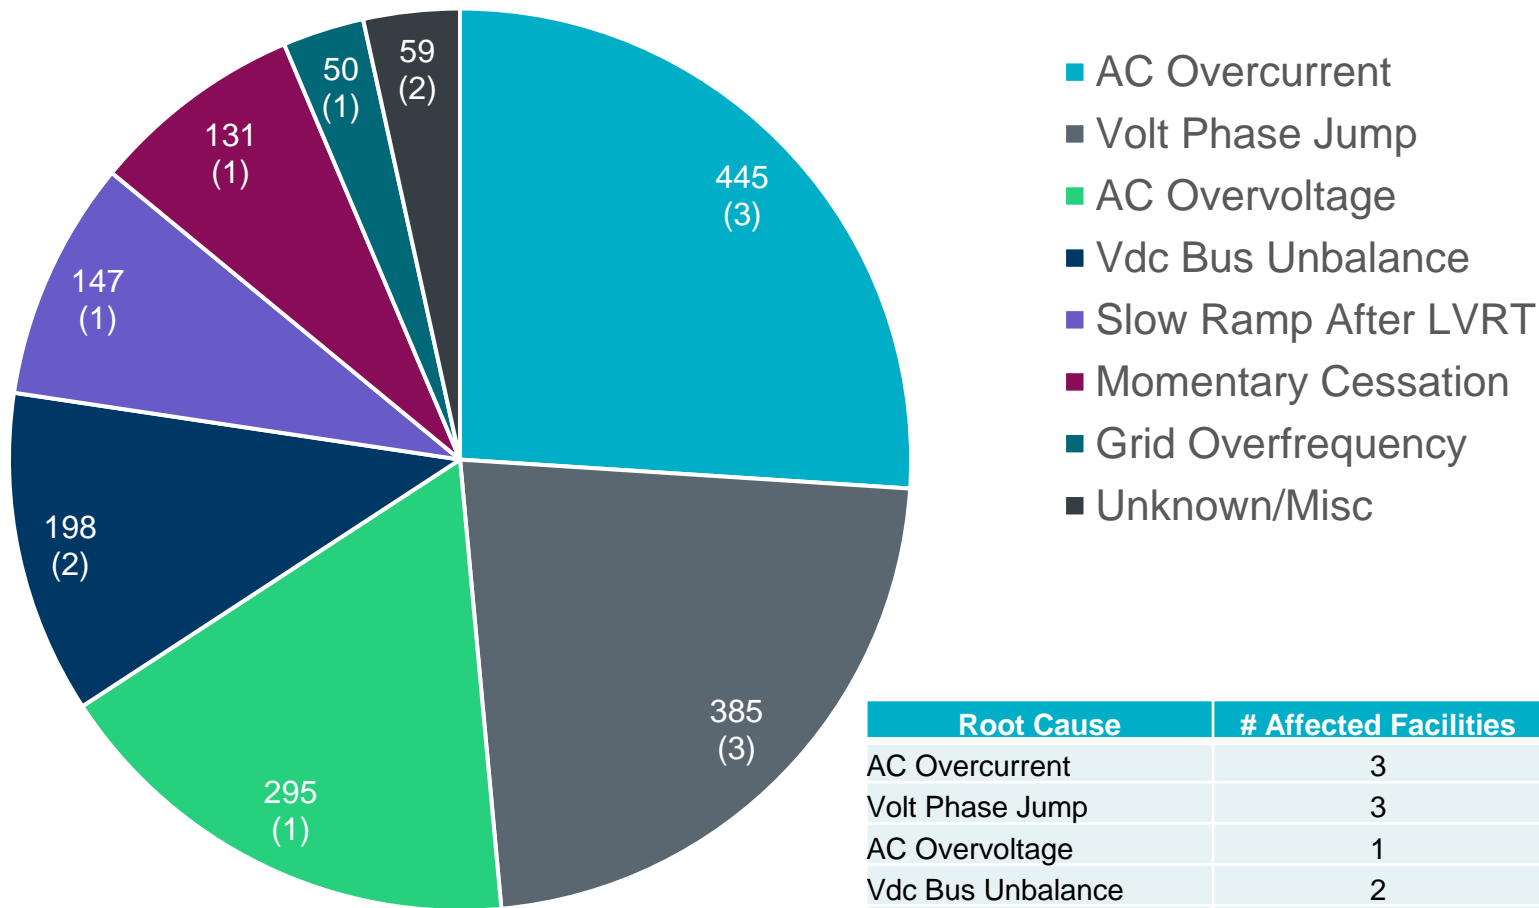
MW Loss by Root Cause

Root Cause	# Affected Facilities	MW Loss
AC Overcurrent	3	445
Volt Phase Jump	3	385
AC Overvoltage	1	295
Vdc Bus Unbalance	2	198
Slow Ramp After LVRT	1	147
Momentary Cessation	1	131
Grid Overfrequency	1	50
Unknown/Misc	2	59
