Odessa Disturbance – Inverter Based Resources (IBR) Task Force

ERCOT

January 10, 2021

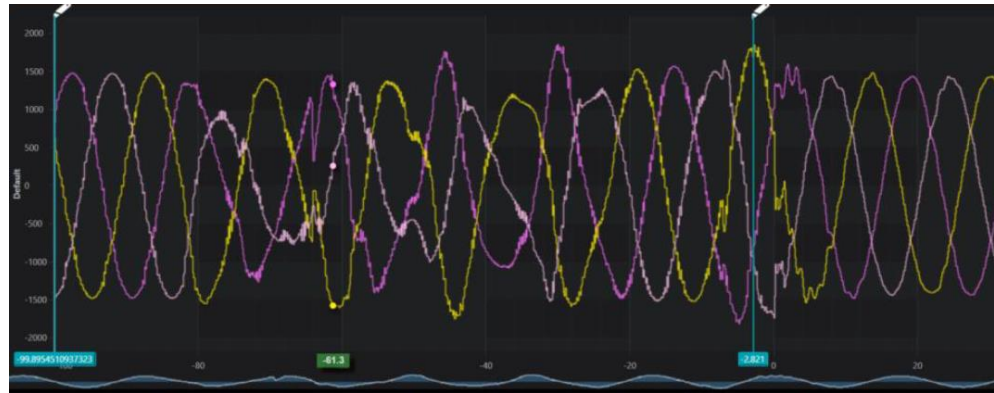
AC Overvoltage – Inverter-Level

- POI high resolution data shows voltage within PRC-024-3 voltage “no trip” curve
- Inverter experiences spikes (instantaneous peak) above 1.3 pu at terminals
- 1.3 pu threshold hard-coded by one OEM; separate from HVRT settings configurable by plant personnel.
- Settings cannot be modified for any existing facilities
 - AC overvoltage tripping for this OEM will likely continue to occur in future
- Identified in nearly all solar PV disturbances analyzed by NERC

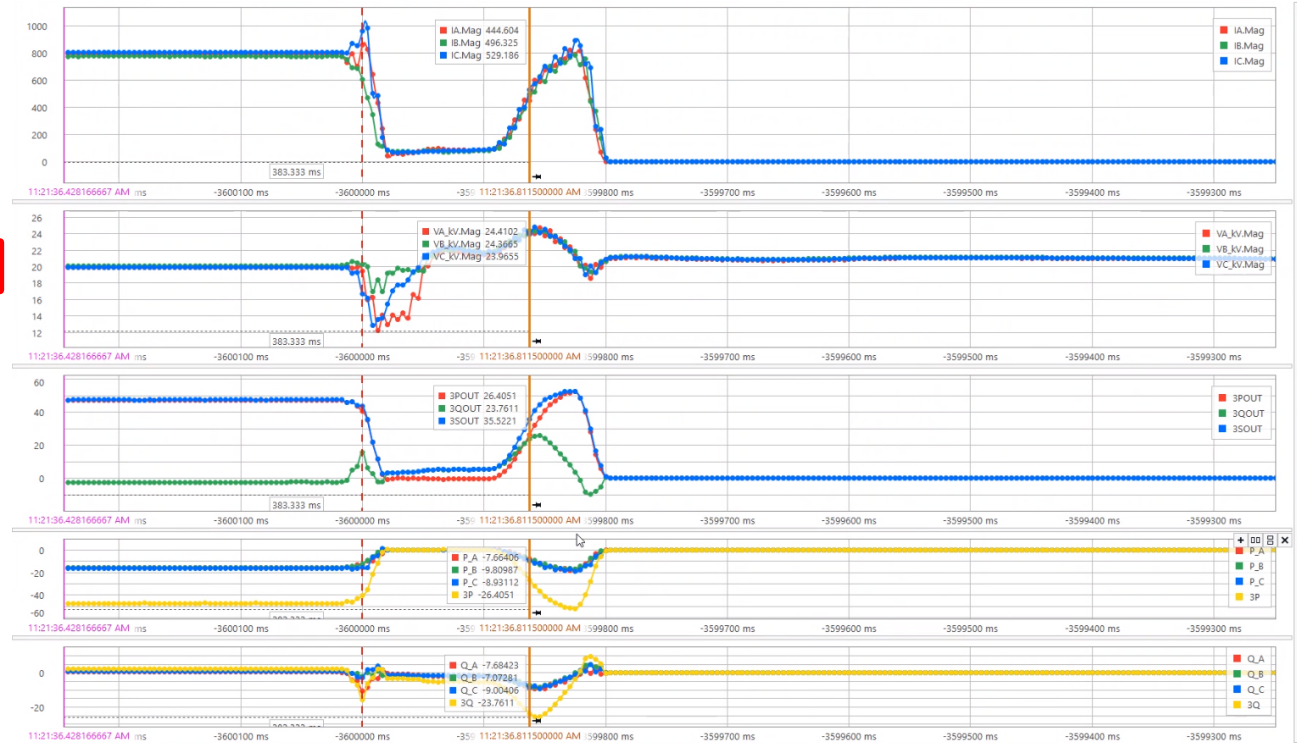
AC Overvoltage – Feeder-Level

- Voltage driven high by abnormal inverter controls during and after fault
- All feeder protection at one facility set to trip on inst phase ac overvoltage
 - Set at 1.2 pu – directly on PRC-024-3 curves
- Review team questioned need for this feeder-level protection
 - Plant personnel unable to clarify what the voltage protection was protecting

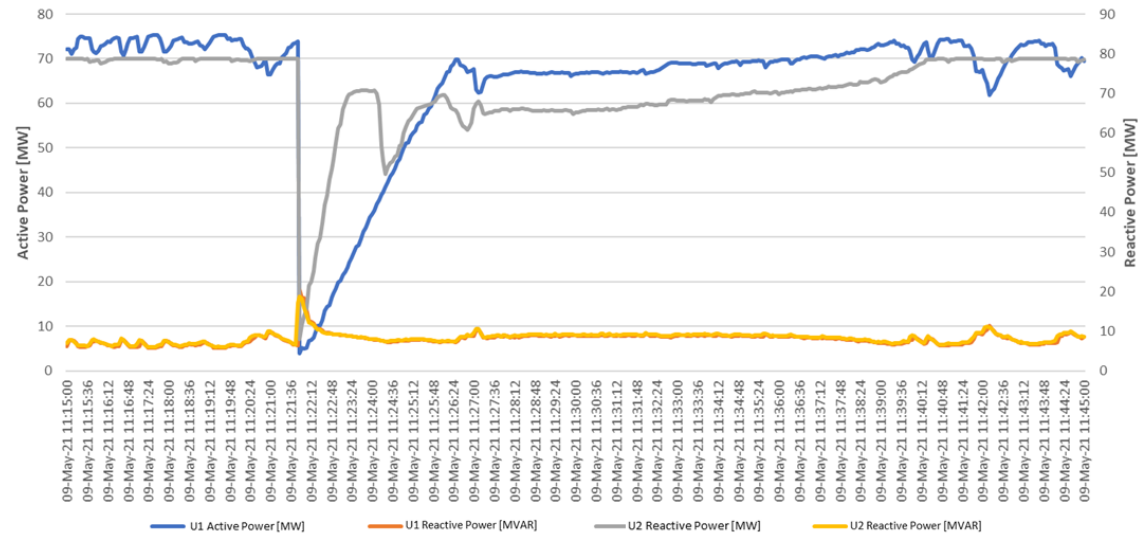
Momentary Cessation

- Legacy inverters at one plant – momentary cessation below 0.9 pu voltage
 - Inverters should recover to predisturbance output relatively quickly when voltage recovers
- Plant-level controller interactions – slowed recovery to BA ramp rate limits
- Not appropriate use of these limits; negatively impacting system stability
- Not meeting recommended performance in NERC reliability guidelines
