REVIEW OF APRIL 17, 2006 EMERGENCY ELECTRIC CURTAILMENT EVENT

ERCOT COMPLIANCE JULY 21, 2006

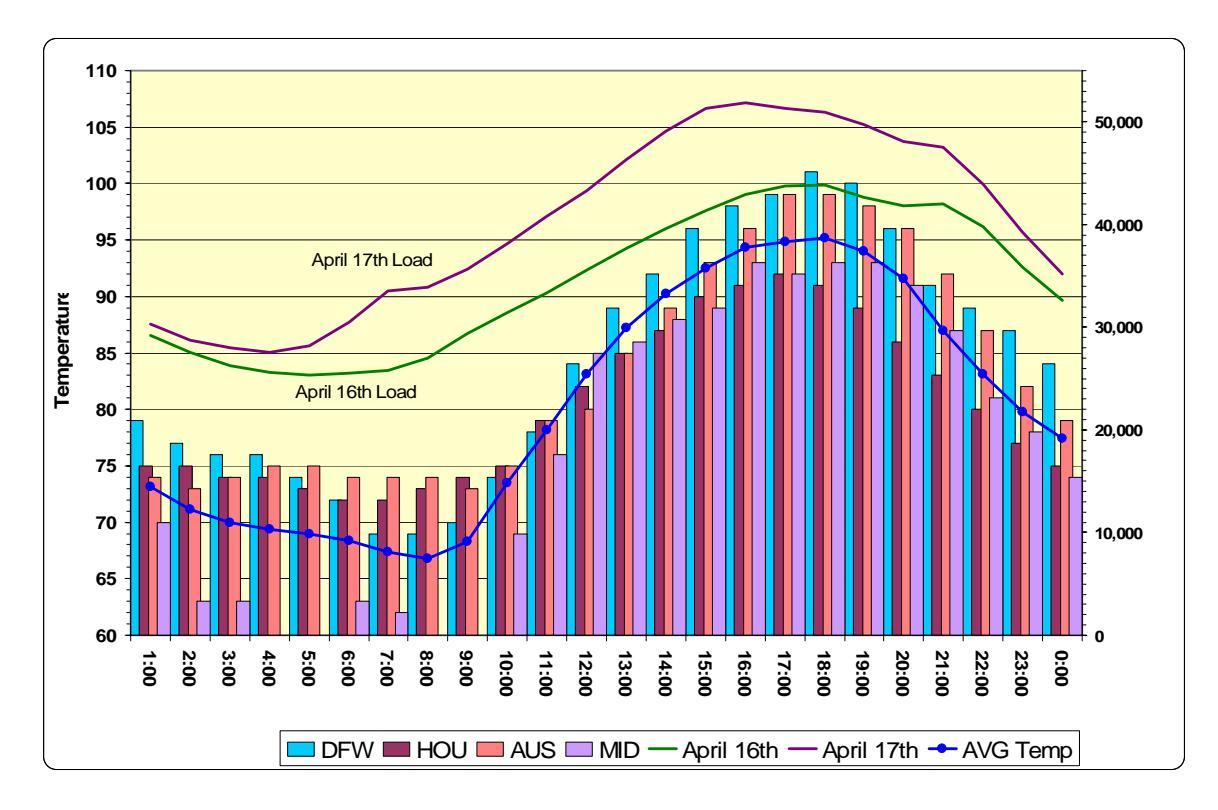
As thoroughly described by ERCOT Operations in their report, errors in the April 17th load forecast primarily occurred for the North and Coastal zones. North zone error between forecast and actual peak of 1250 MW was primarily due to temperatures exceeding the Day-Ahead forecast by 5 degrees F. The "West Texas dry-line" shifted further eastward than predicted by the weather services, reaching to the Dallas-Ft. Worth region. The resulting drier air in the North Texas zone resulted in higher temperatures and loads. The chart below provides hourly temperatures in Dallas/Ft. Worth (DFW), Houston (HOU), Austin (AUS) and Midland (MID), as well as average temperatures (AVG) and ERCOT total load on April 16th and 17th.

ERCOT's vendor, AREVA, examined the Load Forecast Model and concluded that the computed total error in the forecast was 3100 MW, with the majority - 2568 MW – in the Coast Load area. AREVA traced much of this back to model development that used a "filter factor" based on weeks instead of days which restricted ability of the tool to adjust to the actual load and weather ERCOT experienced on April 17th. The load on Sunday, April 16th was 43,895 MW, the highest April load in the last two years. The next highest April load of 41,484 MW occurred on April 28, 2005. The April 17th peak greatly exceeded both of these. Similar days for comparison by the software tool may not fit conditions on the "extreme" day, even with several years of historical records.

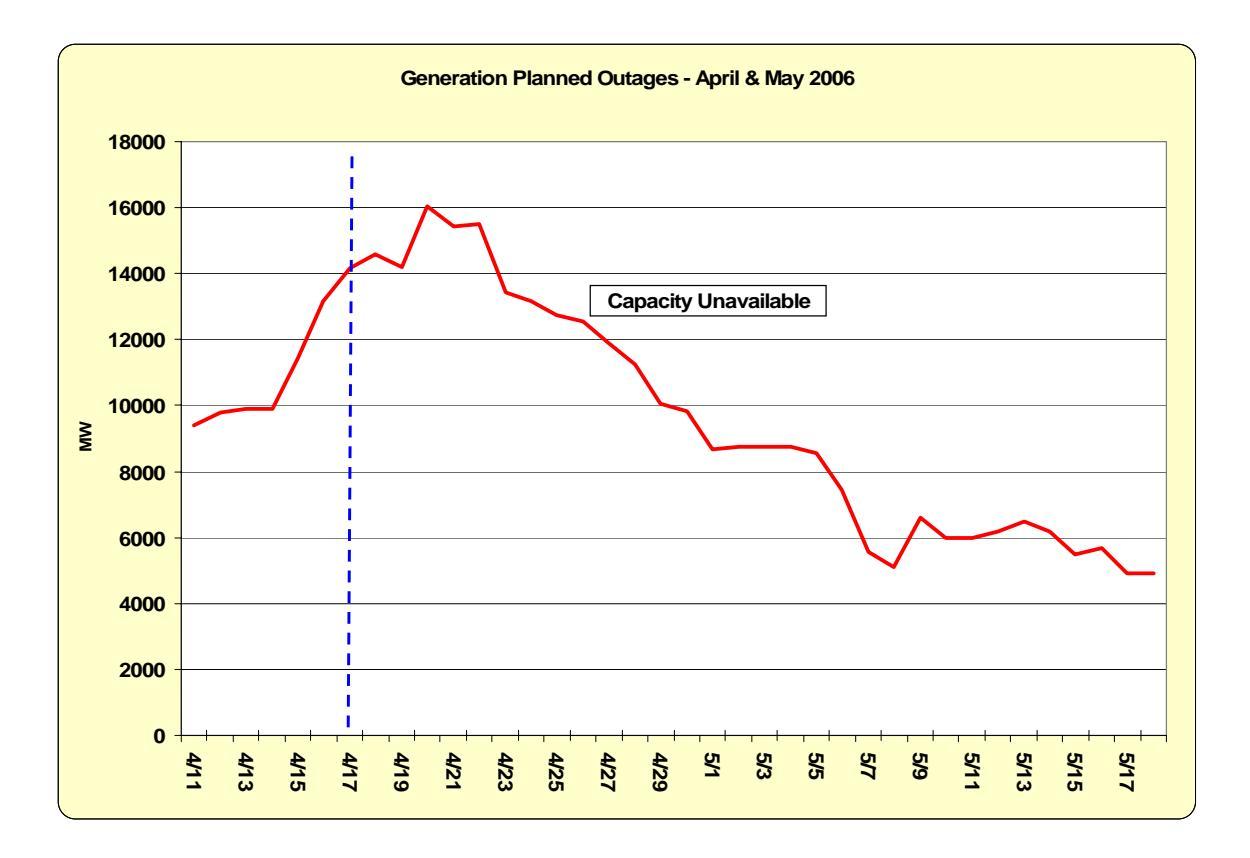
April is also a month with many generators down for maintenance to prepare for summer conditions, and the chart below indicates that this maintenance activity was near a peak around April 17th. ERCOT had 63 Units on Planned Outage representing 14,163 MW at the start of planning for April 17th.

Planned outages need to be accurately reflected in the Resource Plans, along with proper indication of availability, so that ERCOT will know if it can call upon units that are offline. In reviewing Resource Plans, only two instances were noted that incorrectly showed a unit available while it was still shown as out for maintenance in the ERCOT Outage Scheduler. One was not called upon to start by ERCOT due to its lead time, and corrections were made during the operating day, so it was not a factor. Another unit, this one jointly-owned, was shown by QSE G as "on-line" during peak hour, but not by the other QSEs with a share. This unit's capacity was counted in ERCOT's Replacement Reserve studies during peak hour, since it was shown as on-line, which overstated the reserve margin. An extended outage was expected to be completed; the unit ultimately did start on April 17th, but it was later in the day than Resource Plans indicated.

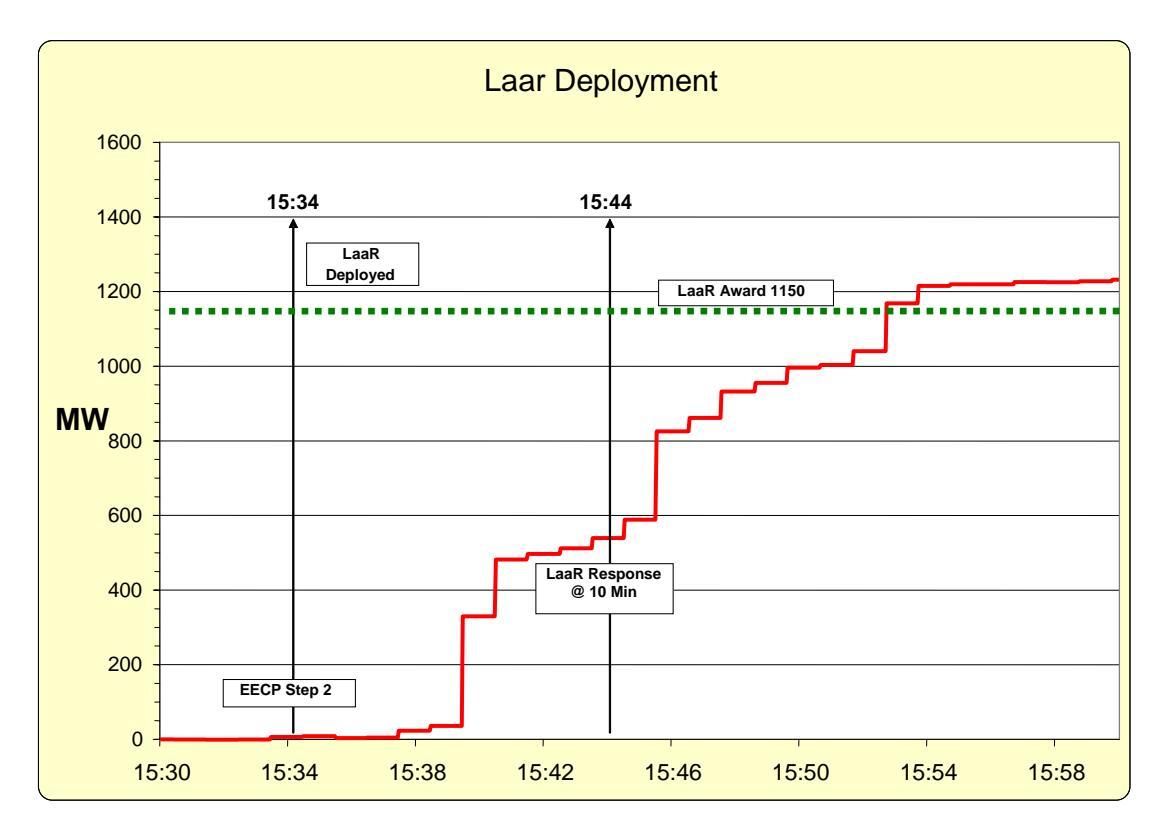
QSEs with LaaR ultimately provided the expected response but it took longer than 10 minutes after notification to achieve criteria defined in the Protocols, as the chart below indicates. Six of nine QSEs with LaaR did not shed 95% of the MW of their LaaR RRS award within 10 minutes of verbal deployment; the chart below indicates what the ERCOT operator would have seen.

However, overall MW response reached 1,093 MW within 19 minutes, which is 95% of the LaaR RRS target of 1,150 MW. LaaR MW response increased further afterwards and remained somewhat above the target throughout the deployment (still within the overall maximum of 150% of award). LaaR delivered total expected MW requirements for RRS, although belatedly.

ERCOT Compliance feels it is imperative that QSE Participants verify that LAAR can be dropped within the parameters set by the Protocols. In the April 17, 2006 event, there were several QSEs whose LaaR response did not meet the ten minute criteria. Those LaaR-owning QSEs unable to achieve Protocols criteria should rehearse manual load drop and restoration to achieve expected 10-minute delivery upon ERCOT instructions and recovery within 3 hours of recall instructions. It is recommended that additional training be done by the QSE to the LAAR in their portfolio to ensure that the proper deployment can be achieved.
