Preliminary Discussion of Potential  
Price Correction:  
DC\_N Settlement Point  
(November 24, 2011)

John Dumas  
Director, Wholesale Market Operations

Board of Directors Meeting  
January 17, 2012

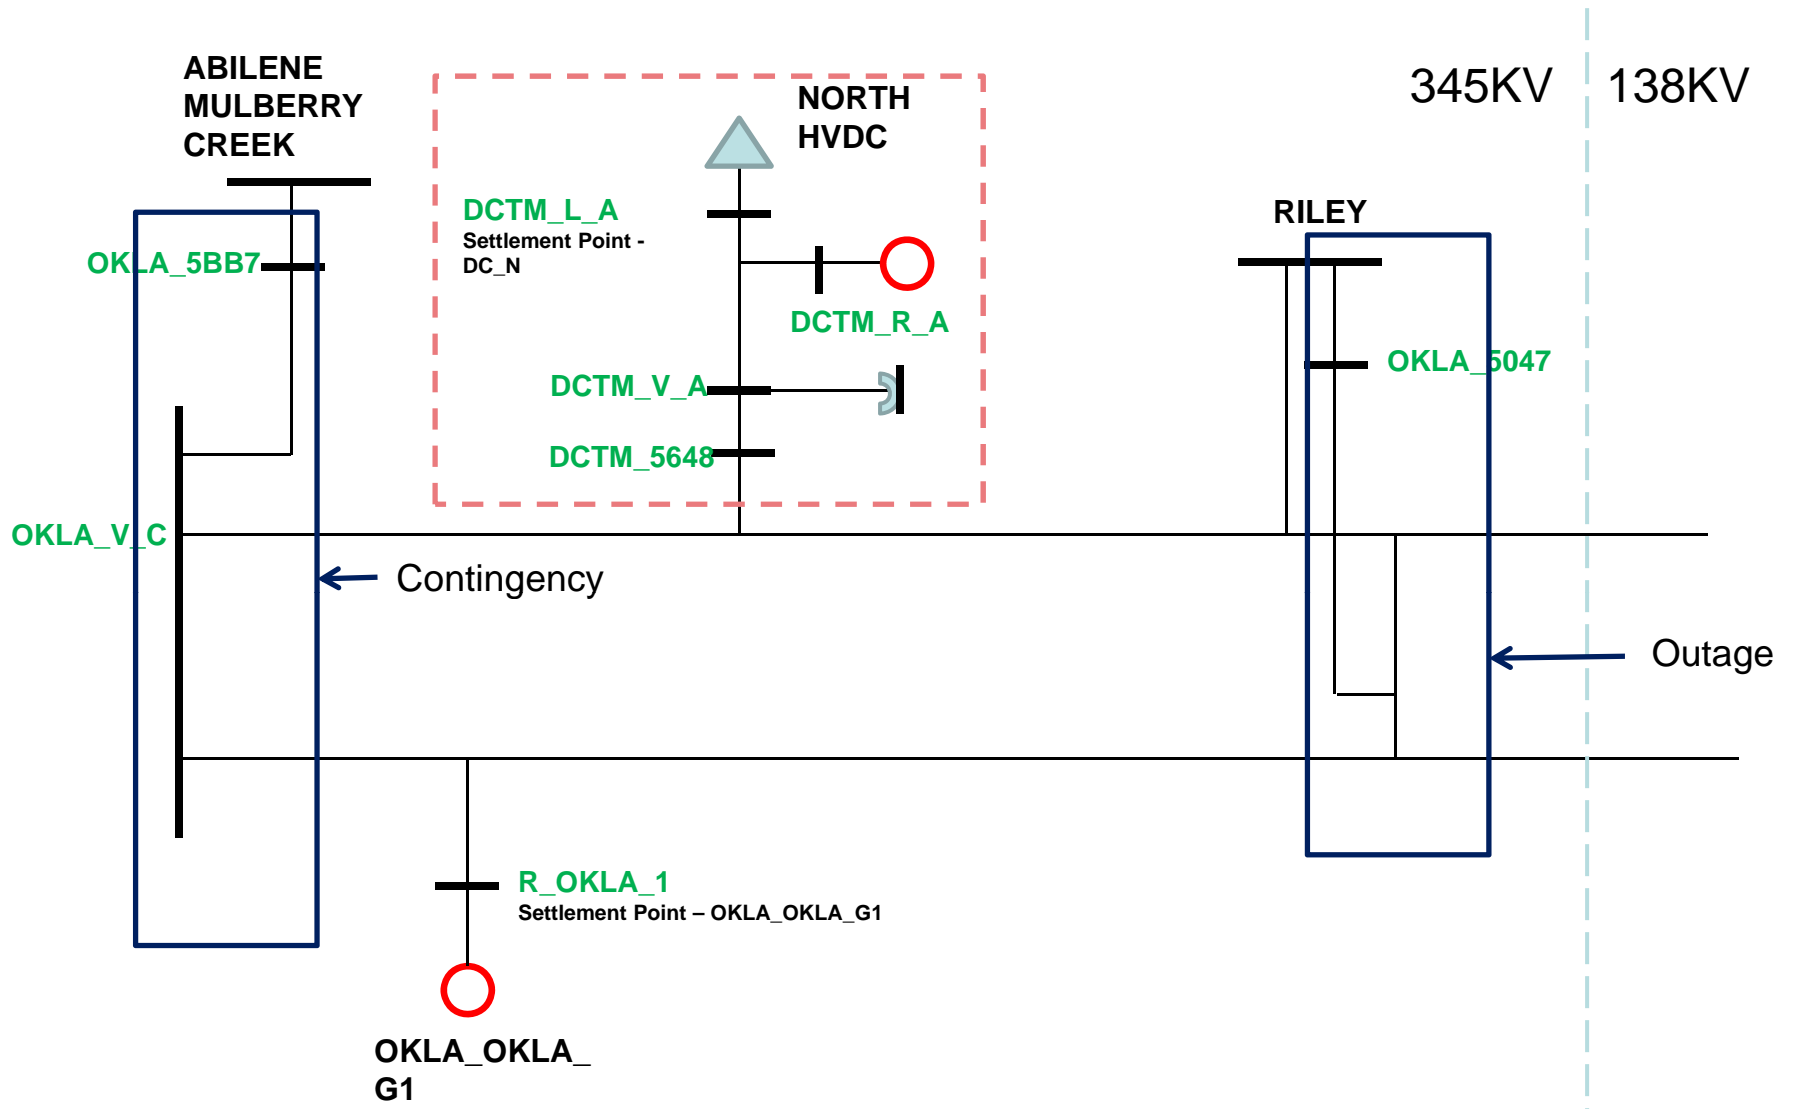
- **DC\_N settlement point (Electrical Buses DCTM\_L\_A) became de-energized due to a software calculation error which disconnected DC\_N settlement point from the grid when there were no exports across the DC Tie.**

- The heuristic rule table, which identifies the buses that set the price at DC\_N when DC\_N is de-energized, did not include sufficient data (due to outages at the Oklaunion station)

- The outages at Oklaunion resulted in the software program de-energizing buses (OKLA\_5047 and OKLA\_5BB7) in the heuristic table
- **Solution to resolve software and data error**

- DC\_N was mapped to DCTM\_L\_A
- OKLA\_OKLA\_G1 was mapped to R\_OKLA\_1
- DCTM\_L\_A, if dead, would be mapped to OKLA\_5047 and OKLA\_5BB7

- Revised the software calculation to not de-energize the DC Tie when not exporting energy
  - Correct the LMP at DCTM\_L\_A when it is de-energized to LMP at DCTM\_R\_A, DCTM\_V\_A and OKLA\_OKLA\_G1, thus reversing the payout of \$4.5 Million on the PTP Obligation

- Add more Electrical Buses to the dead-bus heuristic rule mapping table by including DCTM\_V\_A
