Item 9: Real-Time Market Price Correction for Certain Intervals on Operating Day July 18, 2018

Board of Directors Meeting

August 7, 2018

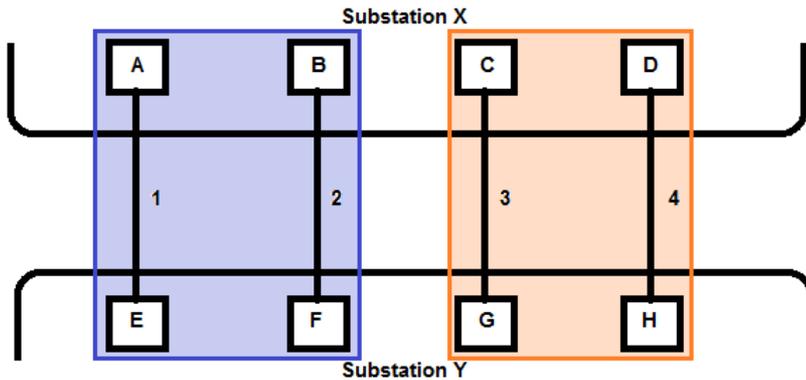
Original Model Data

Double Circuit Contingency 1 contained the following elements: A/1/E & B/2/F
Double Circuit Contingency 2 contained the following elements: C/3/G & D/4/H

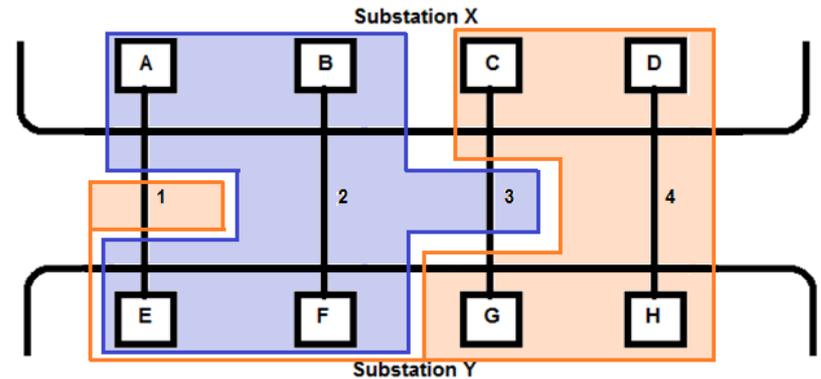
Change Request

(ERCOT received a request to change the lines that shared common towers, which resulted in errors in the contingency definitions.)

Double Circuit Contingency 1 contained the following elements: A/3/E & B/2/F
Double Circuit Contingency 2 contained the following elements: C/1/G & D/4/H

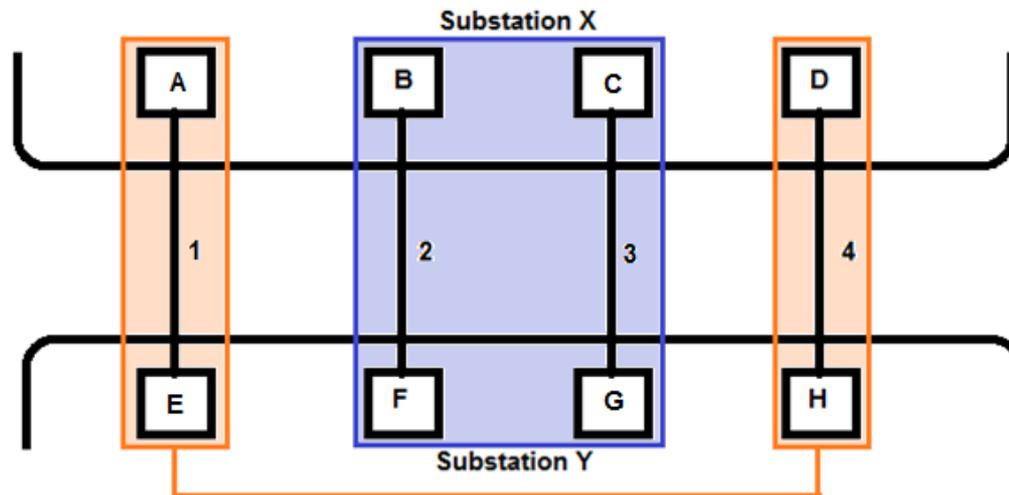
Correct Contingency Definitions

Double-Circuit Contingency 1 contains the following elements: **C/3/G** & **B/2/F**

Double-Circuit Contingency 2 contains the following elements: **A/1/E** & **D/4/H**

- The two double-circuit contingency definitions were corrected with updated model data in all ERCOT systems.
- Going forward, ERCOT will update its models and systems following the receipt of changes that may impact double-circuit contingency definitions by deleting any old definitions, and rebuilding the contingency definition/s.
- Moreover, ERCOT has added a validation check to all double-circuit contingency definitions to ensure that a similar error will not be introduced in other contingency definitions.

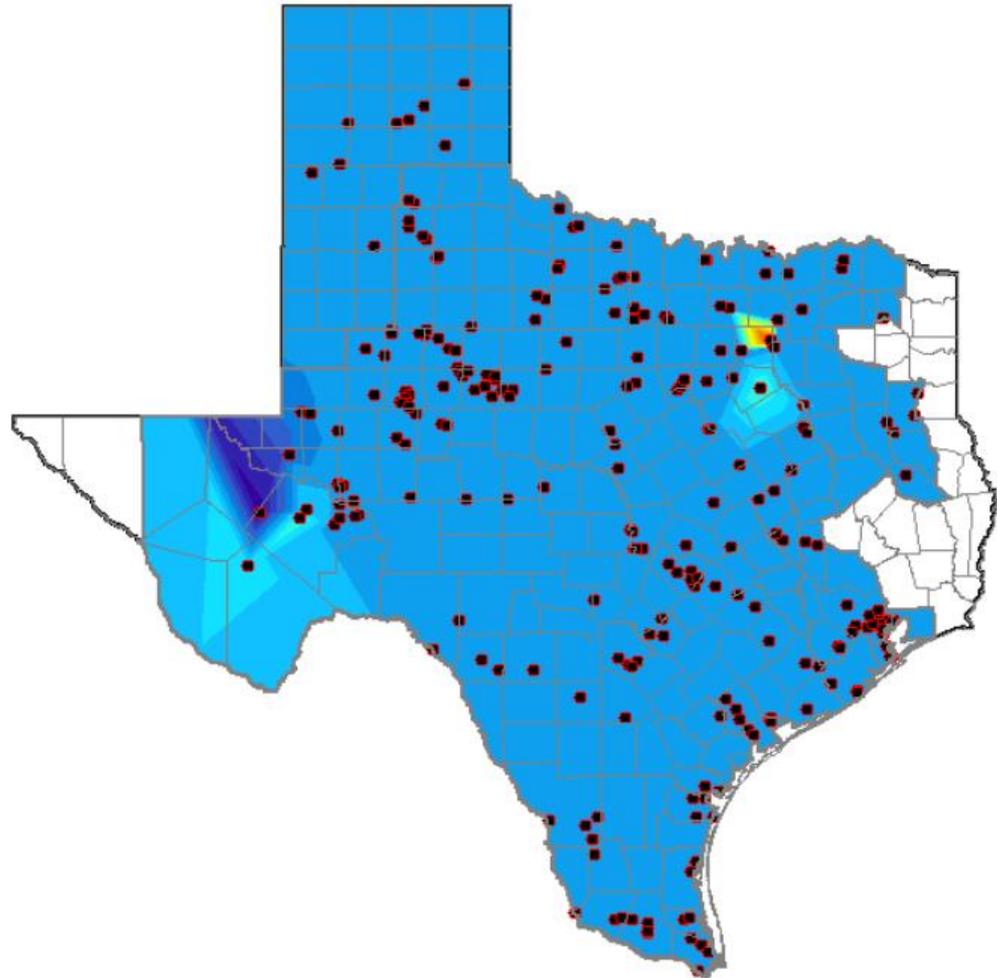
Resource Node LMP Impact for Interval 1630 on July 18, 2018

- Prices most impacted were those near the constraint with the incorrect contingency.
- The shadow prices for other transmission constraints also changed with the erroneous constraint removed.
