## **Item 3: Weatherization and Inspection Update**

Special Board of Directors Meeting

January 17-18, 2022

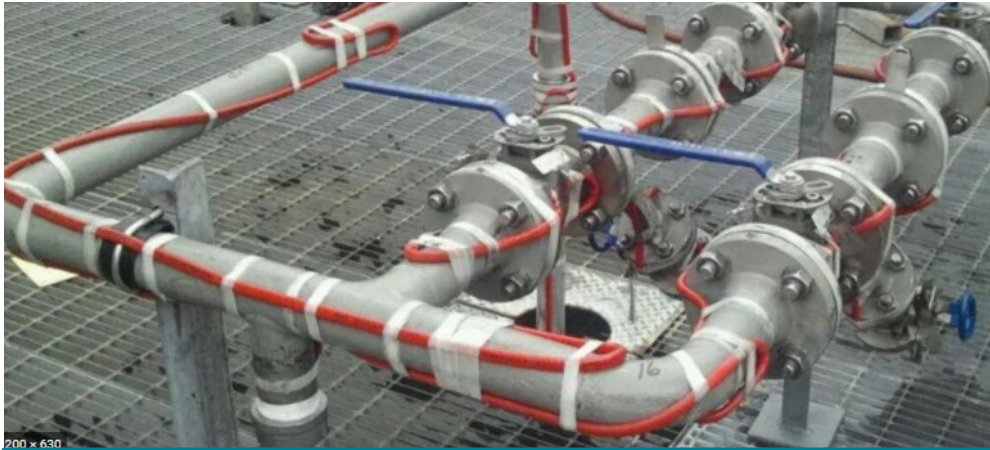
Heat tracing applied to Water Lines  
(prior to applying insulation and cladding)

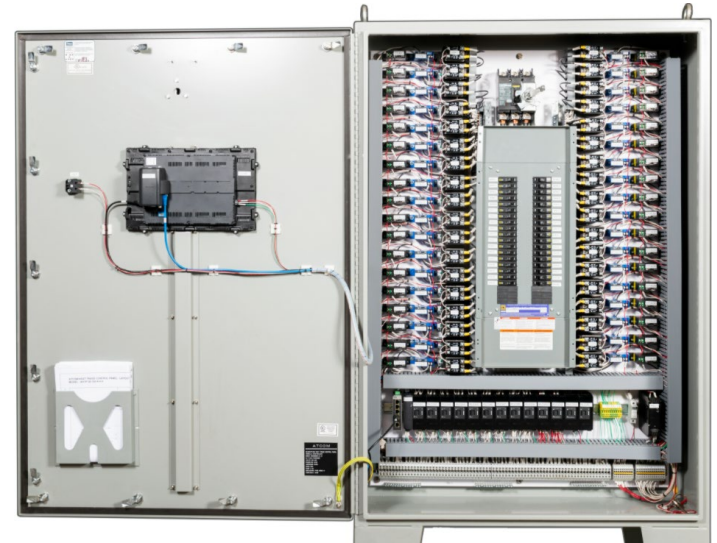
Heat Tracing Control Panel

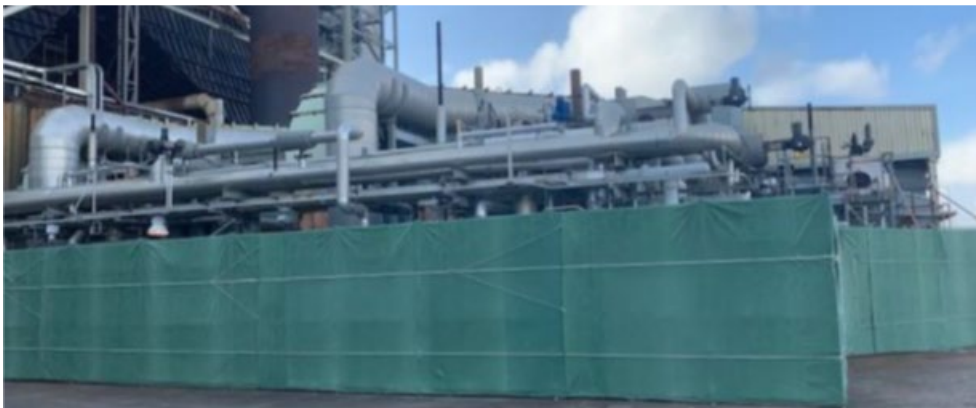
Temporary Wind Break Structures

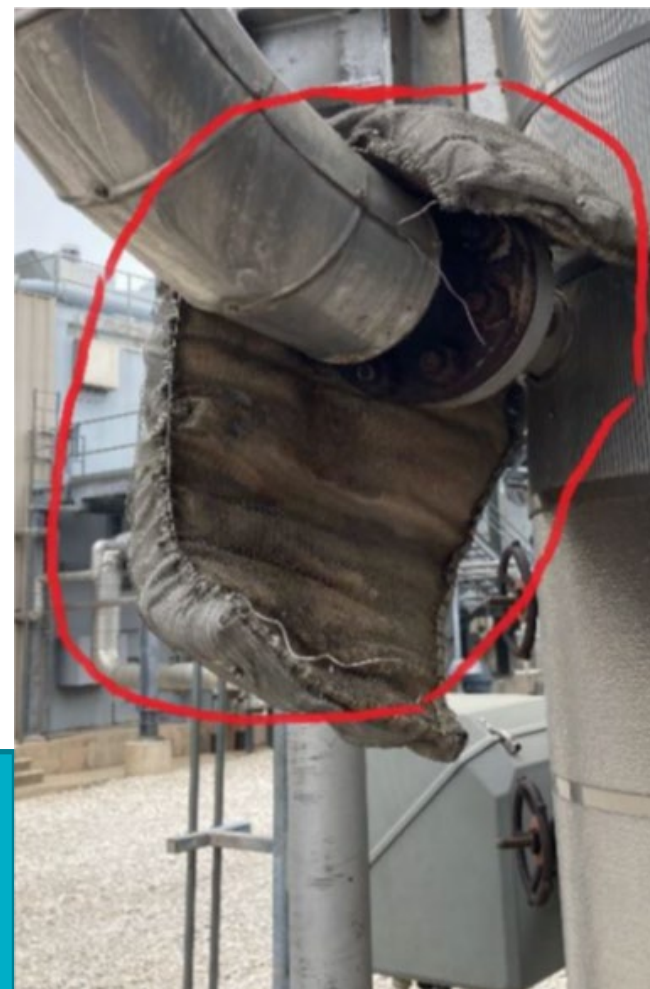
Incomplete Insulation Blanket above, "Clamshell" Instrument Enclosure below

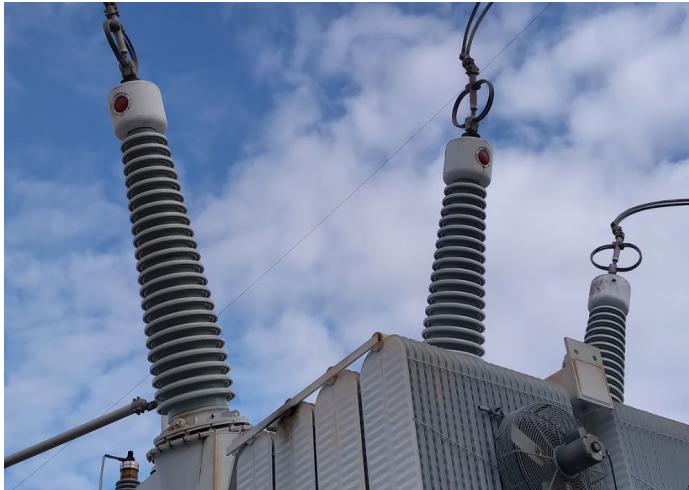
Transformer Bushing Oil Level

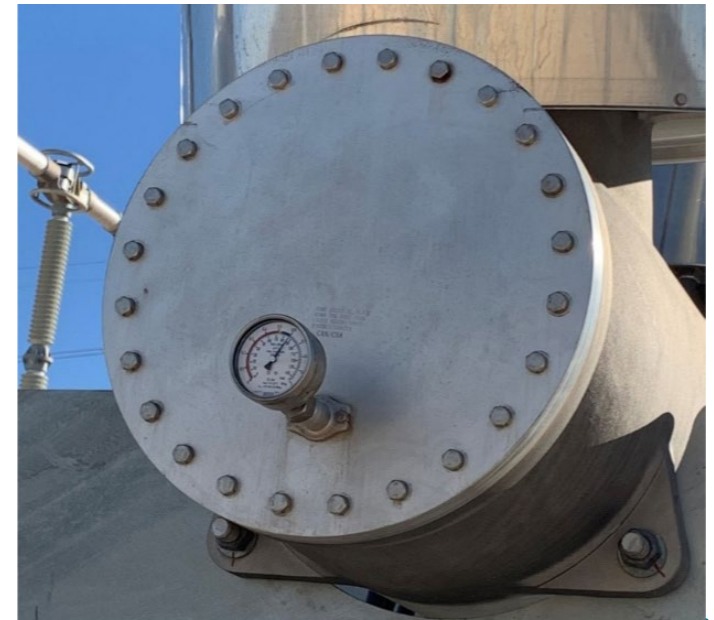
Local Pressure Gauge on SF6 Insulated Breaker

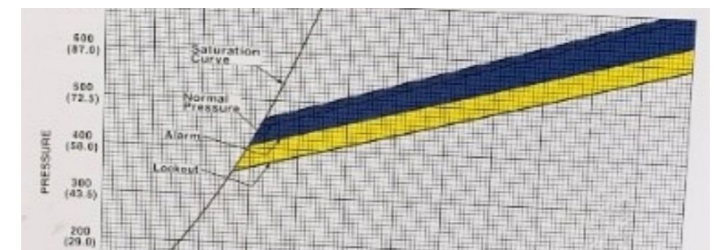
SF6 Pressure/Temperature Curve
