# 2022 Odessa Disturbance Update

Patrick Gravois Operations Engineer – Operations Analysis

IBRTF Meeting November 15, 2022

#### **2022 Odessa Disturbance Event Overview**

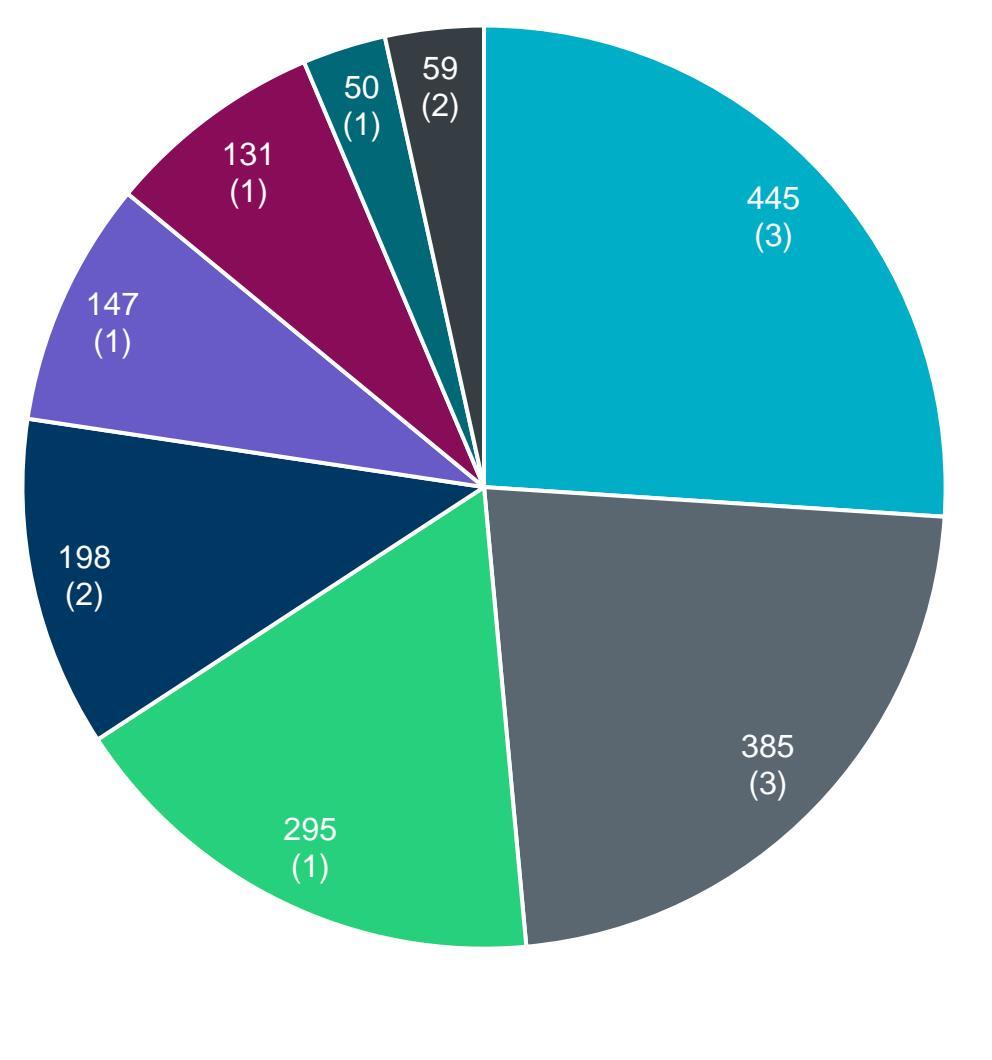
#### MW Loss by Root Cause

Root Cause	# Affected Facilities	MW Loss
AC Overcurrent	3	445
Volt Phase Jump	3	385
AC Overvoltage	1	295
Vdc Bus Unbalance	2	198
Slow Ramp After LVRT	1	147
Momentary Cessation	1	131
Grid Overfrequency	1	50
Unknown/Misc	2	59

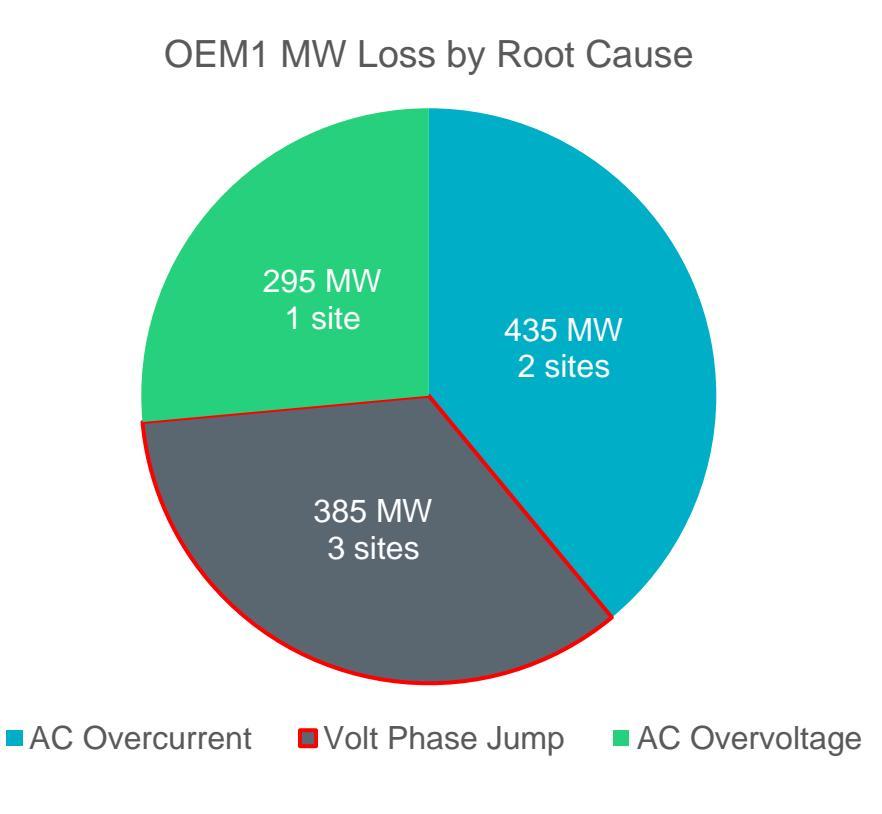
# **OEM1 - Volt Phase Jump**

- Follow up calls with OEM1 and all 3 REs week of August 22
- Anti-islanding protection primarily used in distribution to protect lineman
- Protection not required on BPS nor for inverter protection
- Anti-islanding protection required for UL 1741 certification
- OEM1 recommends either extending threshold from 15 to 35 degrees or disabling protection altogether
- GO must request changes to volt phase jump protection settings
- REs to develop mitigation plan and timeline to submit to ERCOT

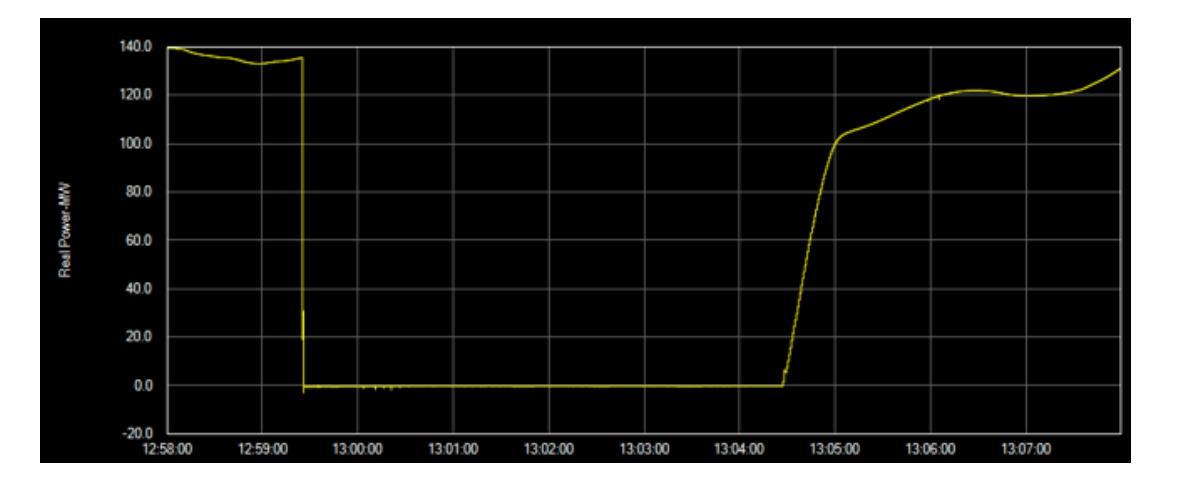
# **Solar Farms with OEM1 Inverters – Plant B**

Facility	MW Loss 2021	Root Cause 2021	Corrective Actions	MW Loss 2022	Root Cause 2022	Corrective Actions	Completion Date
Plant B	150	PLL Loss of Synchronism	Function Disabled	133	Volt Phase Jump	Volt Phase Jump Disabled; VRT thresholds increased; DVC k-factor reduced	9/30/2022

- Overcurrent mitigation already exists in this inverter model
- Volt Phase Jump disabled
- OVRT protection thresholds increased
  - ▶ 125% @ 0 sec
  - ▶ 120% @ 10 sec
  - ➤ 112% @ 15 sec
- DVC k-factor decreased from 2 to 1
- All work complete by 9/30/2022
- No follow up for corrective action implementation
- Will need to resubmit models and currently in process

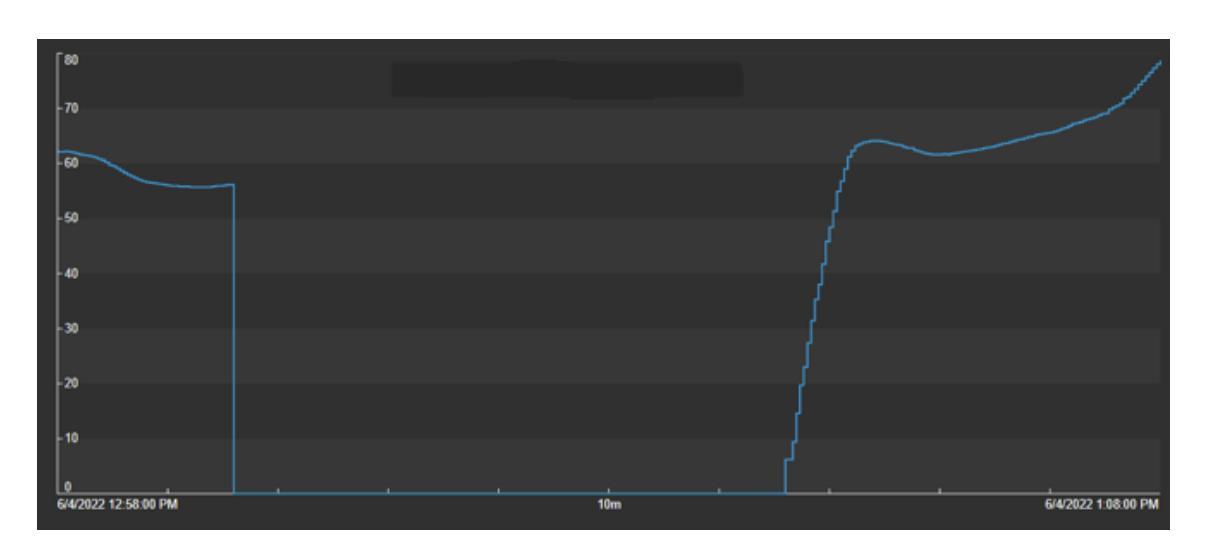
# **Solar Farms with OEM1 Inverters – Plant C/D**

Facility	MW Loss 2021	Root Cause 2021	Corrective Actions	MW Loss 2022	Root Cause 2022	Corrective Actions	Completion Date
Plant C/D	64	AC Inverter Overvoltage	None	56	Volt Phase Jump	VPJ threshold increased; VRT thresholds increased; DVC k-factor reduced	TBD

- In process of modeling k-factor reduction in June 2022
- Volt Phase Jump threshold to be increased from 15 to 35 degrees
- OVRT protection thresholds to be increased
  - > 140% @ 0 sec (momentary cessation >1.25 pu)
  - ▶ 120% @ 2sec
  - ➤ 110% @ 30 sec
- DVC k-factor to be decreased from 2 to 1
- Waiting on OEM to complete testing on overcurrent mitigation
- Waiting on OEM to schedule implementation date
- Will need to resubmit models

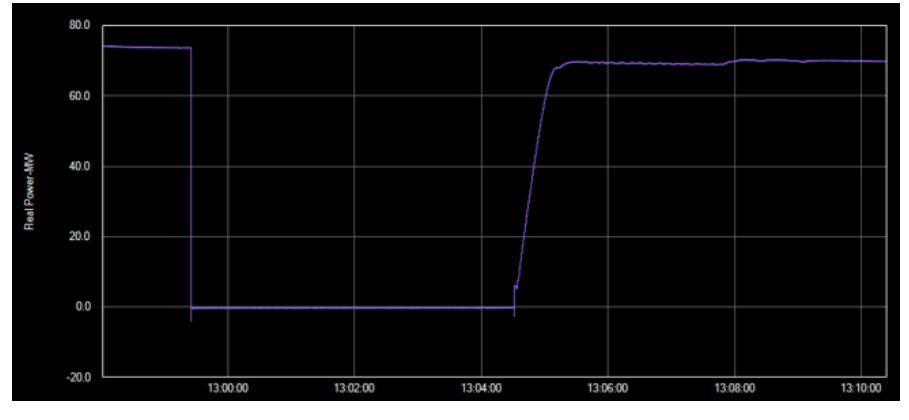
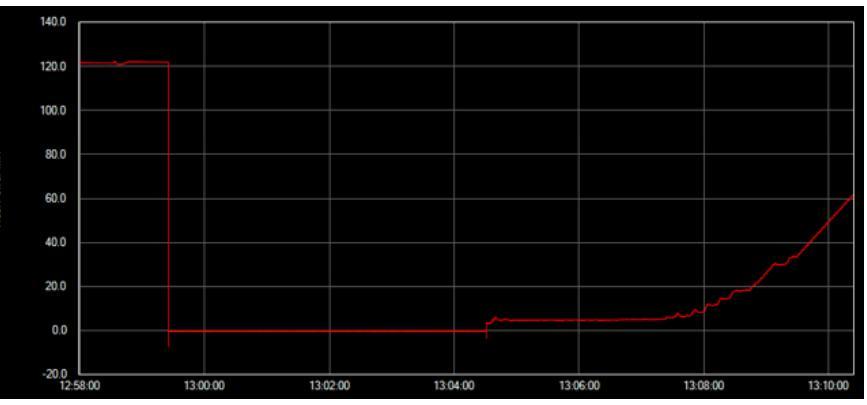
# **Solar Farms with OEM1 Inverters – Plant I/J**

Facility	MW Loss 2021	Root Cause 2021	Corrective Actions	MW Loss 2022	Root Cause 2022	Corrective Actions	Completion Date
Plant I/J	205	AC Inverter Overvoltage	None by June 2022	196	Volt Phase Jump	VPJ threshold increased; VRT thresholds increased; DVC k-factor reduced	10/28/2022

- In process of modeling k-factor reduction in June 2022
- Volt Phase Jump threshold increased from 15 to 35 degrees
- OVRT protection thresholds increased
  - > 140% @ 0 sec (momentary cessation >1.25 pu)
  - ▶ 120% @ 1 sec
  - ▶ 110% @ 65 sec
- DVC k-factor decreased from 2 to 1
- Waiting on OEM to complete testing on overcurrent mitigation
- All other work confirmed complete on 10/28
- Will need to resubmit models

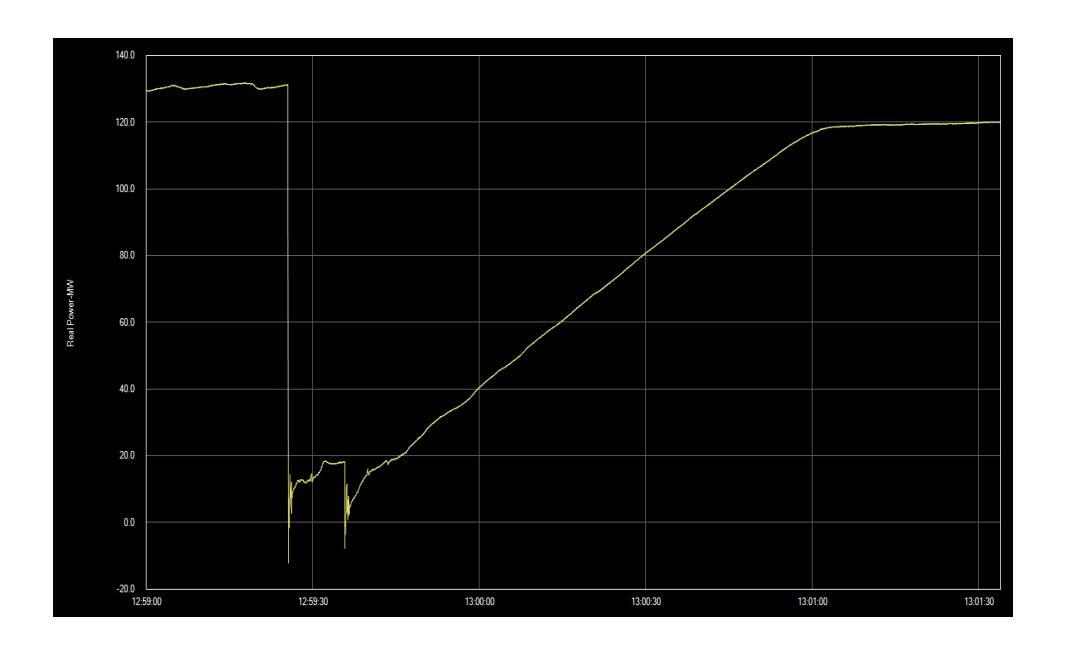
#### **Solar Farms with OEM2 Inverters – Plant K/L**

Facility	MW Loss 2021	Root Cause 2021	Corrective Actions	MW Loss 2022	Root Cause 2022	Corrective Actions	Completion Date
Plant K/L	153	Momentary Cessation	Replaced PPC to improve recovery	131	LVRT disabled; loss of auxiliary power	LVRT/momentary cessation enabled	??

- LVRT/Momentary Cessation disabled during Odessa 2 event
- Loss of auxiliary power and/or phase jump > 20 degrees caused inverters to reduce output – inverter must reset and begin ramping to slower ramp rate
- LVRT/Momentary Cessation has been reenabled
- Momentary Cessation when voltage < 0.9pu
- Should recover to pre-disturbance output in < 1 sec
- Inverters will not ride-through large phase shifts or ROCOF
- Inverters will not provide reactive during LVRT
- Facility does not meet NOG VRT requirements

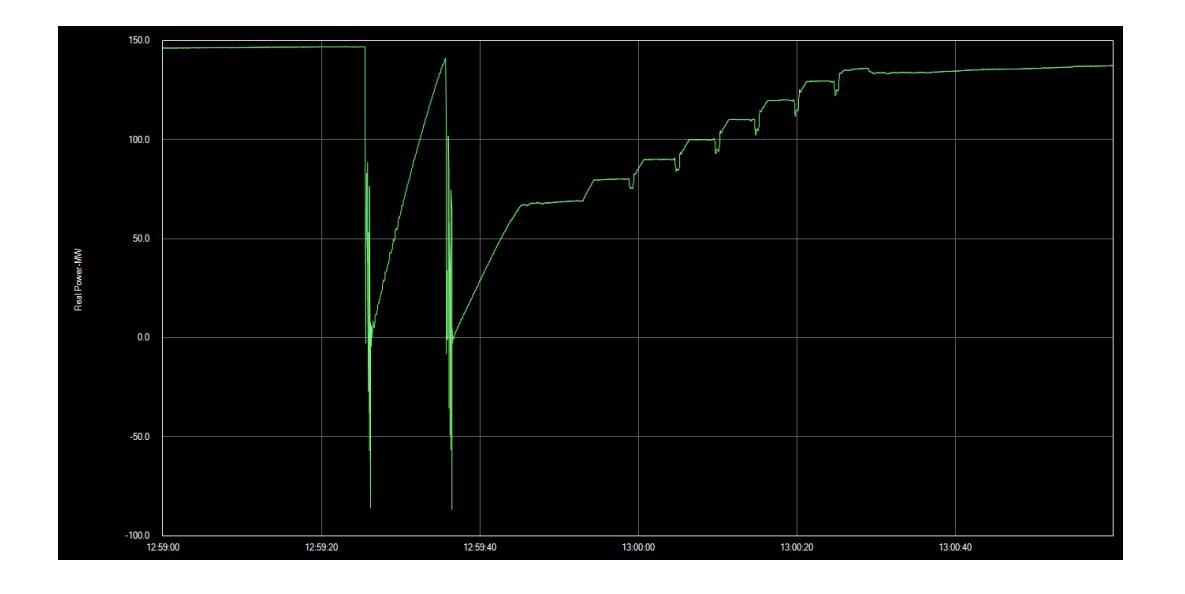
# **Solar Farms with OEM2 Inverters – Plant M**

Facility	MW Loss 2021	Root Cause 2021	Corrective Actions	MW Loss 2022	Root Cause 2022	Corrective Actions	Completion Date
Plant M	147	Feeder Tripping - Overvoltage	Feeder overvoltage protection disabled	147	LVRT disabled; Slow recovery	LVRT/OVRT enabled; Changed LVRT mode; OVRT threshold increased; DVC k-factor reduced	Work completed in October

- LVRT disabled during Odessa 2 event
- Slower inverter ramp rate and PPC interaction caused slow recovery
- LRVT has been enabled
- Changed LVRT mode to limit active power reduction
- Increased fast overvoltage inverter protection to 1.35pu
  @ 0.5 sec
- DVC k-factor changed to 1
- All work completed in October
- Will need to resubmit model and currently in process

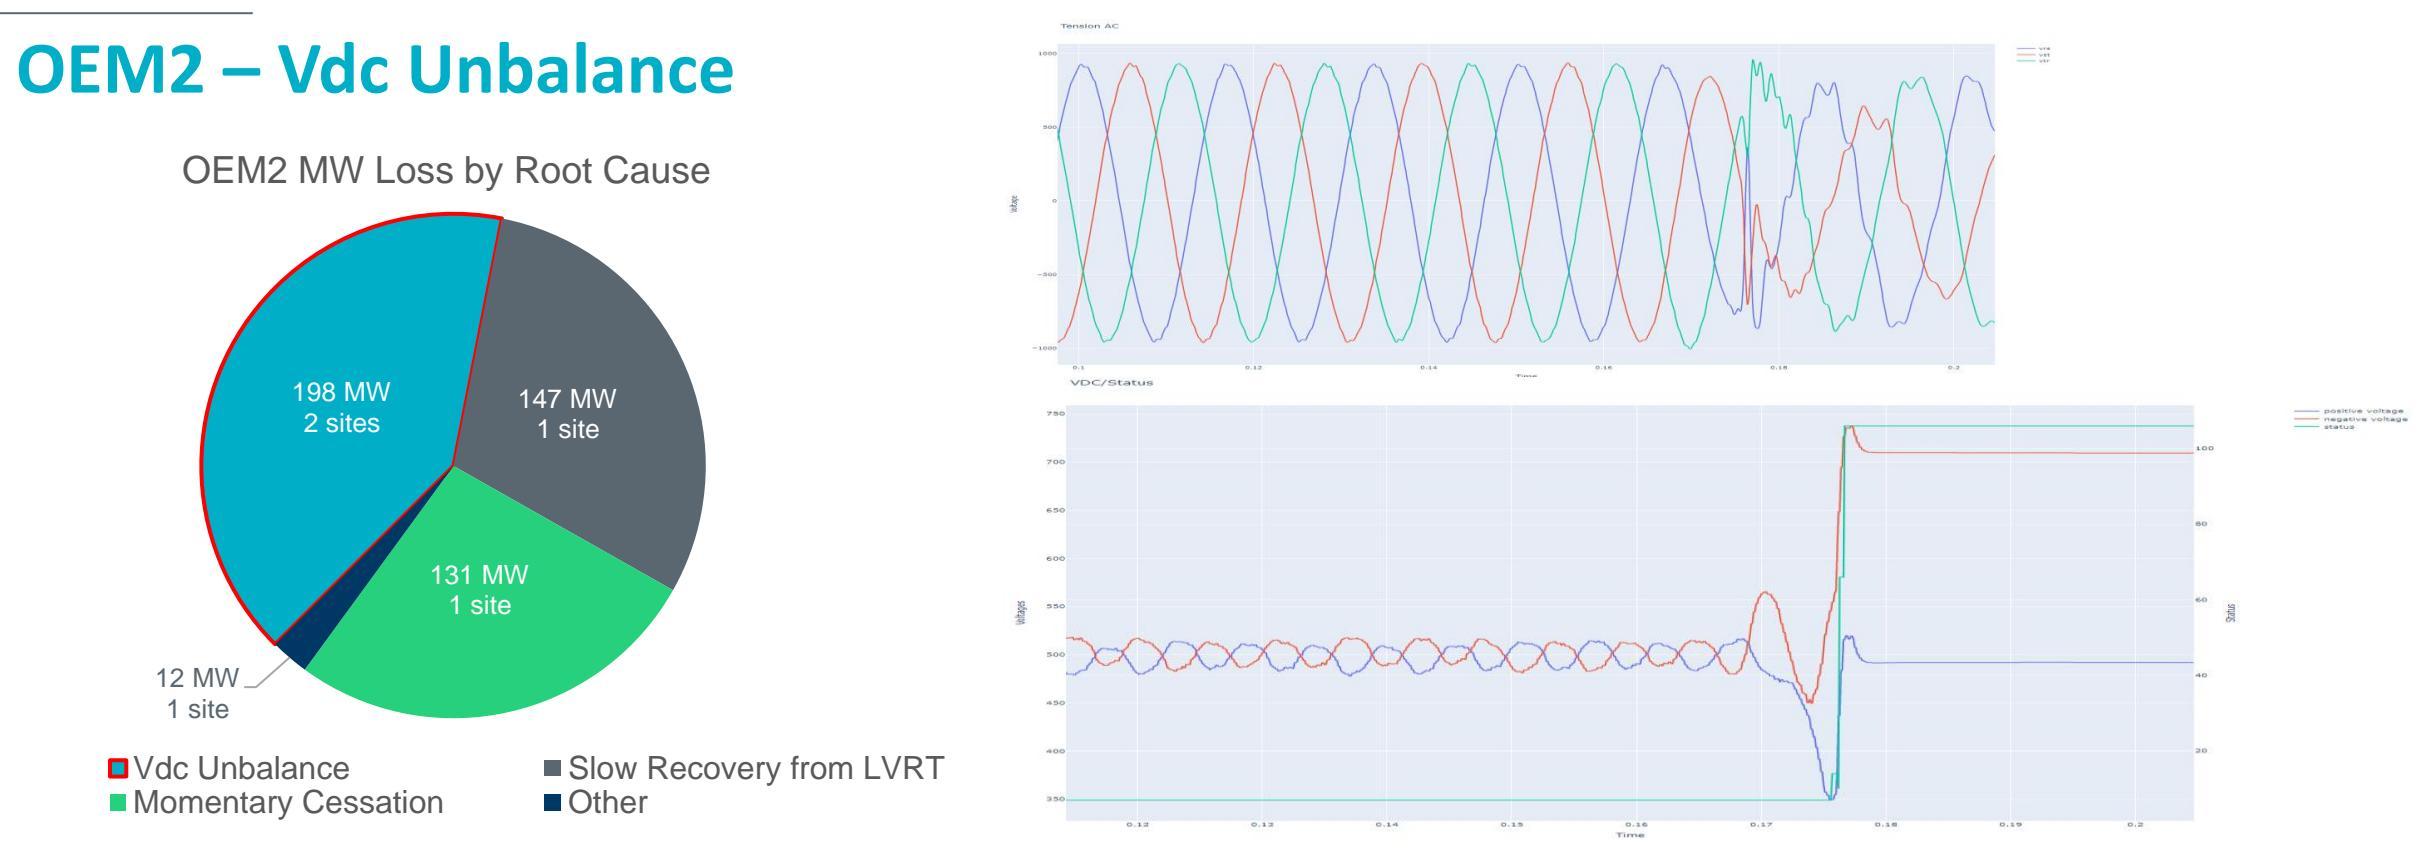
- Protection occurs when DC-side positive and negative bus voltage becomes unbalanced very rapidly potential short
- AC-side voltage phase became unbalanced faster than controls could regulate DC-side due to disturbance
- OEM2 had seen issue in previous events and were already testing software update to mitigate
- Software update improves DC bus regulation response time during voltage disturbances
- OEM completed update to one plant on Aug. 29; second plant to be scheduled soon
- Update to be applied to all OEM2 inverters in ERCOT (with one exception)

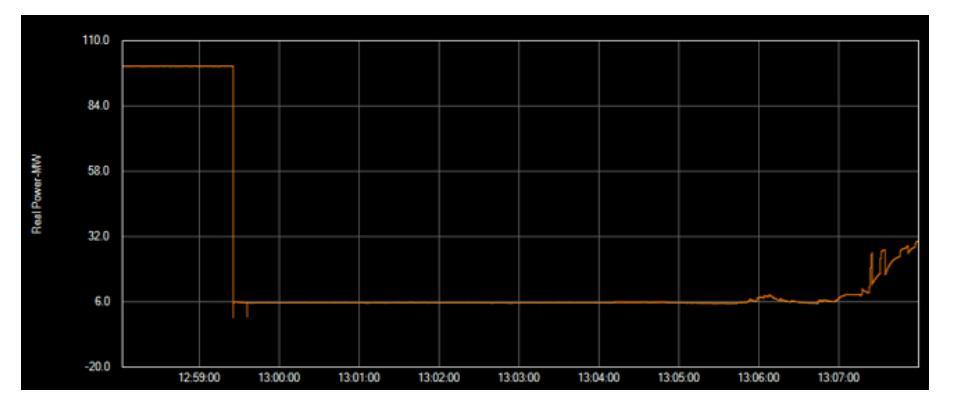
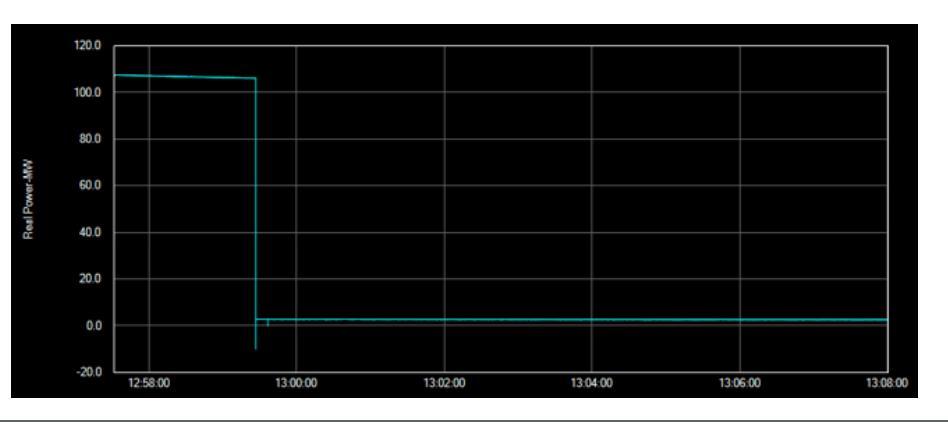
#### Solar Farms with OEM2 Inverters – Plant Q and Plant U

Facility	MW Loss 2021	Root Cause 2021	Corrective Actions	MW Loss 2022	Root Cause 2022	Corrective Actions	Completion Date
Plant Q	N/A	N/A	N/A	104	Vdc Bus Unbalance	Software update to improve DC regulation	TBD
Plant U	N/A	N/A	N/A	194	Vdc Bus Unbalance	Software update to improve DC regulation	8/29/2022

- Plant Q confirmed all inverters had software update implemented on 8/29/2022
- Plant S working on scheduling implementation date with OEM; potentially next week
- OEM confirmed DC side not modeled
- Models will not need to resubmitted for these facilities

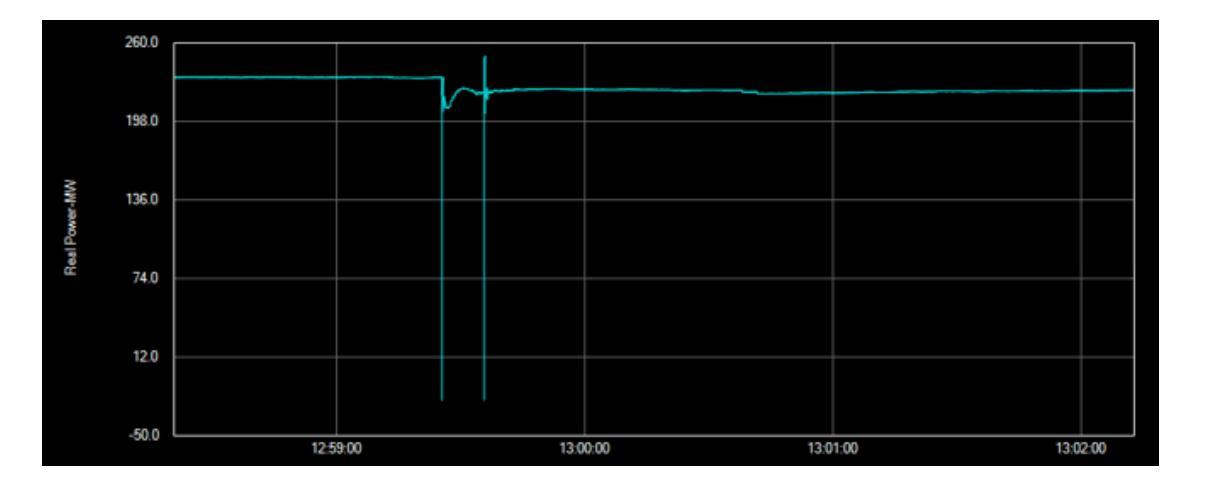
#### **Solar Farms with OEM2 Inverters – Plant S**

Facility	MW Loss 2021	Root Cause 2021	Corrective Actions	MW Loss 2022	Root Cause 2022	Corrective Actions	Completion Date
Plant S	N/A	N/A	N/A	12	IGBT Overcurrent; High inverter temperature	Unknown; logging error – replaced SD cards	In process

- 5 out of 83 inverters tripped during Odessa 2 event
  - > 3 inverters due to high internal temperature
  - 2 inverters due to IGBT overcurrent
- Minimal data available for root cause analysis due to SD card constraint
- In process of replacing with higher capacity SD cards
- OEM unable to determine corrective actions for the 5 inverter trips

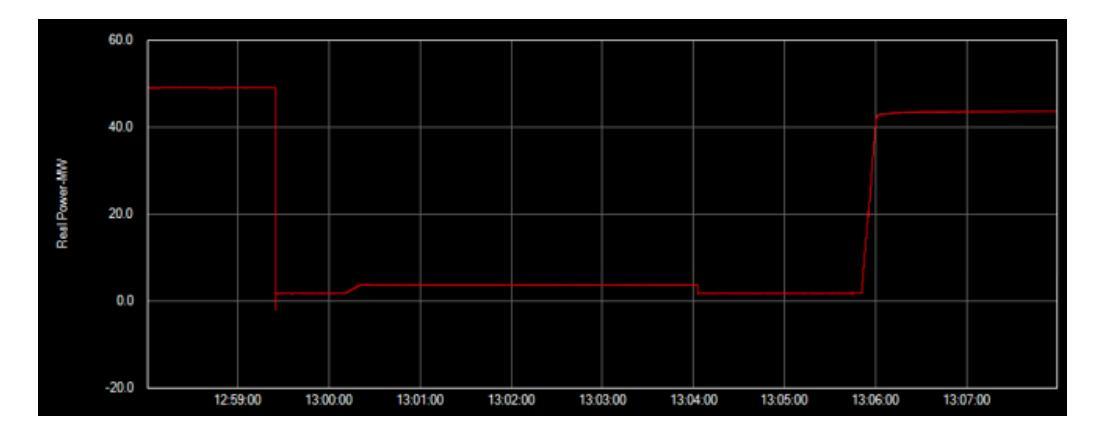
# **Solar Farms with OEM3 Inverters – Plant F**

Facility	MW Loss 2021	Root Cause 2021	Corrective Actions	MW Loss 2022	Root Cause 2022	Corrective Actions	Completion Date
Plant F	48	Underfrequency – Inverter level	None	47	Unknown	Expanded VRT and FRT settings; Improved inverter logging capabilities	Work completed in October

- 25 of 26 inverters went into standby mode for unknown reason
- Inverter logs overwritten by PPC commands
- RE worked with OEM to set VRT and FRT parameters based on equipment tolerances
  - ➢ FRT set for > 63 Hz or < 57 Hz with 3 sec delay</p>
  - VRT parameters expanded with OVRT2 set at 130%
    @ 60 ms
- Modified code to limit number of commands to prevent overwriting inverter logs
- All work confirmed complete on 11/3
- Will need to resubmit models

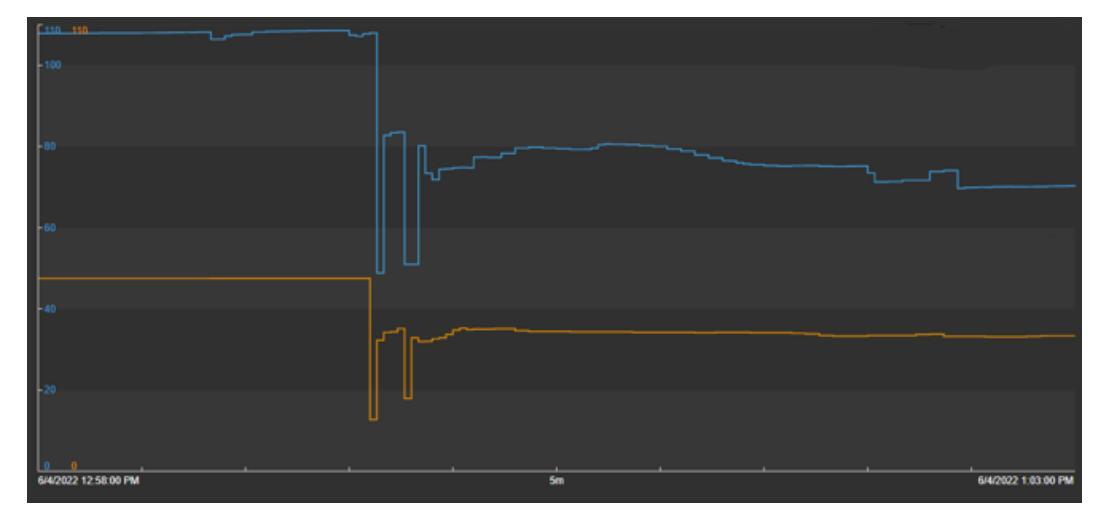
# **Solar Farms with OEM3 Inverters – Plant N/O**

Facility	MW Loss 2021	Root Cause 2021	Corrective Actions	MW Loss 2022	Root Cause 2022	Corrective Actions	Completion Date
Plant N/O	23	Unknown	None	50	Unknown; Inaccurate fault code	Expanded VRT and FRT settings; Improved inverter logging capabilities	RT settings 9/29/2022; Logging in process

- 38 of 166 inverters tripped on fault code Grid Overfrequency
- Fault code registry table incorrectly mapped
- Cause of inverter tripping unknown
- RE worked with OEM to set VRT and FRT parameters based on equipment tolerances
  - ➢ FRT set for > 63 Hz or < 57 Hz with 3 sec delay</p>
  - VRT parameters expanded with OVRT2 set at 130% @
    60 ms
- All ride-through work complete on 9/29
- OEM currently on-site conforming software version for HMI to current fault code error
- Will need to resubmit models

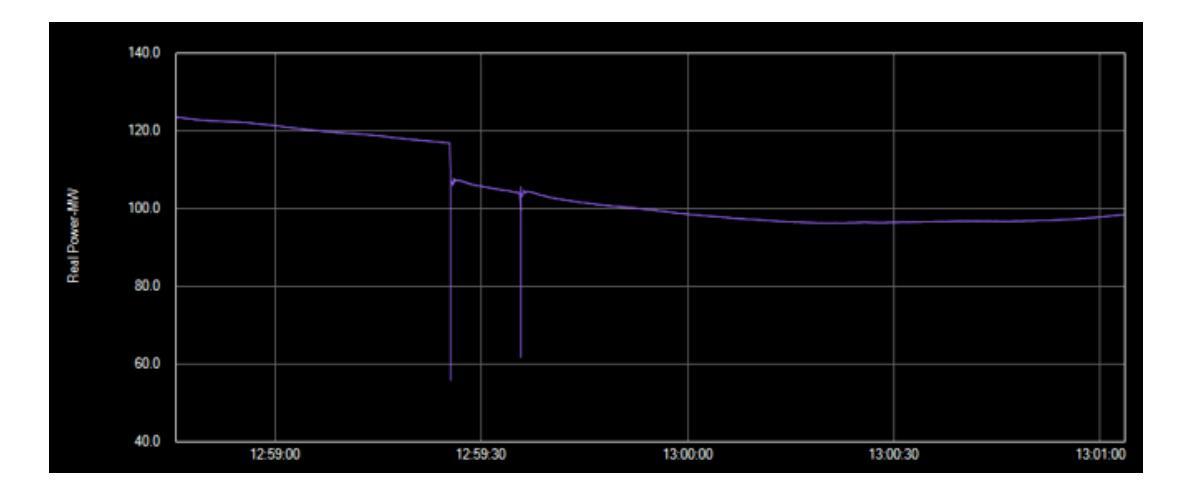
#### **Solar Farms with OEM3 Inverters – Plant R**

Facility	MW Loss 2021	Root Cause 2021	Corrective Actions	MW Loss 2022	Root Cause 2022	Corrective Actions	Completion Date
Plant R	N/A	N/A	N/A	10	IGBT overcurrent	None	N/A

- 7 out of 79 inverters tripped to IGBT overcurrent protection
- OEM states protection is needed for inverter protection
- OEM has not identified root cause of overcurrent nor any corrective actions
- Next course of action with this facility undecided
