# ERCOT STF UPDATE

Synchrophasor Taskforce Meeting  
November 12, 2013

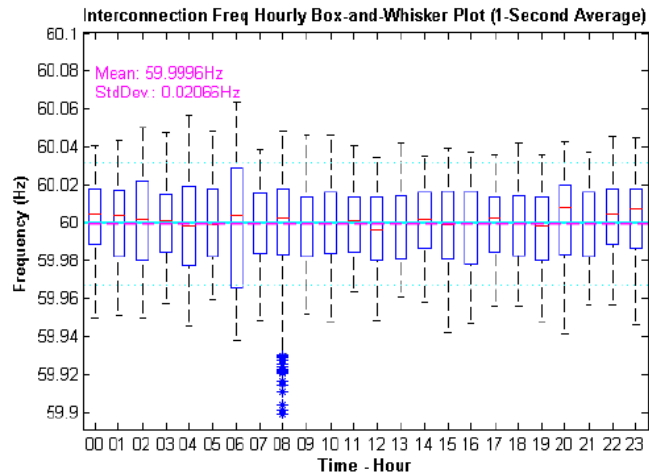
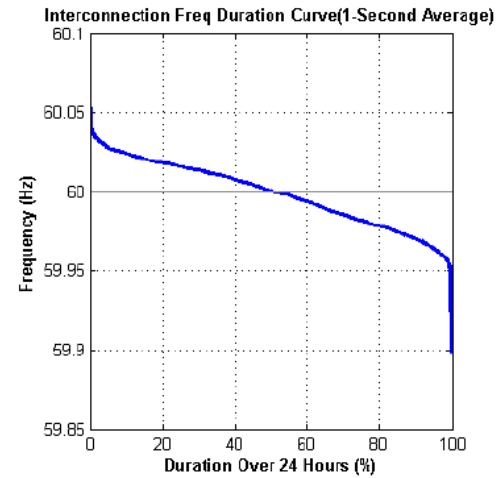
Interconnection Frequency Trends & Statistics

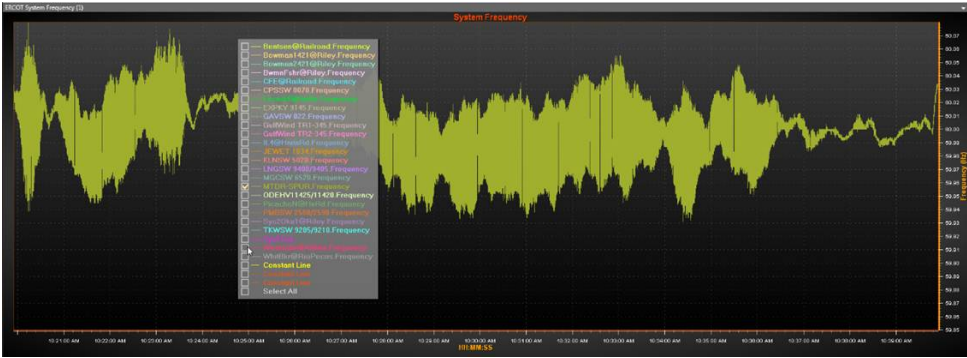
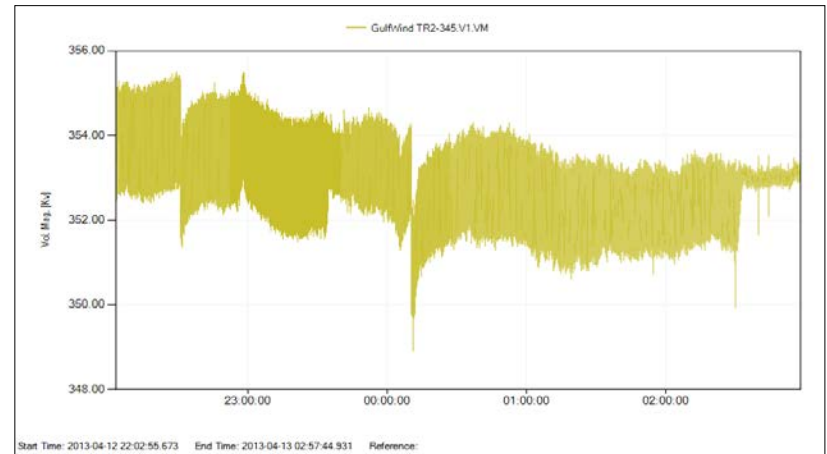
- **System Events have distinct characteristics**
  - Unit trips cause “ramp-down” in frequency
  - Line trips cause “step” changes in voltage angle
    - Accompanying drop in voltage and drop/rise in current would indicate a system fault
  - Capacitor/Reactor switching causes “step” changes in voltage magnitude
  - Oscillation Events can indicate:
    - Poorly tuned controllers (  $> 1$  Hz )
    - Absence or Offline Status of PSS in nearby generation (  $< 1$  Hz )
- **Characterization needs to be developed and formulated**
  - Should be easily programmable in software
  - Should be easy for the Operators to understand and use in day-to-day functioning.
  - Should be incorporated (once developed) into a system of protocols for Operators both at ERCOT and TSPs to follow

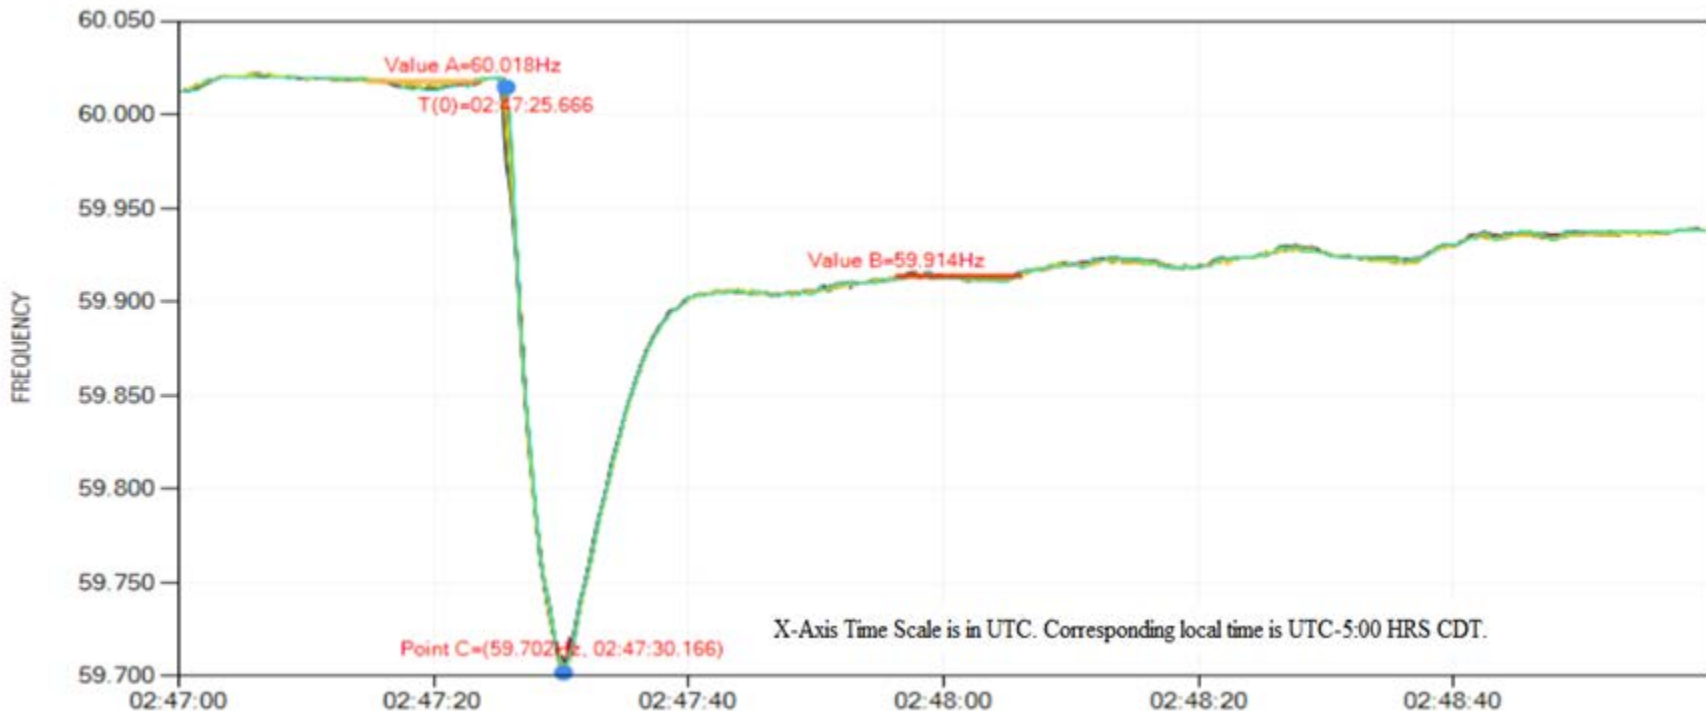
The RTDMS captured the following event at the time of 21:47:25 on XX/XX/XXXX. The Advanced Network Applications group studied the dynamic characteristics of this event based on recorded phasor data from 55 available PMUs. The system frequency recovered to 59.95 Hz in around 110 seconds.

Frequency (Hz)	Damping rate (%)	Mode Shape Description
0.64	8.6	
Identified by analysis of voltage angle data of PMUs in Central, North and West Texas referred to KLNSW
