EVENT DETAILS

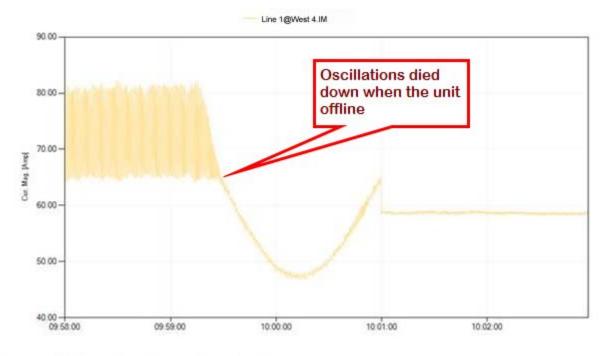
Figure 3: EMS trend for generation at the power plant on February 18th, 2014 at 10:00 am

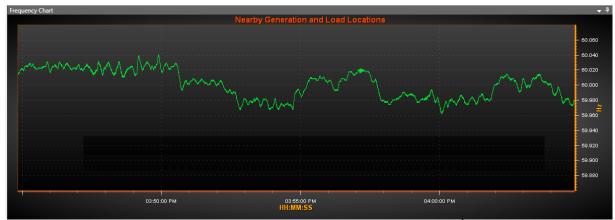
Figure 7: EMS display showing Unit 1 coming online at 4 pm on March 5th, 2014

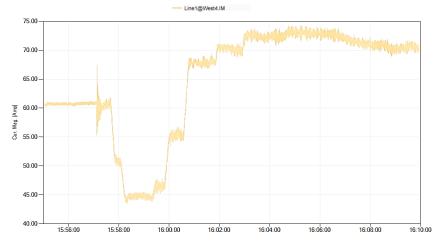
Figure 8a : Frequency display on RTDMS on March 5th, 2014

On February 18th, 2014, at about 8:30 am, after logging on into RTDMS system, ERCOT Operations Engineers noticed oscillations on the RTDMS displays as shown in Figure 1. On analysis, it was found that the oscillations were showing up only at Line 1@West 4 PMU as shown in Figure 2a and Figure 2b. ERCOT looked at the generation at the Hydro Unit close to West 4 PMU. It was generating about 25 MW (Figure 3). It was found that when the unit went offline at about 10:00 am, the oscillations died down as shown in Figure 4. It was noticed that, when the second unit at the same plant was running there were no oscillations observed. Oscillations showed up again on February 27th, 2014 when Unit 1 came online, as shown in Figure 5a and Figure 5b. Analysis of these oscillations using Phasor Grid Dynamics Analyzer (PGDA) tool indicated that the dominant mode that was present was 1.8 Hz as shown in Figure 6a and 6b. ERCOT discussed with the power plant operators to find the root cause of these oscillations with one of the units of the plant. It was confirmed that they could also see the oscillations for that unit. It was then decided that the plant operators would change some of the control cards for the problematic unit and test to see if it would solve the problem. Usually they operate the units alternatively. Since ERCOT was going through some severe weather conditions, the plant operators decided to operate only the good unit until ERCOT passed through this severe weather conditions. On March 5th, when weather conditions were good, Unit 1 (for which some of the control cards had been replaced) was brought online at about 4:00 pm (Figure 7). It was found that the oscillations were significantly reduced, as shown in Figure 7a, Figure 7b and Figure 7c after the control cards were replaced.
