**FINAL REPORT ON THE
AUGUST 18, 2004 DCS EVENT**

ERCOT COMPLIANCE

January 2005

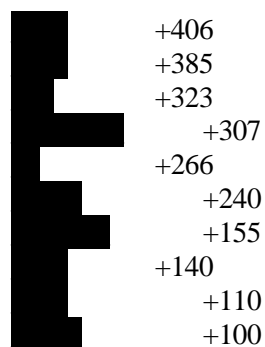
Schedule Changes from IE 10:00 to IE 10:15 greater than 100 MW

Cumulative ERCOT schedule change over the 10:00 a.m. ramp period on August 18 was 2746 MW. While no individual QSE had a base power schedule change of over 400 MW, the total is a large value for any interval and changes of this magnitude are normally observed only at 06:00 and 22:00.
