# ERCOT HURRICANE IKE Summary

On Behalf of the ERCOT Reliability and Operations Subcommittee

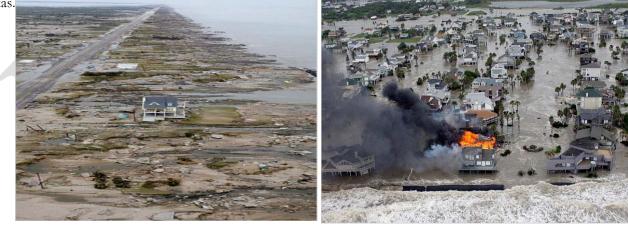
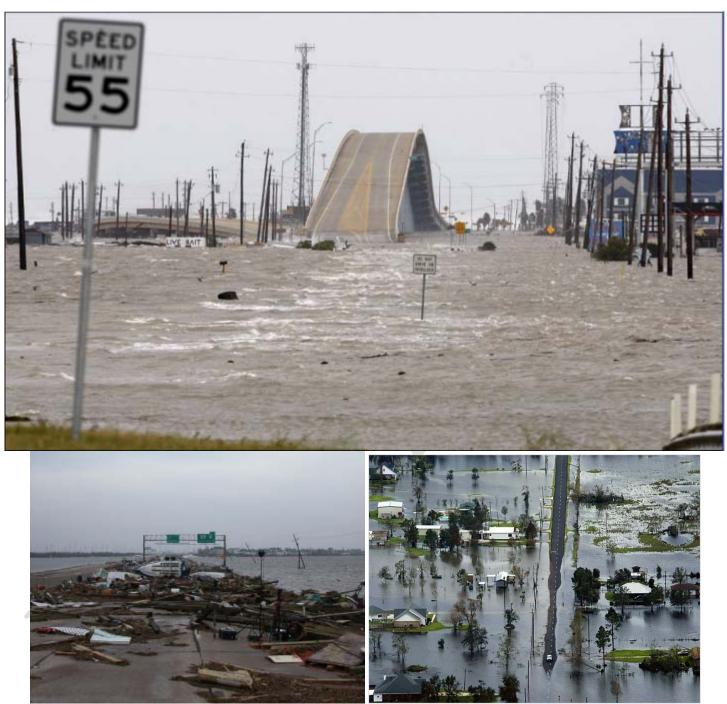
Getting crews in to access the damage was a challenge as large amounts of debris and flooding prevented access.

Highway 45 into Galveston was littered with boats and debris. Note the vehicle in the picture on the right is blocked due to high water.

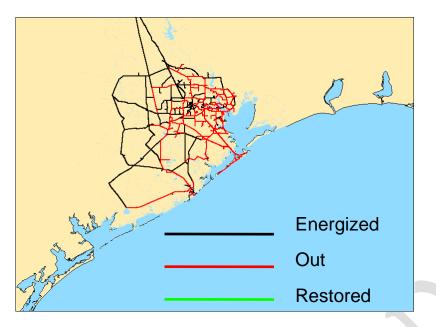
### HURRICANE IKE 9/13/2008 3 PM

97 CIRCUITS OUT

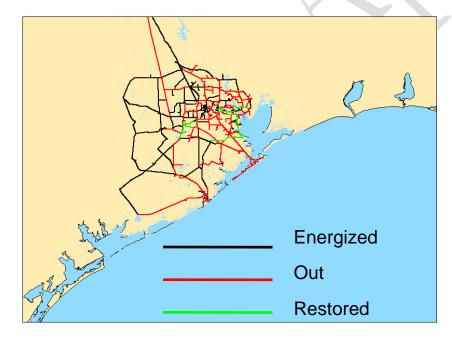
### HURRICANE IKE 9/13/2008 EVENING

90 CIRCUITS OUT & 7 CIRCUITS RESTORED

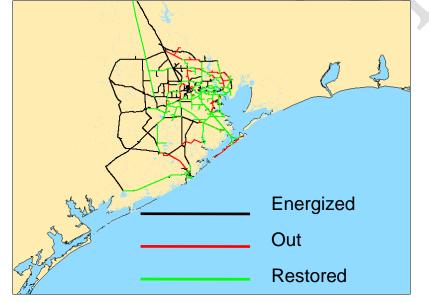
HURRICANE IKE 9/15/2008 RESTORATION - 70%

30 CIRCUITS OUT & 70 CIRCUITS RESTORED

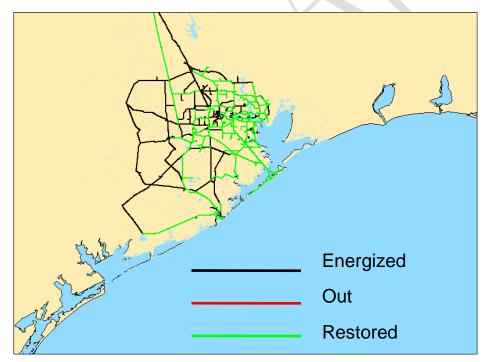
HURRICANE IKE 9/23/2008 RESTORATION - 100%

100 CIRCUITS RESTORED

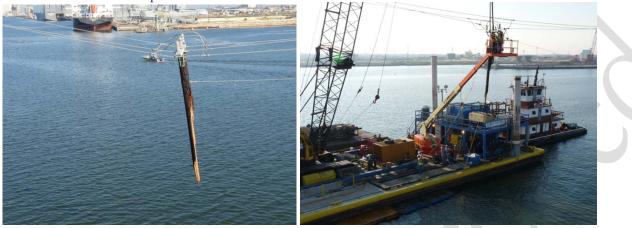
Not all lines in the CenterPoint area could be reached with normal crew support. Barges were required and on standby for areas like the Houston ship channel.

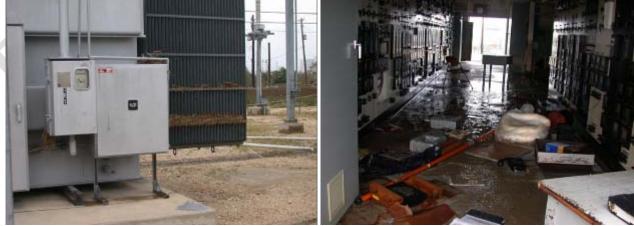
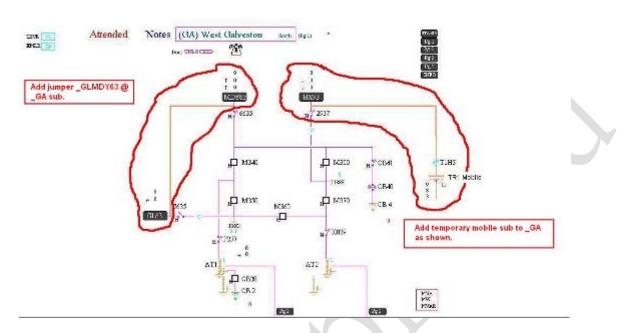
STORM SURGE IN GALVESTON WAS SIGNIFICANT AND DAMAGE TO THE WEST GALVESTON SUBSTATION WAS PRIMARILY DUE TO ITS PROXIMITY TO THE COAST.

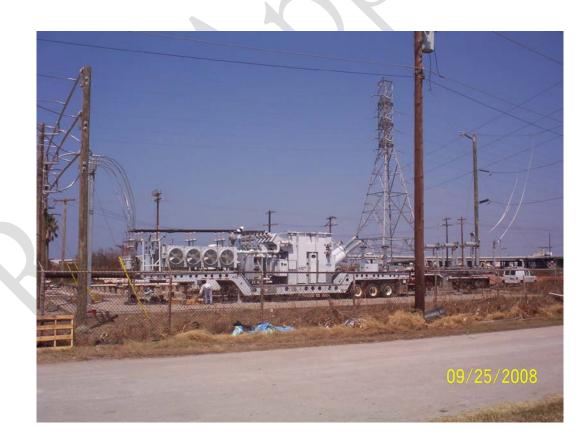
CenterPoint installed a Mobile Substation in order to restore circuits in the Galveston area. This could supply approximately 45 MW of load.

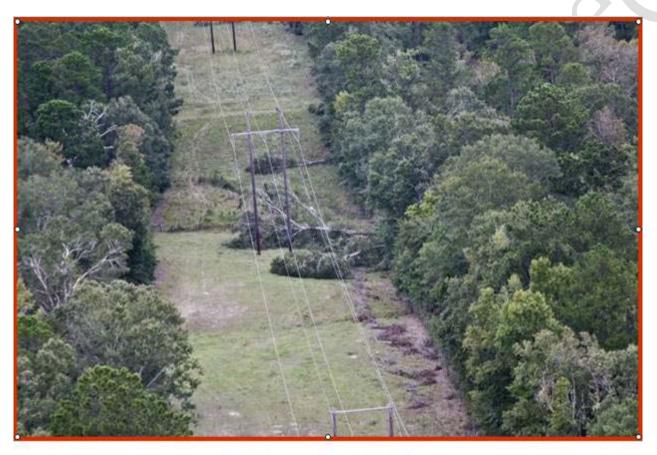
## Aerial patrol near Lufkin

Damage Summary					
Trees in Lines	Structures Damaged	Wood Poles Replaced	Cross-arms Replaced		
60	18	10	8		
Assets Impacted					
69 kV	138 kV	345 kV			
# Lines	# Lines	# Lines	Substations	Feeders	Customers
7	10	1	25	52	37,361

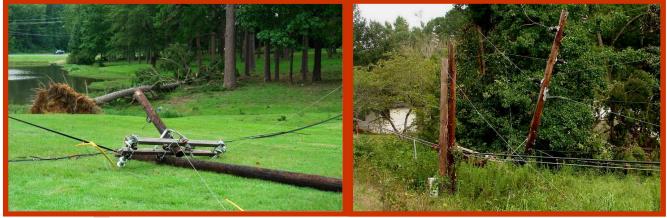
The majority of damage was caused by high wind and trees falling into the lines. ONCOR replaced 658 poles in total.

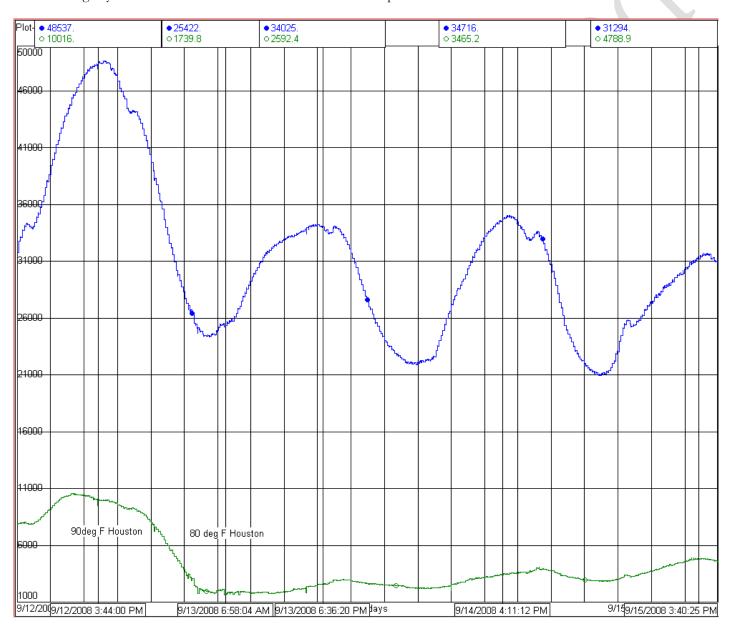
Chart-ERCOT Total Load shown with the Coastal zone included 9/12/2008 6:00:00PM to 9/15/2008 6:00:00PM

The following chart shows the load before during and after the hurricane. The Blue trend is the ERCOT LOAD and the Green trend is the COAST LOAD. At 4 pm on Friday Sept 12<sup>th</sup> the load in the Coast region was approximately 10,000 MW. The next morning on the 13<sup>th</sup> of September the load fell below 2,000 MW. Along with this load drop due to the Hurricane the following day a front hit the Houston area which reduced temperatures into the 80s.

Houston load is typically 10,000 MW in September but after the Hurricane struck the load fell as low as 1,600 MW. Many Co-Gen facilities and industrial processes along the Gulf Coast were shut down prior to the storm. It took up to a week for some of these facilities to return to normal operations. Some industrial facilities in the Texas City area were damaged as a result of the tidal surge from the storm. Two distribution poles and all metering were replaced at these facilities. Normal operations was restored on Thursday, September 18, to those facilities. As can be seen by the following day peaks about 1300 MW were added the first day and 1000 MW were added the second day and 1000 MW were added the third day. The Load pick up was slow in the affected area due to the extensive distribution network damage received to the CenterPoint and TNP service areas. CenterPoint reported approximately 1200 distribution circuits of their 1500 total circuits were out of service immediately after the Hurricane passed over the Houston area. Commercial and industrial shut downs, utility crew access limitations and evacuations of residents were significant factors in how the load picked up.

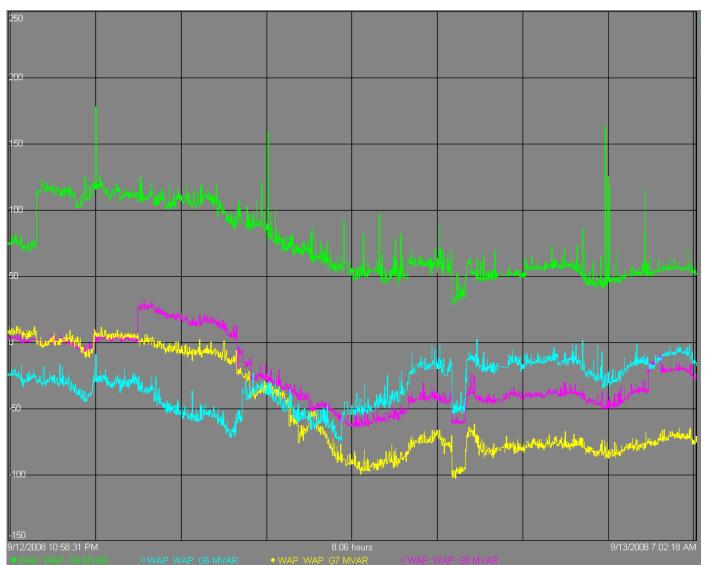
WAP5-8 VAR shows WAP was a net 20 MVAR consumer with WAP 5 supplying 80 MVAR and WAP6-8 in the lead a total of 100 MVAR.
