ERCOT and Texas RE 2015-2016 Generator Winter Weatherization Workshop  
September 1, 2015

## ERCOT's Authority for Spot Checks

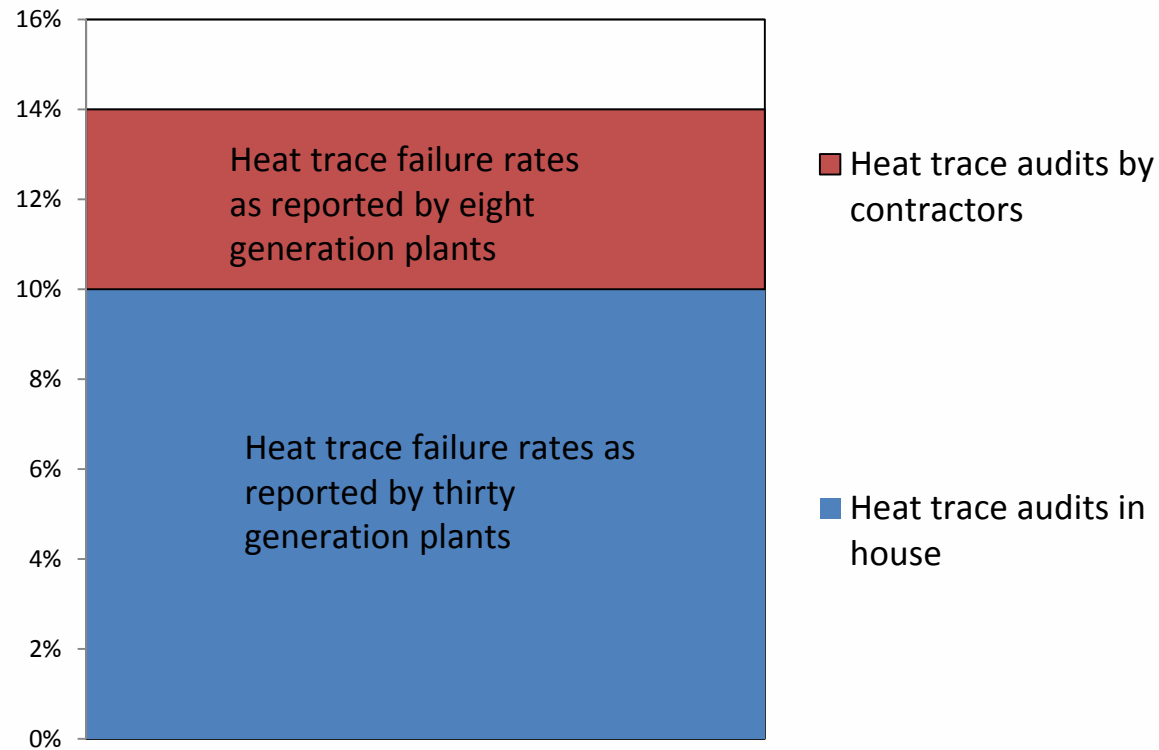
## Heat trace annual maintenance testing results – winter 2014/2015

Six plants reported they do not test their heat trace.

- Heat trace maintenance testing should include meggar, voltage, amperage testing and comparing to design criteria, if known or previous season.
- Thirty eight plants spot checked report annual testing of their heat trace circuits.
  - ✓ ***Recommendations given to continue annual audit on heat trace systems.***
- Six plants spot checked report they do not perform annual testing their heat trace circuits.
  - ✓ ***Recommendations given to start annual audit on heat trace systems.***
- ***Because heat trace circuits worked last winter doesn't mean they're working this year. Annual maintenance testing is necessary.***
