2022 Odessa Disturbance Update

Patrick Gravois
Operations Engineer – Operations Analysis

IBRTF Meeting
September 13, 2022

2022 Odessa Disturbance Event Overview

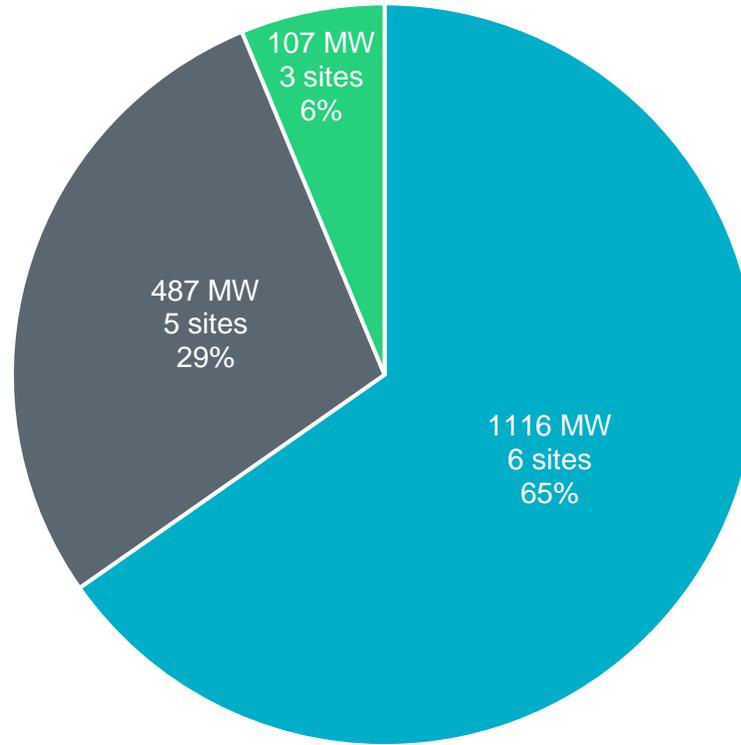
Odessa 2022

- On June 4, 2022, @ 12:59 PM CDT, Phase-B to ground fault occurred due to lightning arrester failure in the Odessa area
- Fault cleared within 3 cycles, consequentially tripping off 542 MW of thermal generation
- Additional 309 MW lost from combined cycle plant in South Texas
- Non-consequential loss of 1,709 MW of solar generation from 14 different sites following the fault
- Combined loss of 2,560 MW of generation
- 1,116 of Load Resources provided Responsive Reserve Service automatically
- Categorized as NERC Cat 3a event (generation loss > 2000 MW)

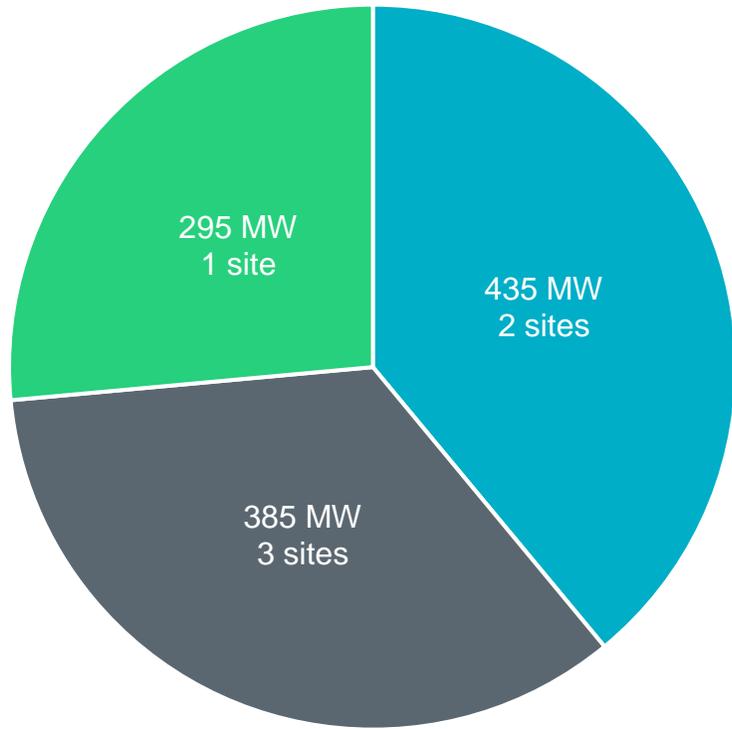
TMEIC MW Loss by Root Cause

Root Cause	# Affected Facilities	MW Loss
AC Overcurrent	3 (2 TMEIC)	445
Volt Phase Jump	3	385
AC Overvoltage	1	295
Vdc Bus Unbalance	2	198
Slow Ramp After LVRT	1	147
Momentary Cessation	1	131
Grid Overfrequency	1	50
Unknown/Misc	2	59

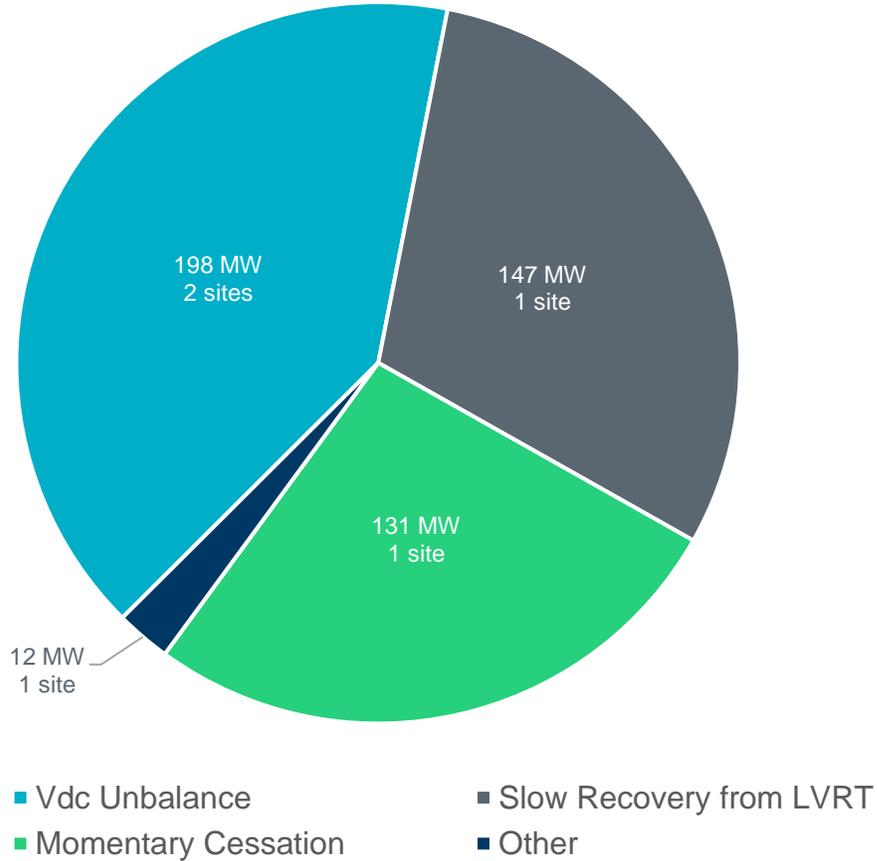
OEM2 MW Loss by Root Cause

Root Cause	# Affected Facilities	MW Loss
AC Overcurrent	3	445
Volt Phase Jump	3	385
AC Overvoltage	1	295
Vdc Bus Unbalance	2	198
Slow Ramp After LVRT	1	147
Momentary Cessation	1	131
Grid Overfrequency	1	50
Unknown/Misc	2 (1)	59 (12)
