Odessa Disturbance – Inverter Based Resources (IBR) Task Force

ERCOT

January 10, 2021

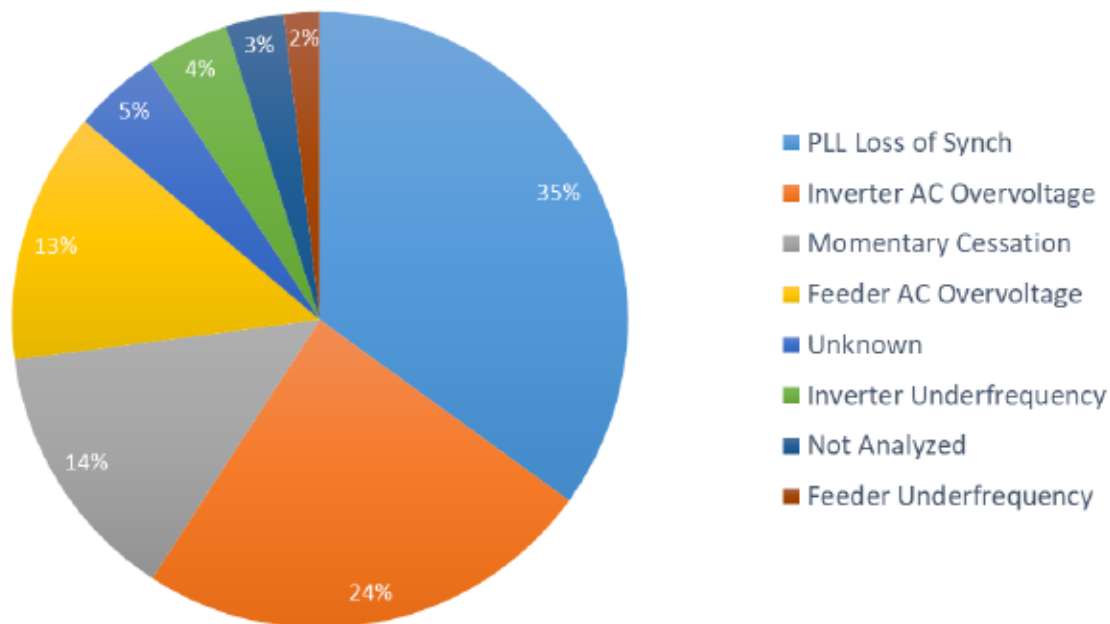
Table 1.1: Causes of Reduction

Cause of Solar PV reduction

*charts and tables from NERC Event Report - https://www.nerc.com/pa/rrm/ea/Documents/Odessa_Disturbance_Report.pdf
