# 2022 Odessa Disturbance Update

Patrick Gravois Operations Engineer – Operations Analysis

IBRTF Meeting November 15, 2022

#### **2022 Odessa Disturbance Event Overview**

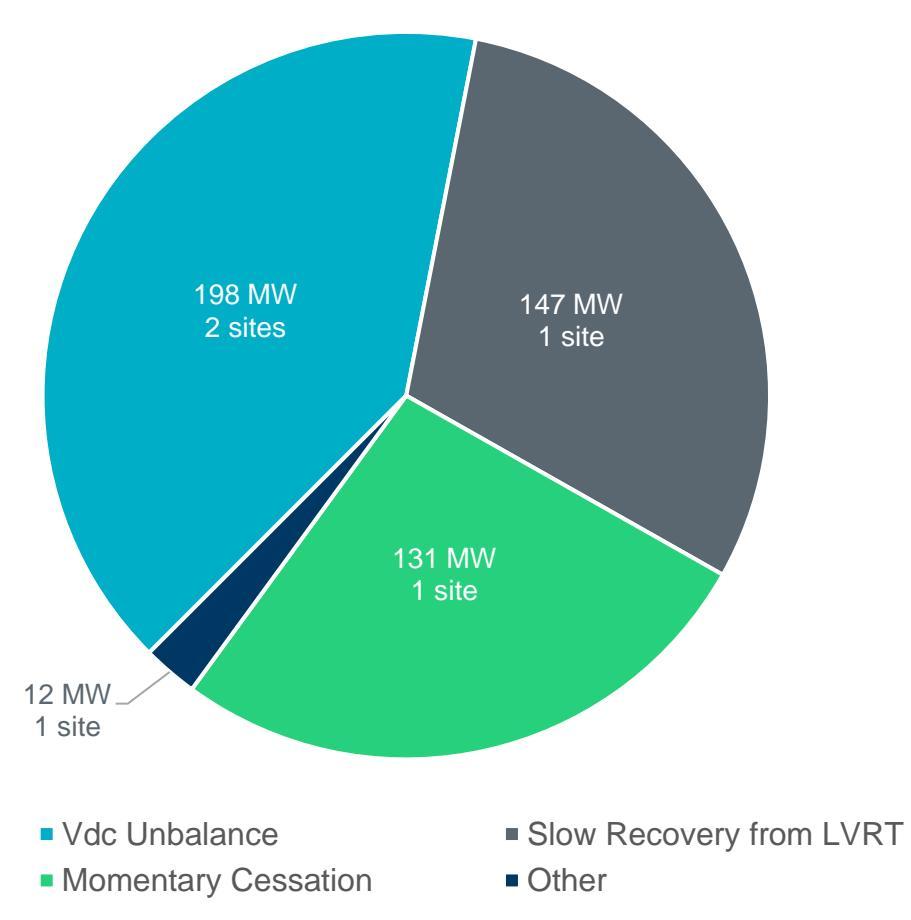
OEM2 MW Loss by Root Cause

Root Cause	# Affected Facilities	MW Loss
AC Overcurrent	3	445
Volt Phase Jump	3	385
AC Overvoltage	1	295
Vdc Bus Unbalance	2	198
Slow Ramp After LVRT	1	147
Momentary Cessation	1	131
Grid Overfrequency	1	50
Unknown/Misc	2 (1)	59 (12)
