Electric Reliability Council of Texas

Final Report: January 6 2014 EEA

Event Date: January 6, 2014

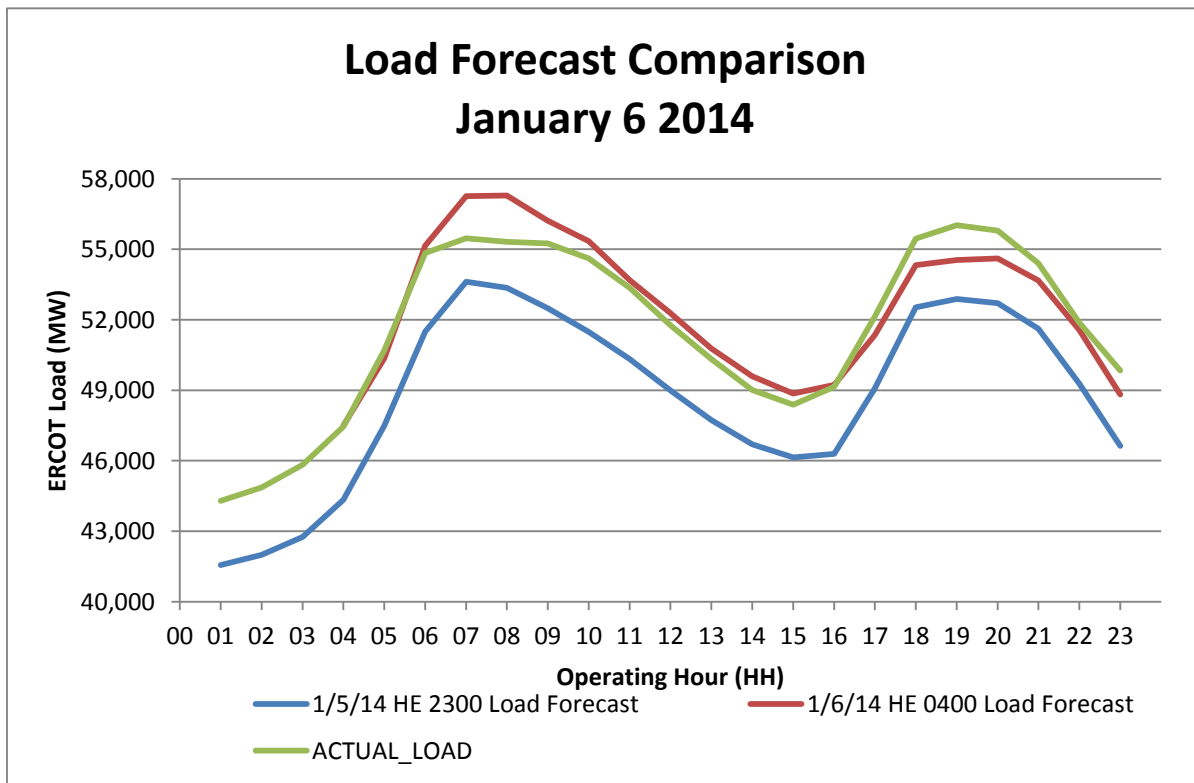
The January 5 2014 23:00 load forecast for snapshot January 6, 2014 predicted load levels much lower than what were experienced in real-time. As can be seen from the graph below, the actual load on average was 2,400 MW higher than the January 5 2014 23:00 forecasted load for Operating Hours 7-10. The current day Load Forecast snapshot taken at 04:00 on January 6, 2014 was closer to the actual load for most of the day. Contributing factors to the discrepancy across the 08 Operating Hour between the current day Load Forecast snapshot and real-time can be attributed to deployment of Load Resources (1082 MW) and ERS (620 MW) as well as public response to media appeals to conserve energy and voltage reduction measures. Adding the Load Resource and ERS deployment numbers back into the load, brings the load forecast error for HE08 to less than 300 MW. Regarding the difference between the January 5 2014 23:00 load forecast snapshot and the January 6 2014 04:00 snapshot, this difference can be attributed in part to updated temperature forecasts in the five hours between these two snapshots. Additionally, the load forecast tool is able to adjust its forecast based on the differences it observes between the past several hours' forecasts compared to the actual load that occurred.

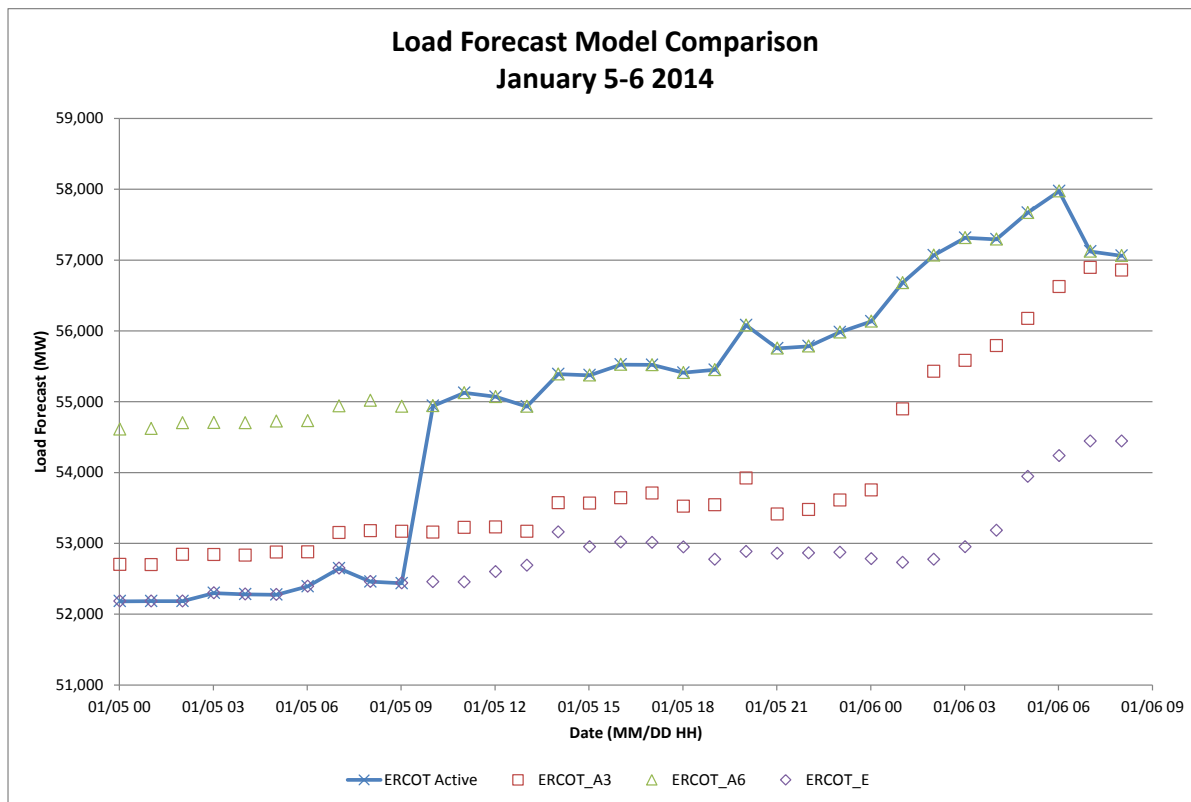
The graph below illustrates which of the three load forecast models was being used on January 5 and 6. On January 5 around HE09, the active forecast was changed to the Areva 2006 model, and remained during the event on January 6.

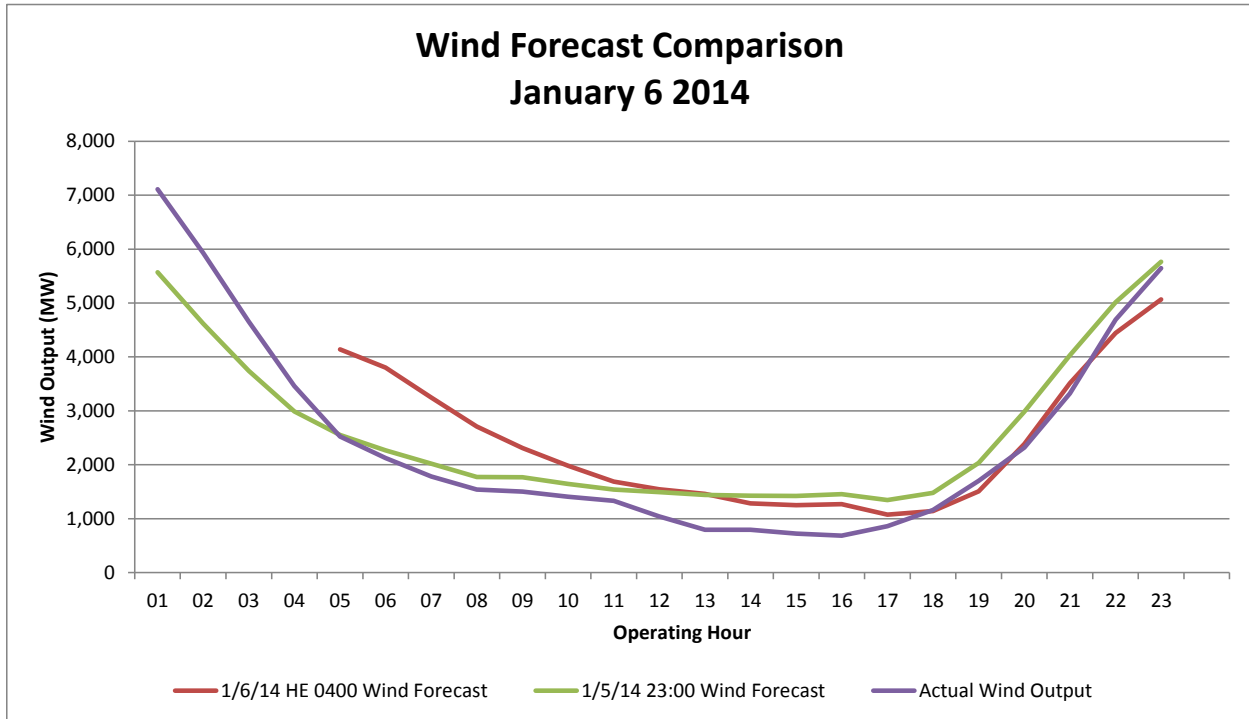
The January 5 2014 23:00 wind forecast for January 6 2014 predicted wind output fairly consistent to the actual wind output observed. As can be seen from the graph below, the actual wind output, on average, was 240 MW below the January 5 2014 23:00 forecast for Operating Hours 7-10. The current day wind forecast snapshot taken at 04:00 predicted a much higher wind output, resulting in a forecast on average 1000 MW above the actual wind output for Operating Hours 7-10. It is important to note that the current wind forecast model does not take into account ambient temperature impacts or icing impacts on wind turbine availability. Wind farm generation companies are required, per Sections 3.15 (12) and 6.5.5.2 (4) of the ERCOT Nodal Protocols, to provide ERCOT with a telemetered value corresponding to the number of turbines available based on local weather conditions. This information is provided back to ERCOT’s wind forecast vendor, however the typical operating conditions of the wind farms are not known to the vendor in advance. In absence of the information, the forecast is unable to adjust to reflect those conditions specific to each wind farm. ERCOT is working with the wind farm generation

companies to collect this information. ERCOT observed 618 MW of derated MWs at 07:00 from wind generators due to weather limiting turbine availability which is also accounted for in the Resource Outages section below.

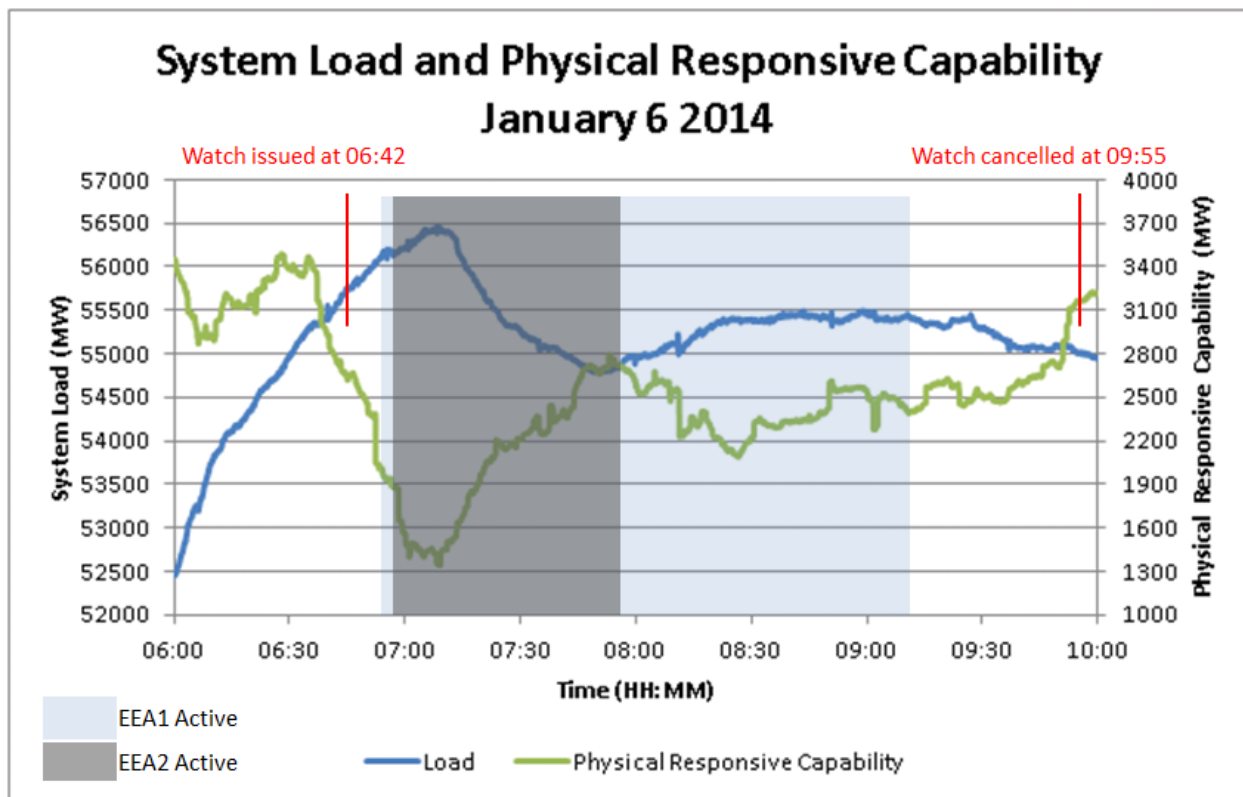
Watch is declared when PRC is below 2500 MW. EEA level 1 is declared when PRC is below 2300 MW and EEA level 2 when below 1750 MW. ERCOT's NERC Contingency Reserve is 1375 MW.

The graph below plots PRC and the system load between 06:00 and 10:00. Notice the inverse relationship between PRC and system load during the ramp. PRC gradually decreased throughout the morning of the 6th as load increased and resource trips and derates continued to occur. The rapid decrease of PRC around 06:30 was the result of the morning load ramp coupled with sudden resource trips and derates across the short period of time. PRC reached its lowest point of 1344 MW at 07:09, and by 07:51 was 2709 MW when ERCOT exited out of EEA level 2. PRC crossed above 2400 MW by 09:11 when ERCOT exited out of EEA level 1. ERCOT was only below its NERC Contingency Reserve of 1375 MW for one minute.

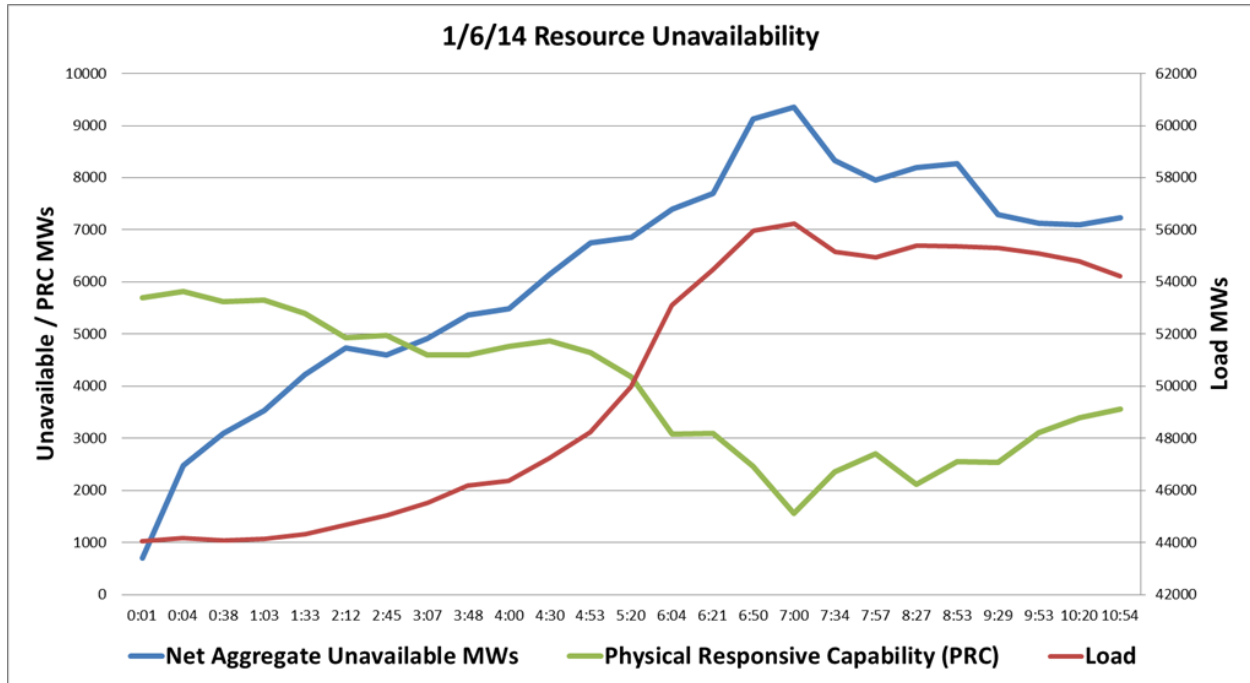
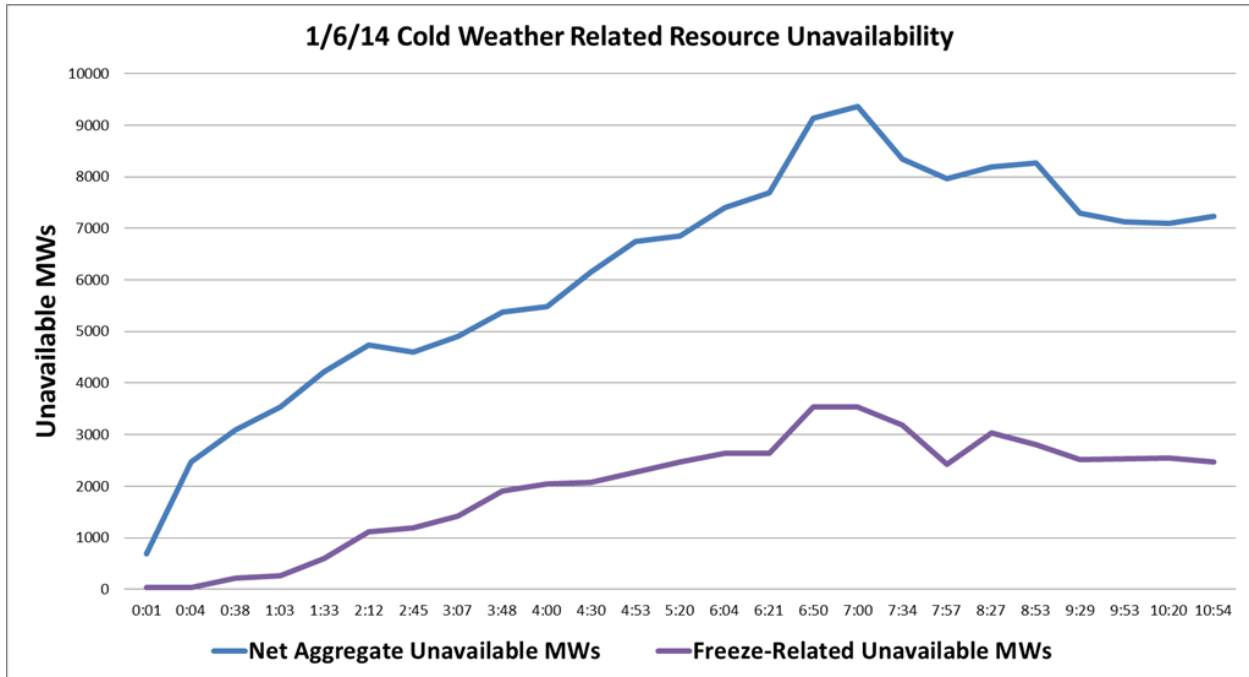
As can be seen from the graphs on the next two pages, at the peak loss of MWs, 9355 MW was unavailable. 3541 MW were related to issues encountered due to weather. From a cumulative perspective, 97 units tripped, derated, or failed to start during 1/6/14 from 00:00 to 23:59. While not expressed in the graph below, ERCOT also had 2468 MW of capacity on planned outage and 2938 MW of capacity on forced outage leading into the operating day. This would indicate a cumulative peak impact of 14,761 MW of generation that was unavailable entering the EEA.

These values represent an increase from previously reported values due to responses received from Requests For Information (RFIs) sent to Qualified Scheduling Entities (QSEs) as well as additional analysis. A majority of the difference can be accounted for by wind derates that were not entered in Outage Scheduler or captured in ERCOT ISO operator logs. Additional information is provided in Appendix A.

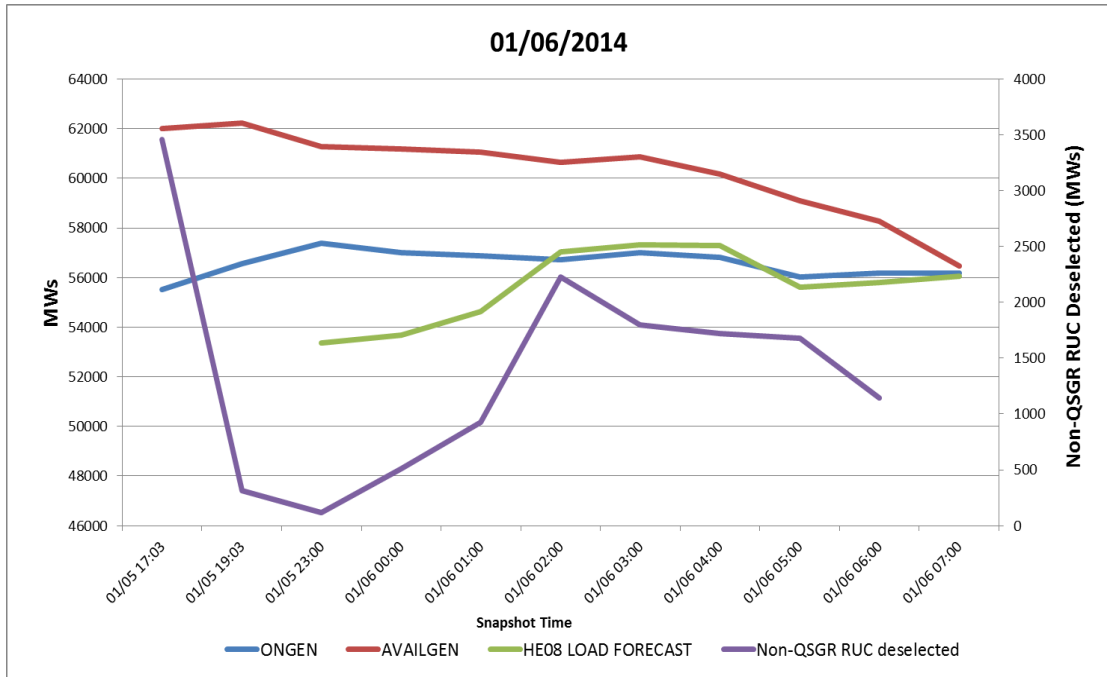
ERCOT performed additional analysis into HE08 for January 6 2014 with regards to available off-line capacity. The graph on the next page illustrates available capacity for HE08 as a function of time, beginning at 17:00 on January 5, through 07:00 on January 6. The graph indicates that during this time, the amount of off-line capacity available to come online to serve load diminished as the operating hour approached. In other words, even though there may have been off-line, non-outaged capacity on the system, that capacity’s temporal limitations (e.g. minimum off-line time, minimum start time) prevented that capacity from being utilized in real-time. This graph also indicates the amount of non-QSGR capacity which was deselected for commitment over time. Note that while this indicates that as much as 1500 MW of capacity was available for commitment in the hours leading up to the event, many of the resources contributing to this number were on-line during HE08 or experienced issues in coming online. Additional details of the RUC process are discussed in the “Resource Outages” section of this report.

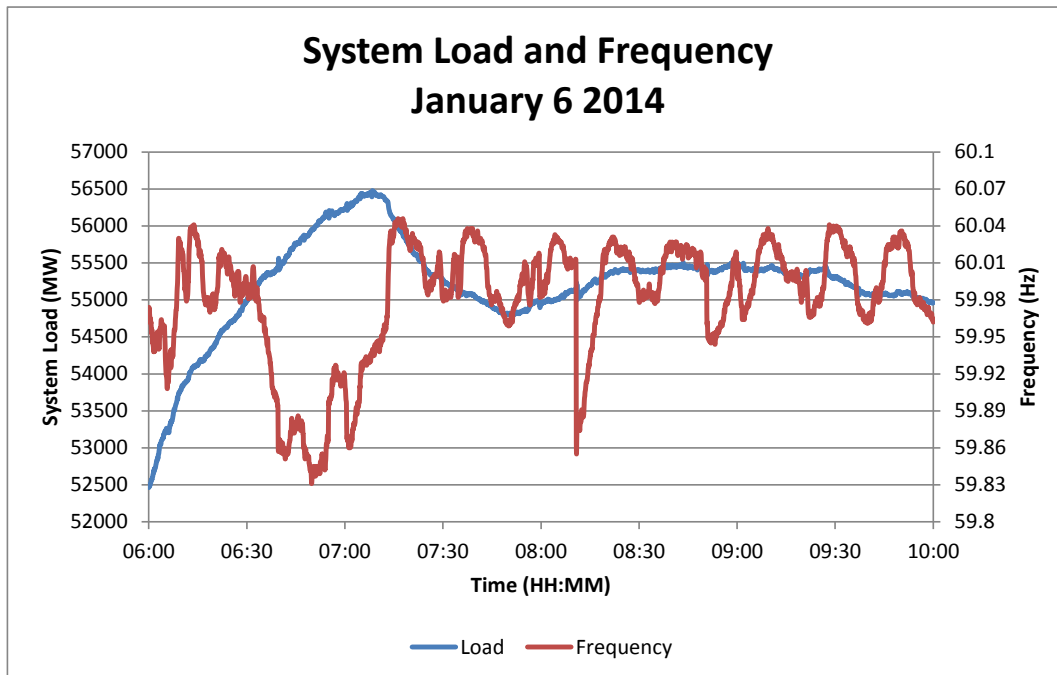
Frequency began decaying at 06:32, and continued declining until 06:49, with a brief period of recovery around 06:44. Frequency reached its lowest point of 59.831 Hz at 06:49:48. Frequency then recovered, crossing 60 Hz at 07:13. There was a frequency spike at 08:10, attributed to the large unit trip (900 MW), and frequency quickly was restored. The graph below illustrates the system frequency during the event.

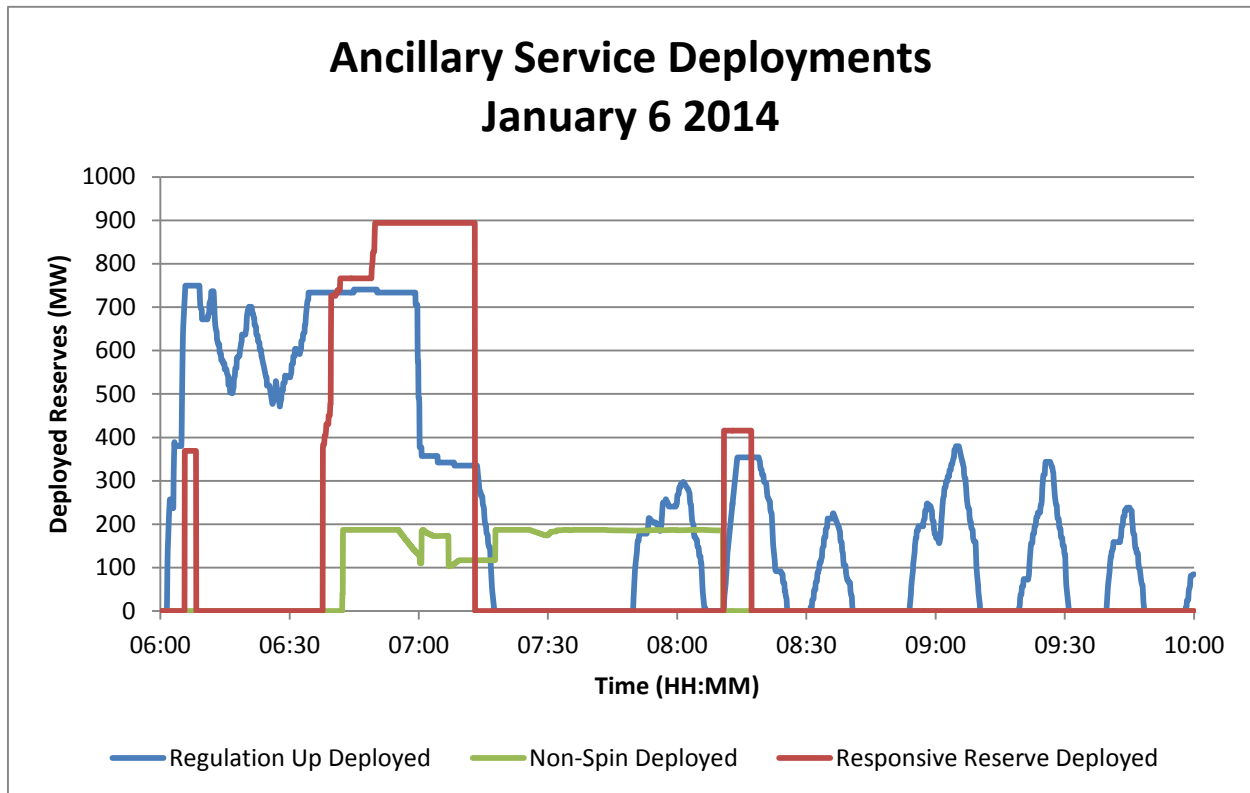
The graph below illustrates the deployment of Ancillary Services during this event. Note that ERCOT had 1500 MW of Non-Spin available during this event. A large percentage of Non-Spin comes from quick-start resources whose capacity is always released to the Security Constrained Economic Dispatch (SCED) application for dispatch subject to price floors. The amount of Non-Spin deployed in this graph is only for that portion of Non-Spin (187 MW) which was provided by off-line resources which ERCOT manually instructed to be deployed. The 187 MW of off-line Non-Spin was deployed to three units. All three units responded to the Non-Spin deployment as required within the required time.

The Responsive Reserve Deployed only indicates those MWs deployed to generators. Note that the Responsive Reserve deployment to generators follows a similar pattern to that of Non-Spin. An RRS deployment is a release of capacity to SCED for dispatch subject to administrative price floors. Details on the Responsive Reserve performance from Load Resources are provided in the section below.

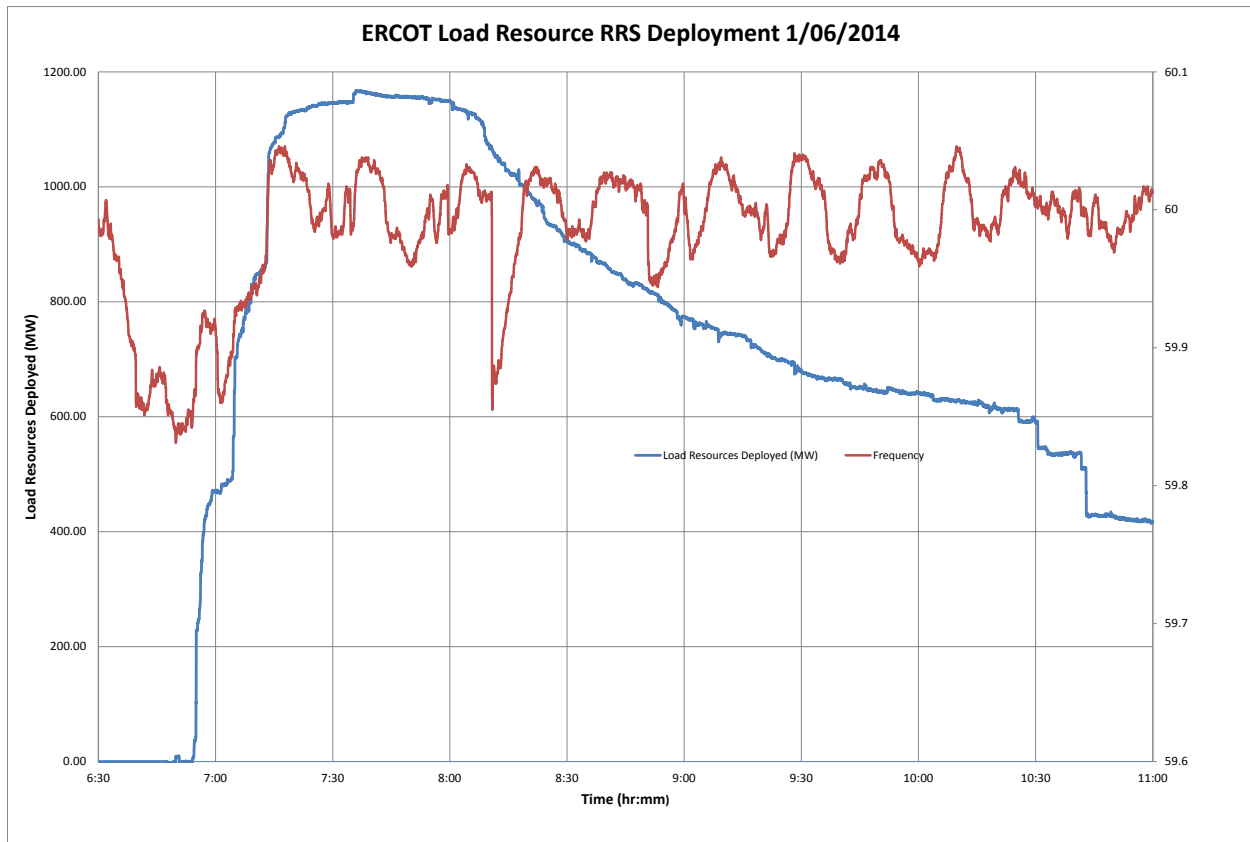
The graph below illustrates the deployment of Load Resources providing RRS between 06:30 and 11:00 on January 6 2014.

Load Resources providing Responsive Reserve Service (RRS) were also deployed during this event. Of the 1085.5 MW of Load Resources deployed, 1018.3 MW responded, for a 94 % performance overall. Section 8.1.1.4.2 Responsive Reserve Service Energy Deployment Criteria, of the ERCOT Nodal Protocols requires energy deployment performance of Load Resources to be between 95% and 150 % of the requested MWs within ten (10) minutes of the deployment instruction. Overall, the Load Resources were very close to meeting the 95 % requirement. The table below indicates the performance by each Qualified Scheduling Entity (QSE) providing Load Resource RRS.

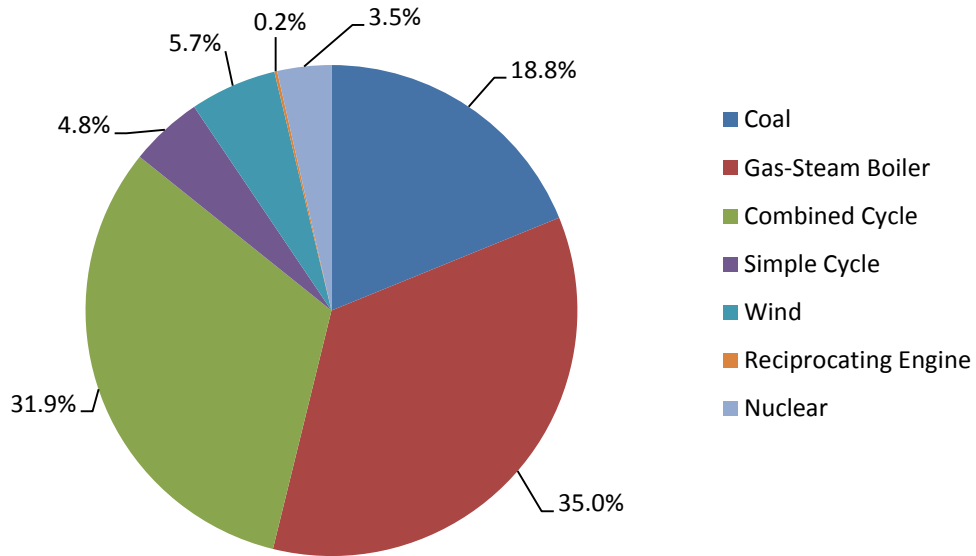
MW Outage by Type

The table below indicates the units which experienced a trip, failure to start, or derate during January 6 2014 (in time sequence). The Pie charts provide a breakdown of the types of units and cause of trips.
