## System Protection Working Group (SPWG)

Update to ROS

DECEMBER 2<sup>ND</sup>, 2021

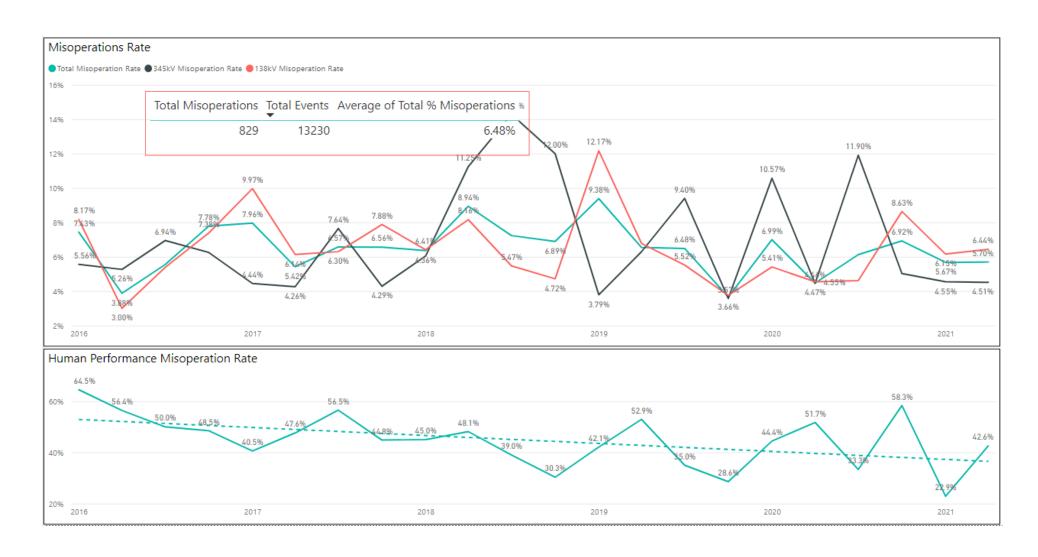
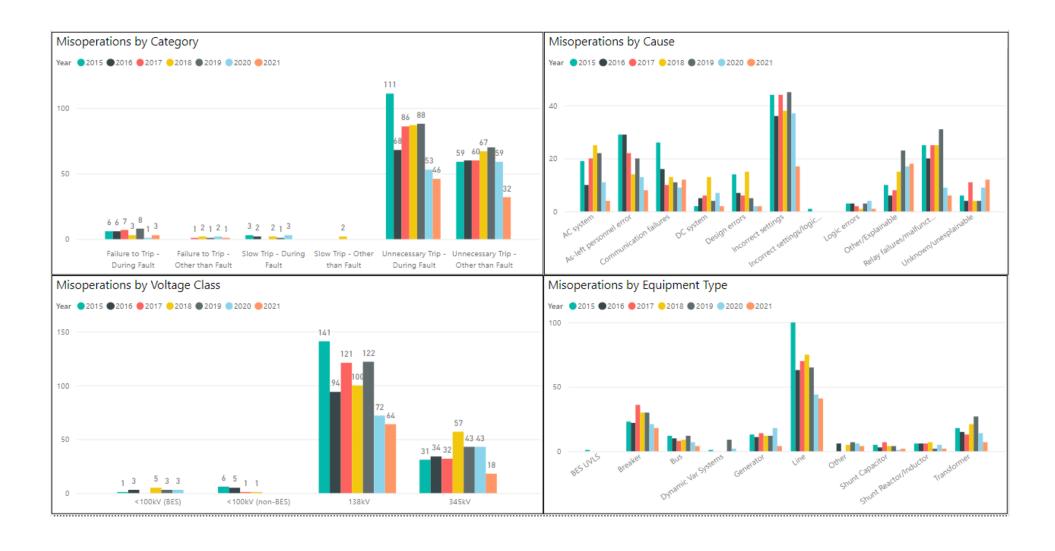
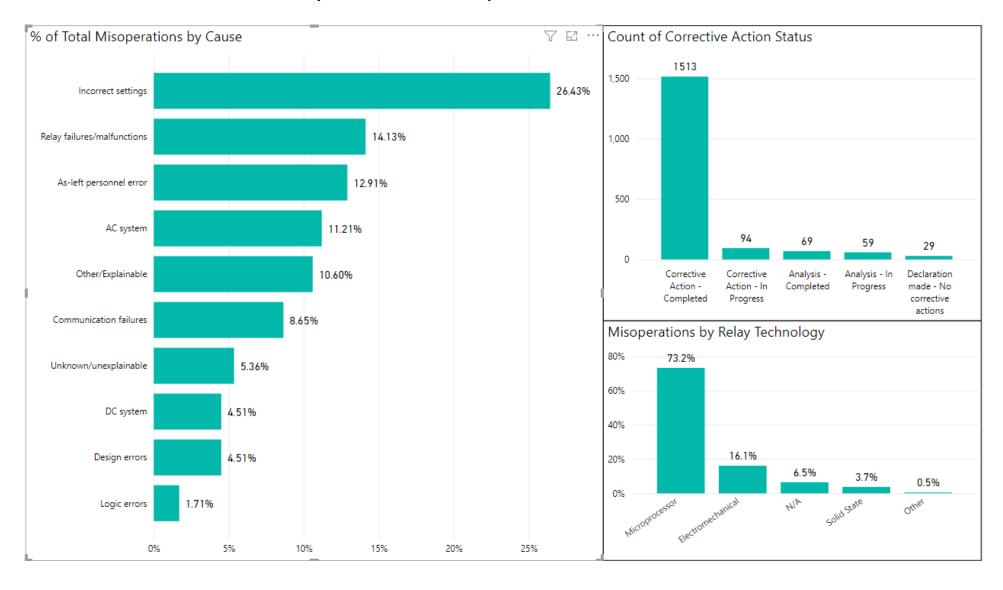
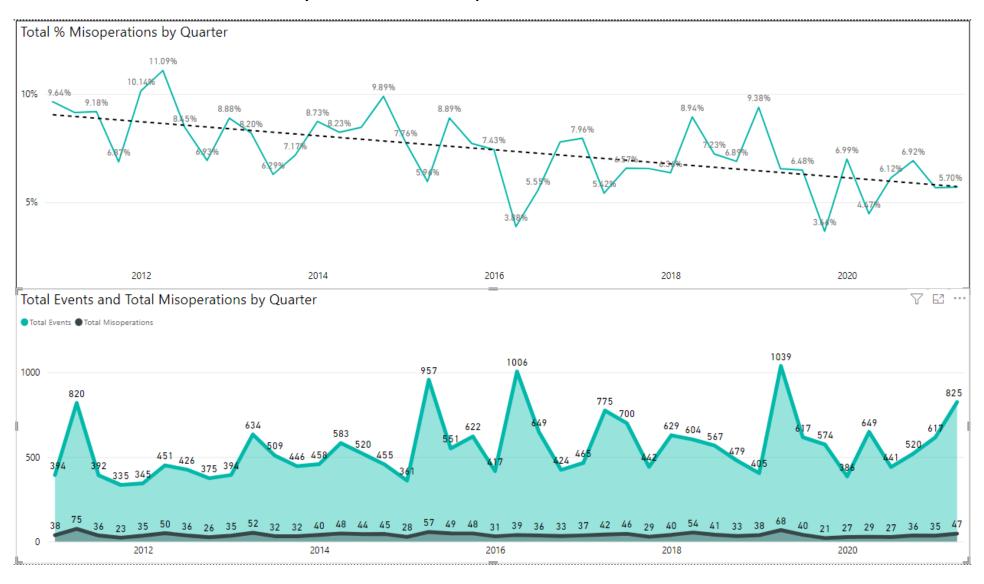
Q2	2021 YTD
# of Misoperations	Total	47	82
	345 kV	11	18
	138 kV	36	64
	< 100 kV	0	0
By Category	Failure to Trip	1	4
	Slow Trip	0	0
	Unnecessary Trip during Fault	27	46
	Unnecessary Trip – Non Fault	19	32
	SPS	0	0
By Relay System Type	Electromechanical	3	9
	Solid State	0	0
	Microprocessor	39	61
	Other/ N/A	5	12
By Equipment Protected	Line	27	41
	Transformer	6	7
	Generator	2	4
	Shunt/Series Capacitor	1	2
	Shunt/Series Reactor	2	2
	Dynamic VAR system	0	0
	Bus	2	4
	Breaker	6	18
	Other	1	4
