Oncor – Peck to Driver 138-kV Line Project ERCOT Independent Review Status Update

RPG Meeting March 22, 2023

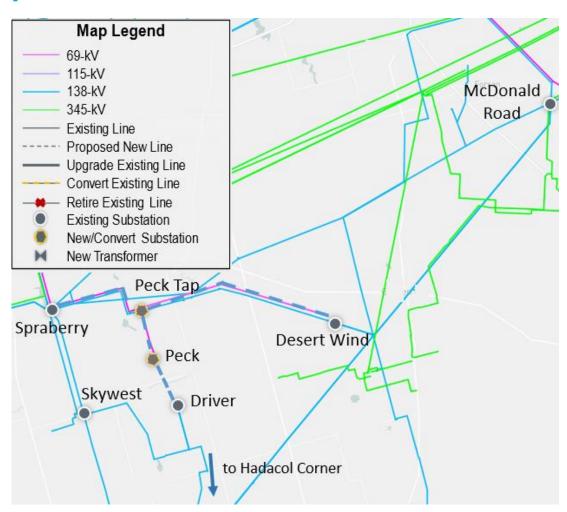
- Construct the new 138-kV Peck Tap Switch
- Convert the existing 25.4-mile Spraberry – Peck Tap – Desert Wind 69-kV line section to operate at 138-kV
- Construct an approximately 0.1mile loop of the existing Spraberry

McDonald Road 138-kV line into the new Peck Tap Switch
- Convert the existing 4.0-mile Peck
 Tap Peck 69-kV line to 138-kV
- Construct a new Peck Driver 138-kV line (~ 4.1 miles)
- Reconfigure the existing Desert
 Wind 138-kV substation from a
 single-tap configuration to a
 double-tap configuration so the
 substation is served from the Peck
 Tap Midkiff/McDonald Road 138kV double-circuit line

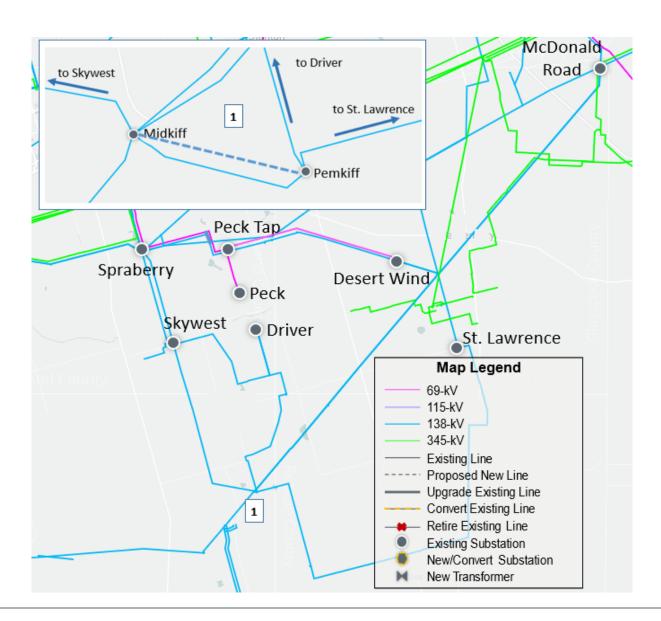
Option 2: New Midkiff – Pemkiff 138-kV Line

Construct a new Midkiff – Pemkiff 138-kV line (~ 0.3 miles) on separate structures

Option	Load Serving Capability (MW)	Violation
Option 1	210	Bus Low Voltage
Option 1 plus capacitor bank	800	Bus Low Voltage
Option 2	90	Thermal
Option 3	90	Thermal

- In Option 1, adding capacitor bank at a 138-kV bus could significantly increase the load serving capability (~ 800 MW)
- In Options 2 & 3, thermal overload of 69-kV system was observed with additional 90 MW load in the four counties. Adding shunt reactive support would not be able to relieve the thermal overload

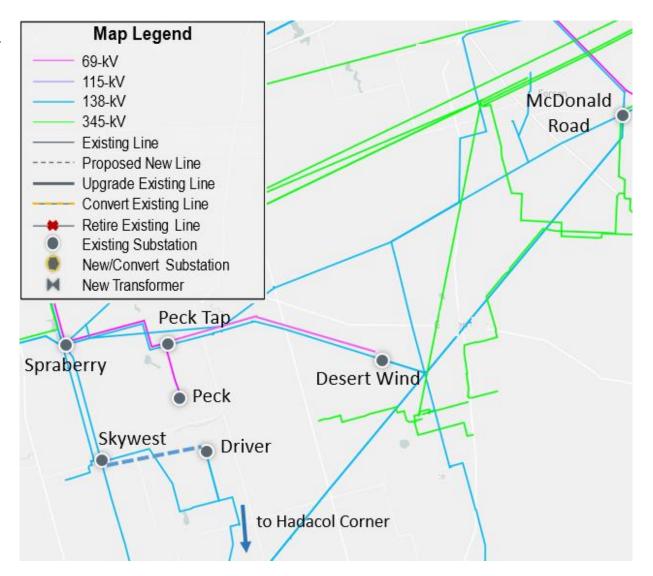
Option 3: New Skywest – Driver 138-kV Line

Construct a new Skywest – Driver 138-kV line (~ 9.4 miles) on separate structures
